January 13, 2015

Re: Summary of Geotechnical Monitoring and Inspection Services on December 22, 2014
Inclinometers/Piezometers/Wells at Kelok Way, Clayton, California
SFB Project No: 555-2

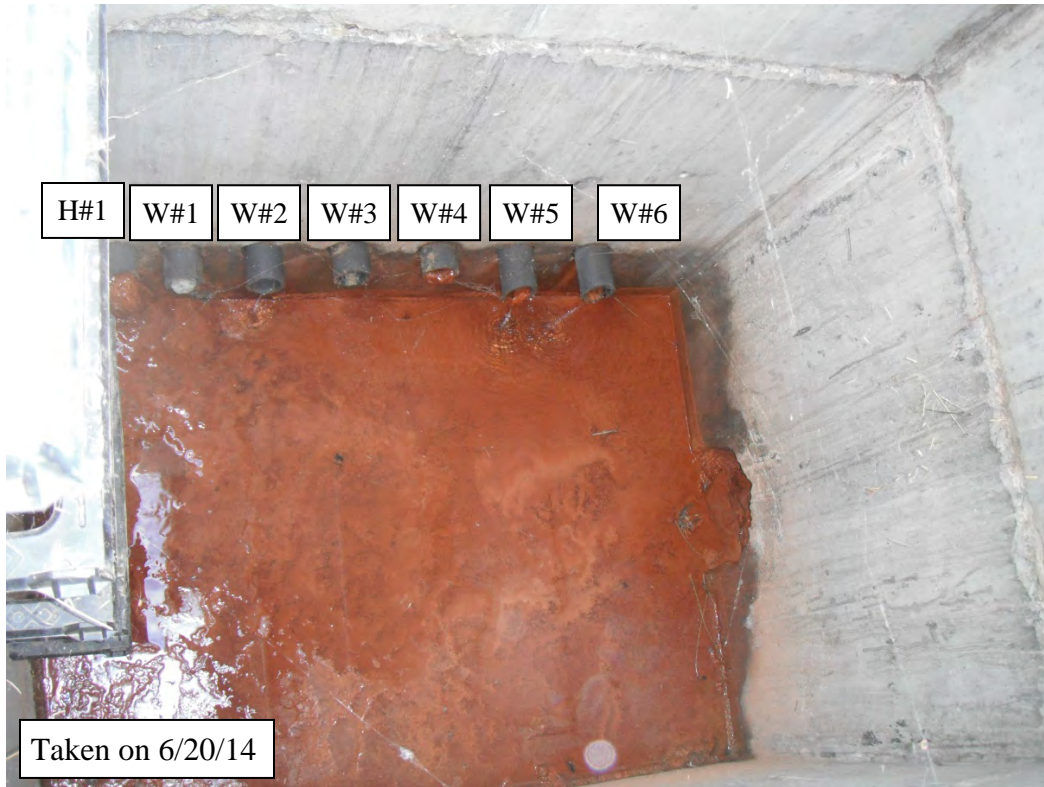
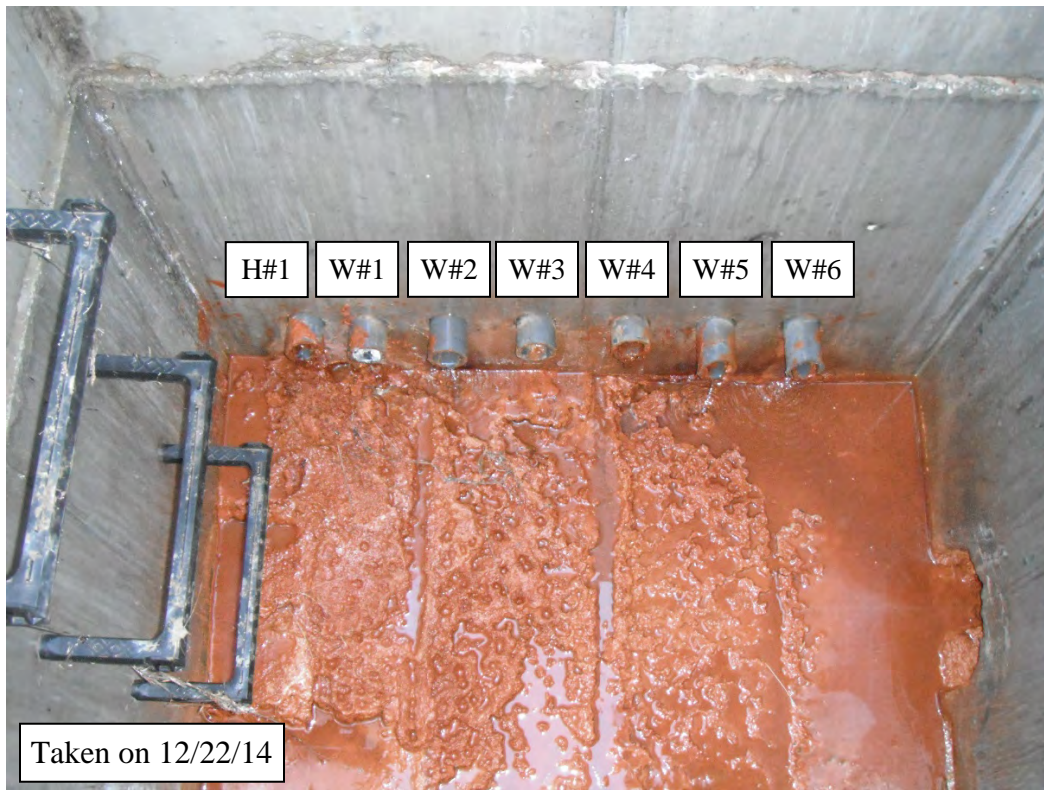
Figure 2, Photograph of Outlet Pipes

Discharge from the dewatering well outlet pipes in the collector box was observed on 12/22/14, with Drains H#1, W#2, W#5, and W#6 exhibiting a stream of water, Drains W#1 and W#4 showing dripping water. Drain W#3 appeared to be blocked with only some moisture observed at the pipe end. Drain H#1 is an outlet pipe that was encountered at the approximate collector box location during the construction of the collector box in the fall of 2012; it is unclear what H#1 drains. Field photographs of these outlet pipes taken on 6/20/14 and 12/22/14 are attached as Figure 2 for reference.

The results of our vibrating wire and open pipe piezometer monitoring generally showed similar results as those indicated by historical monitoring records. The measured groundwater levels in the piezometers generally indicated slightly higher groundwater level conditions on 12/22/14 compared to the previous monitoring results on 6/19/14 and 6/20/14, which may be related to seasonal fluctuations. The discharge conditions of dewatering well outlet pipes are similar to what was observed at the completion of the wells, except for Drain W#3 that appears to be blocked.

We recommend outlet pipes in the collector box shown on Figure 1 be hand cleared of any built up debris or deposits. We recommend this removal occur on a yearly basis.

To increase the water discharge from Wells W#1, W#3, and W#4, consideration should be given to installing sump pumps directly into the wells located within Kelok Way and discharging the pumped water to the existing storm drain system.

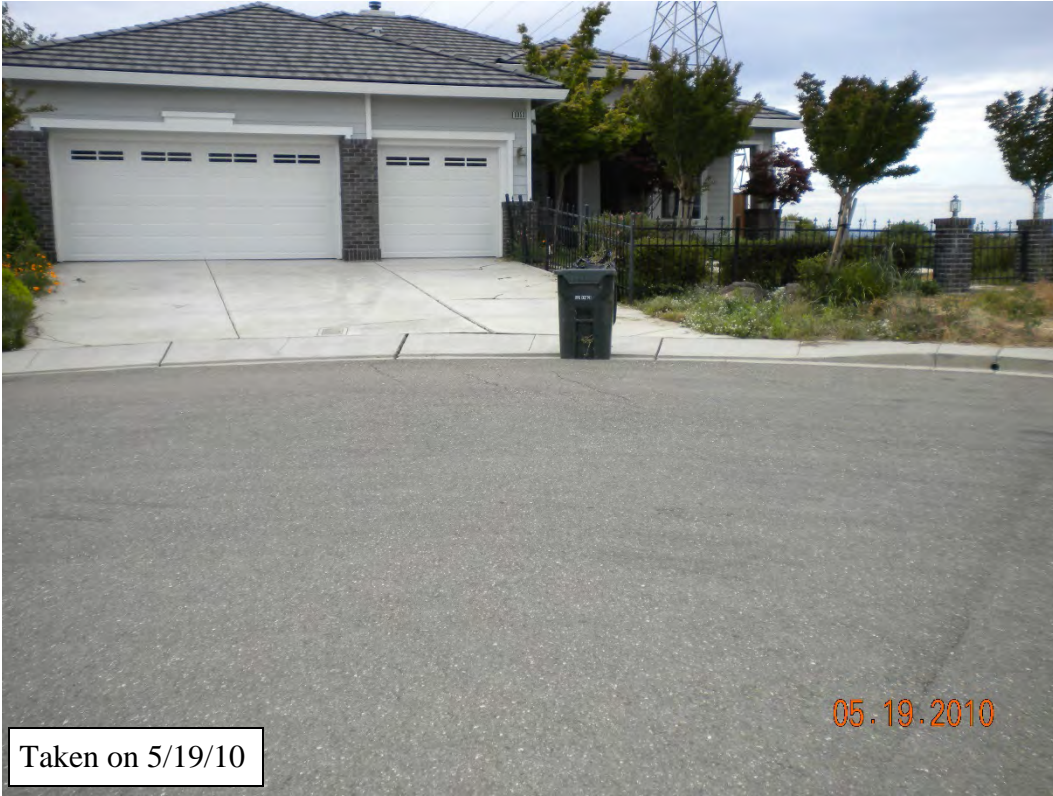
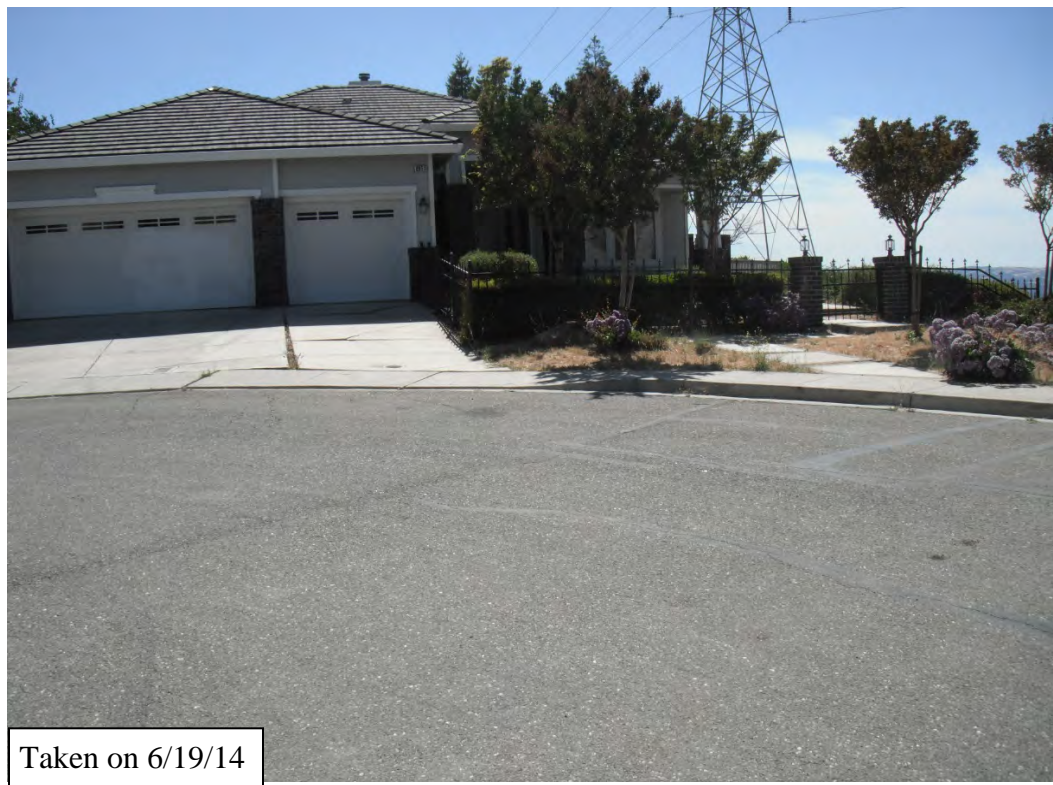
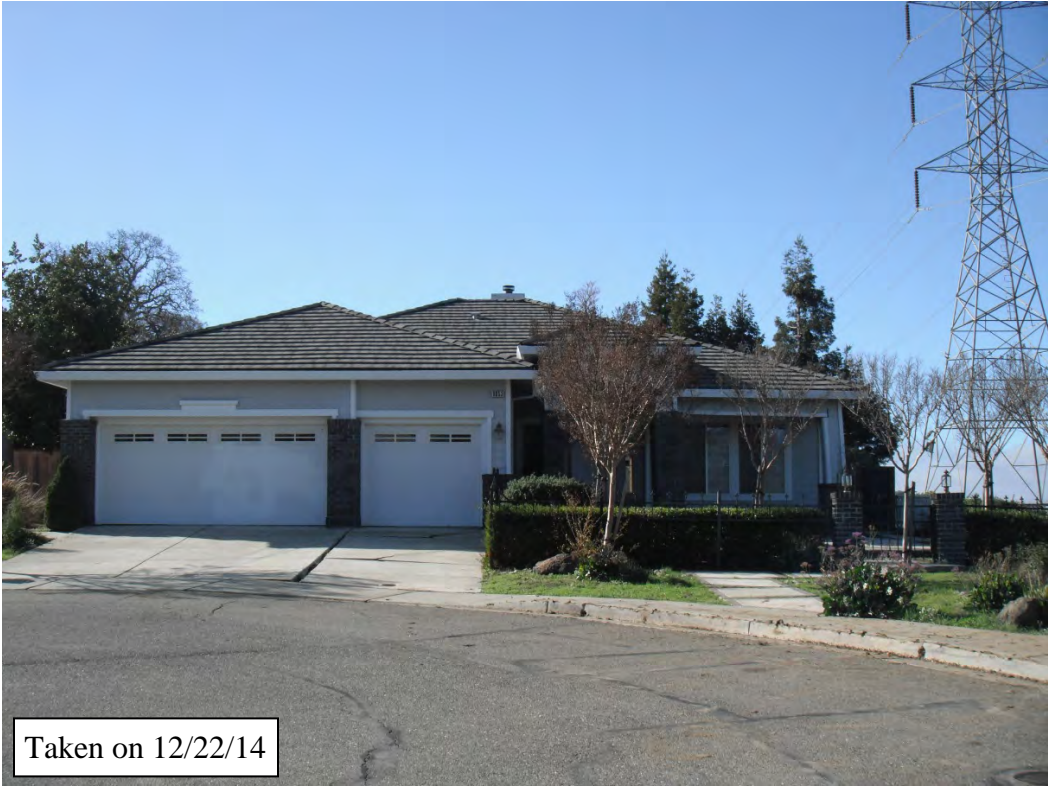
Figure 3, 8053 Kelok Way

The past slope movement in the area of CSA SI-4 has caused movement of the Kelok Way cul-de-sac, associated infrastructure, and the home and improvements at 8053 Kelok Way. The home at 8053 Kelok Way has clearly undergone detrimental movement that affects the structural integrity of the house. Future slope movement will result in significant and detrimental damage to the public and private property and associated improvements located upslope and downslope of CSA SI-4 shown on Figure 1. The magnitude of damage and when the damage will occur cannot be accurately predicted due to numerous variables. We recommend a replacement inclinometer casing be installed in the area for further monitoring. Serious consideration should be given to stabilizing the movement and repairing the damage. We also recommend the existing infrastructure (including underground utilities) be inspected to determine if detrimental damage has occurred. Any damage to water bearing utilities should be repaired immediately to reduce the potential for subsurface water breaks that could decrease the stability of the slope.
