January 19, 2009
Job No. 2947.100

Oakhurst Geologic Hazard Abatement District
c/o Permco Engineering
5375 Clayton Road
Concord, California 94521

Subject: Slope Inclinometer Plots and
Observations of Progressive Offset to V ditches
Open Space Slope Below Lots 59 through 61
Pebble Beach Drive
Clayton, California

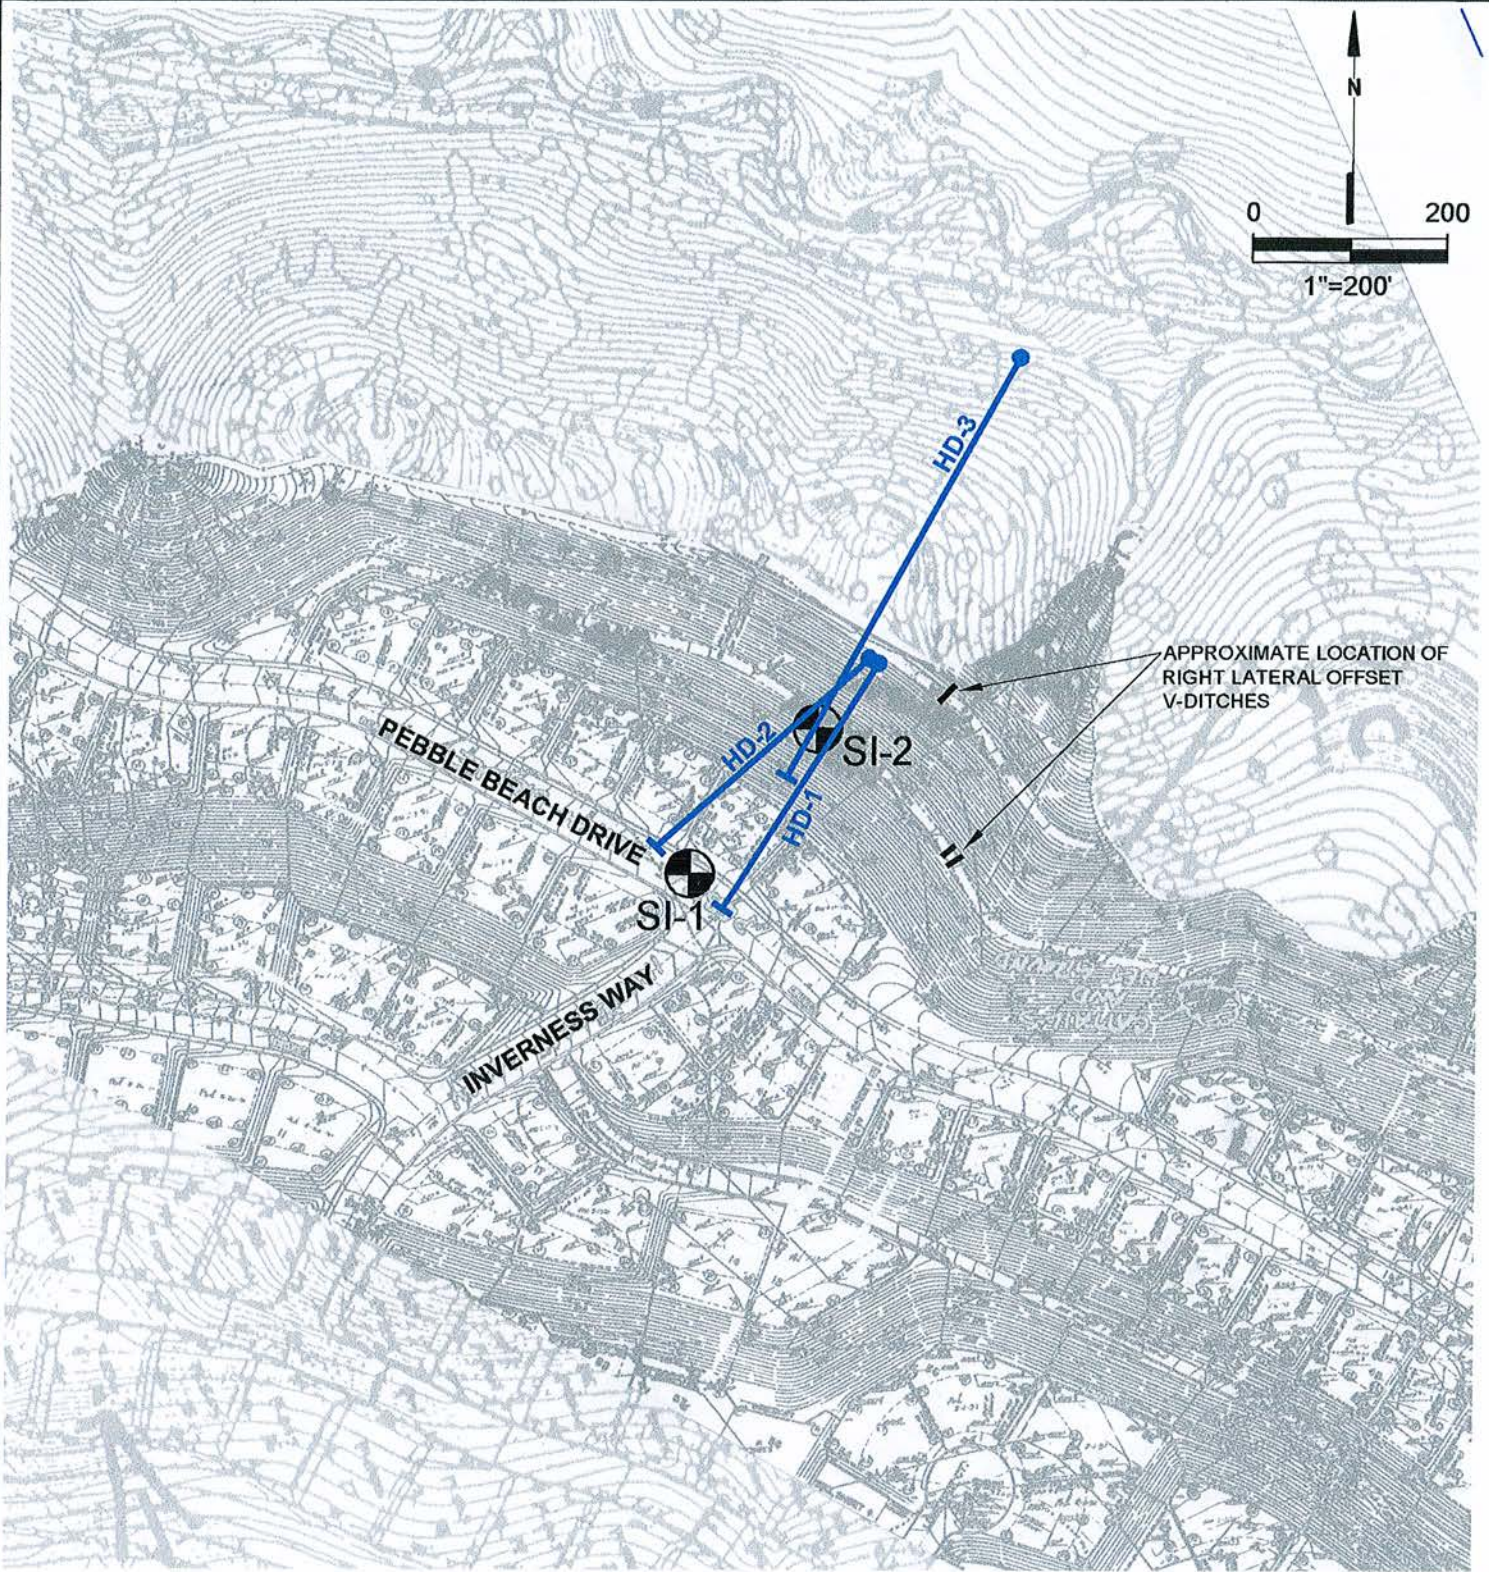
SITE PLAN

We recently performed our annual site reconnaissance on October 23, 2008. We observed that the street section along Pebble Beach Drive had recently been slurry sealed and the cracks discussed in our February 11, 2008 letter were no longer visible. The separations between driveways and the sidewalk and gutter and the cracking of the sidewalk are generally about the same as previously observed. On the open space slope, we observed that the right-lateral offset of the concrete v-ditches below Lot 59 has continued. We previously measured two areas of V-ditch offset below Lot 59 that showed about 1 to 1½ inches at each location. These cracks now show up to about 1½ to 2 inches of right lateral offset. Additionally, the next V-ditch downslope of these offset cracks is also right-laterally offset about ½ inch at the location where a gap had been previously filled with concrete. The approximate locations of offset to the V-ditches are shown on Plate 1.

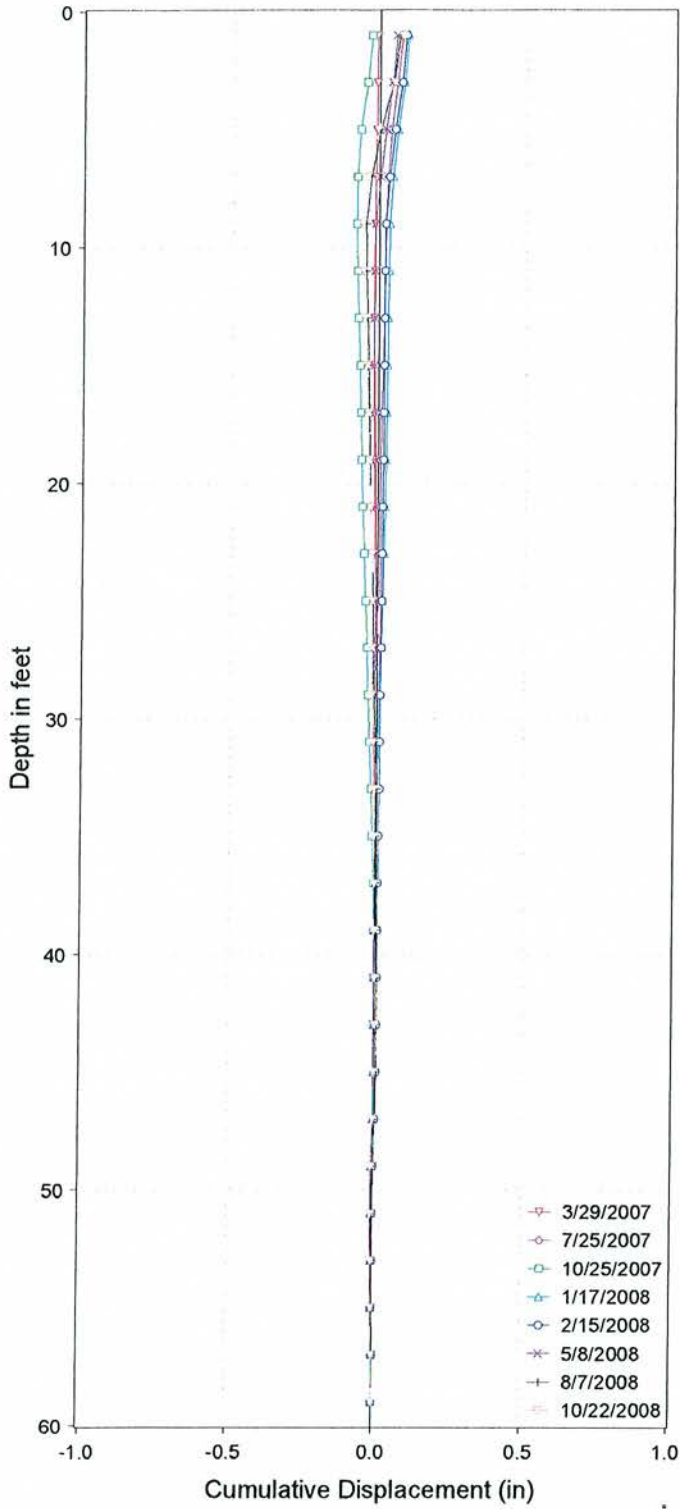
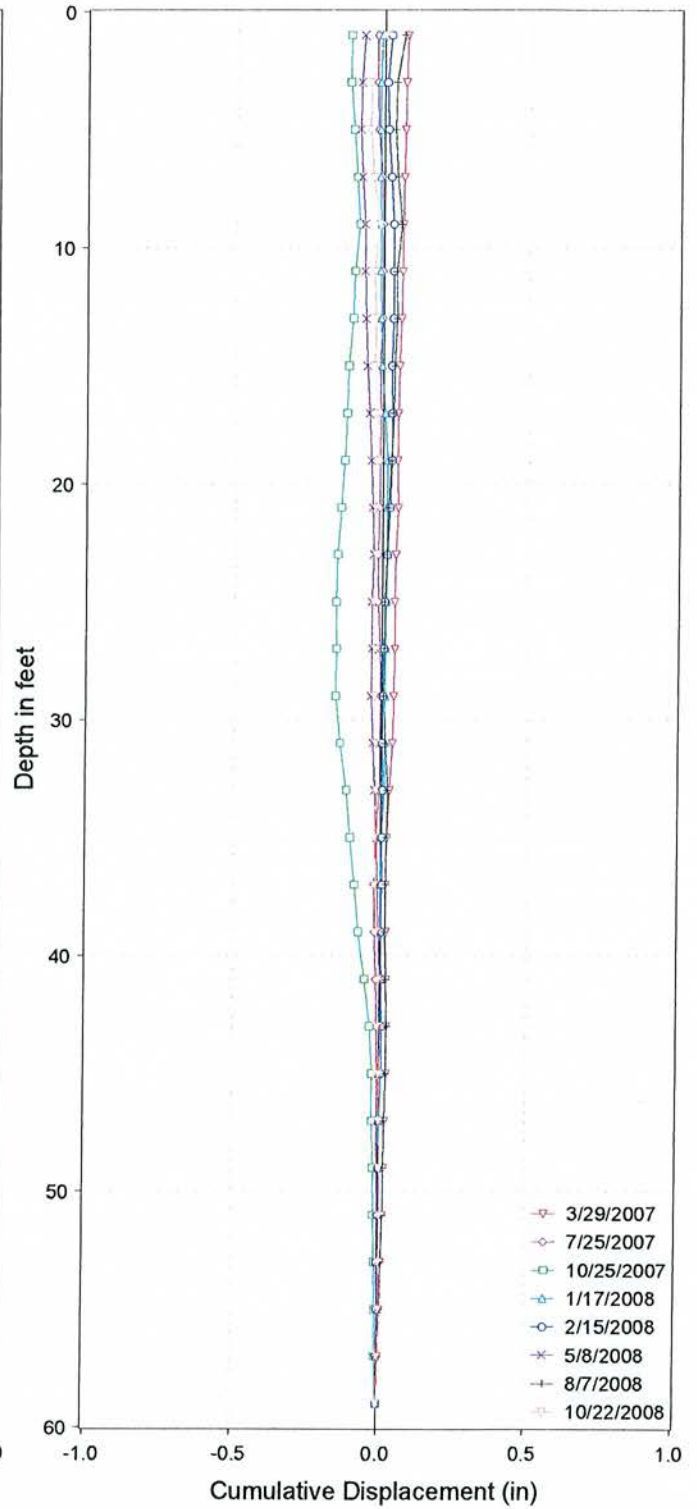
SI-1, A-Axis

As part of our quarterly monitoring program for the subject slope, slope inclinometer readings were recently taken on October 22, 2008. Slope Inclinometer SI-1 is located along Pebble Beach Drive adjacent to Lot 60 and SI-2 is located on the open space slope below Lot 60. Slope Inclinometer SI-1 does not show definitive deformation. The plots for SI-2 show continual deformation of the slope inclinometer casing at a depth of about 72 feet. The shape and character of the plot of Slope Inclinometer SI-2 is clearly the result of landslide movement. Since the baseline readings on February 20, 2007, the landslide has deflected the slope inclinometer casing about 1½ inches. Additionally, the rate of deformation of the SI-2 casing has increased over the past two readings and is currently displacing the casing at a rate between about 1 and 1¼ inch per year. The Plots for SI-1 and SI-2 are presented on Plates 2 and 3, respectively.

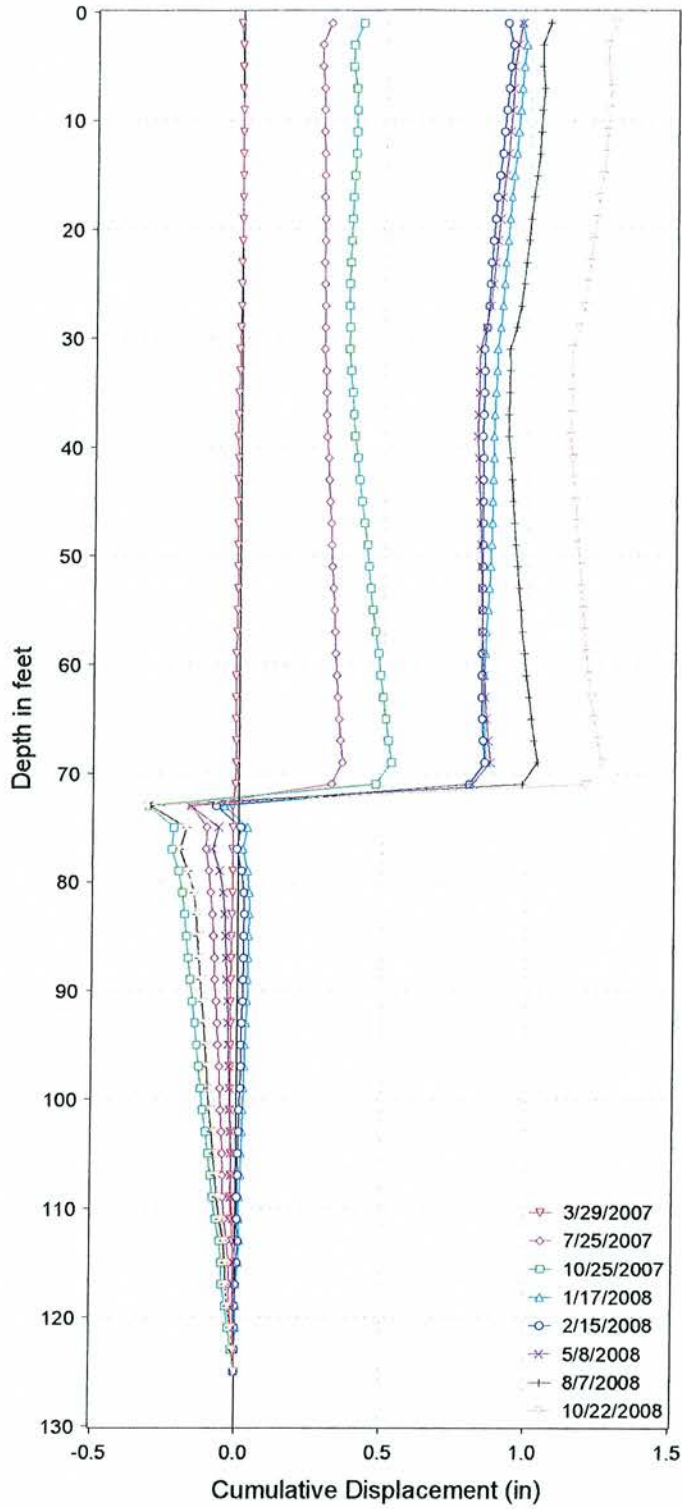
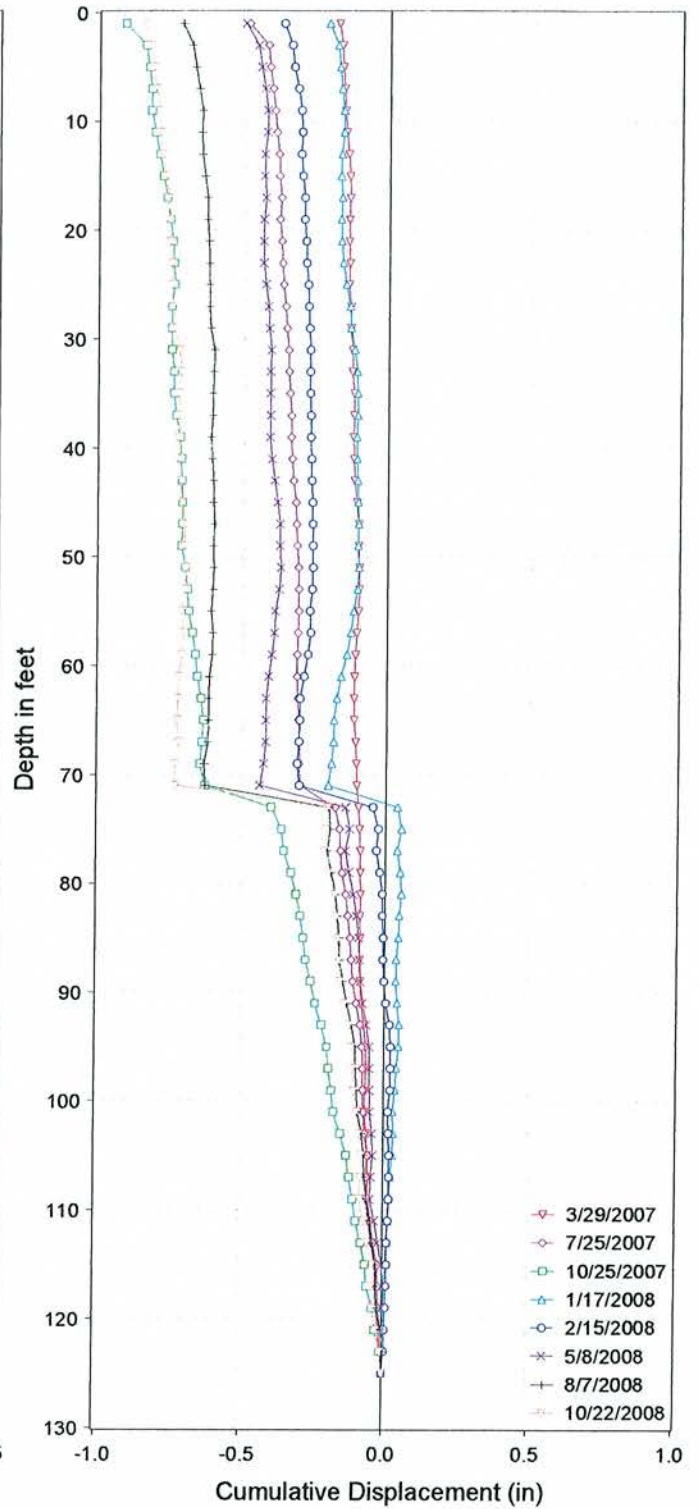
SI-2, A-Axis

The information provided to date by our on-going slope monitoring program indicates that a landslide is moving below a substantial portion of the development. If this landslide is not stabilized, affected homes may be seriously damaged and perhaps, in some cases, totally destroyed. It is expected that the landslide will continue to move and exhibit further definition at the ground surface within a short period of time. The recent readings show that the rate of deformation of the slope inclinometer casing SI-2 has increased from previous readings.

As stated in our November 29, 2007 proposal, the area of distress appears to be much larger than originally believed. Therefore, additional investigation and expanded slope monitoring should be performed as soon as possible to better define the problem area and to gather critical information needed for the design of landslide stabilization measures.
