January 28, 2025 (revised 1/30/2025)

BSK Project No. G24001595

SUBJECT: Annual Geological and Geotechnical Site Reconnaissance – 2024-2025
Oakhurst Geological Hazards Abatement District (GHAD)
Clayton, CA

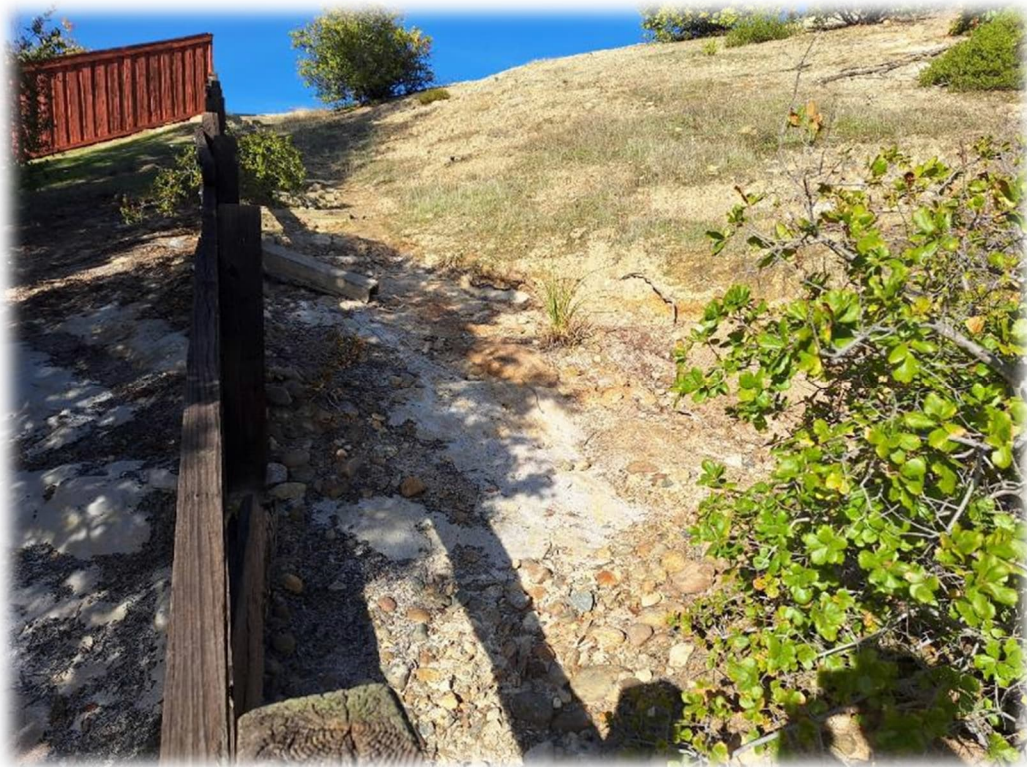
Photograph 1 – Recent slope erosion/wash along trail access point at the end of Crow Place.

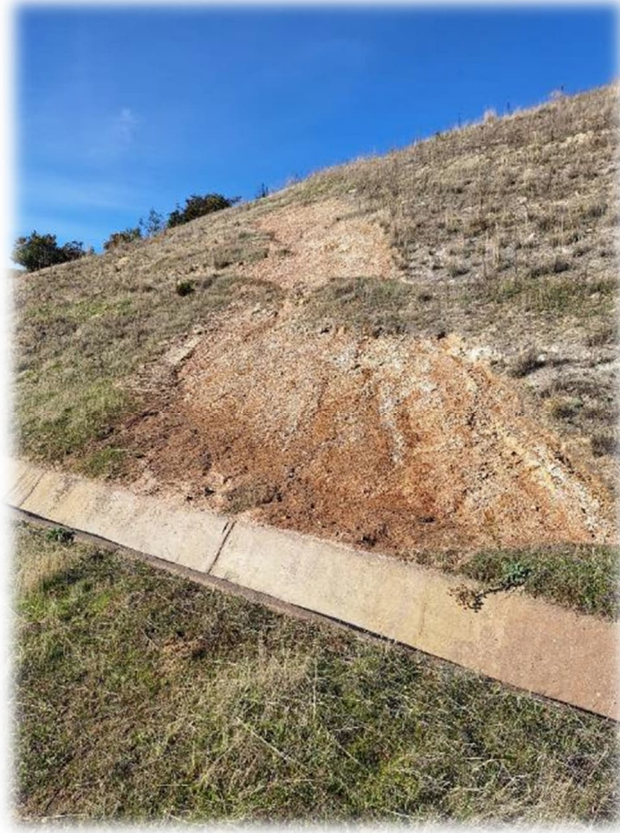
Photograph 2 – Recent slope erosion/wash north of 3027 and 3029 Windmill Canyon Drive.

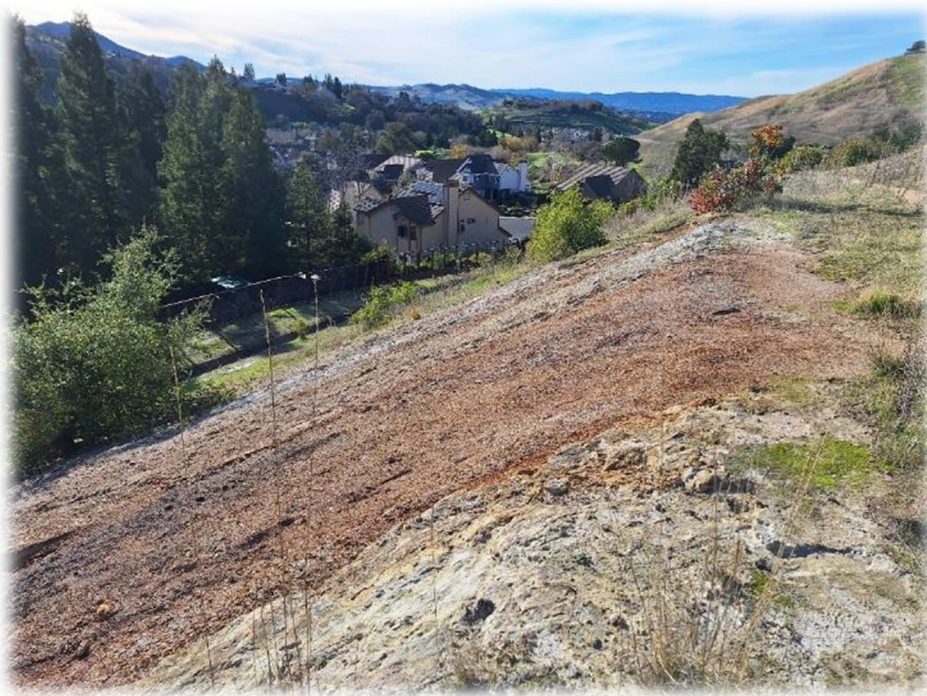
Photograph 3 – Additional slope erosion immediately south of Photograph 2.

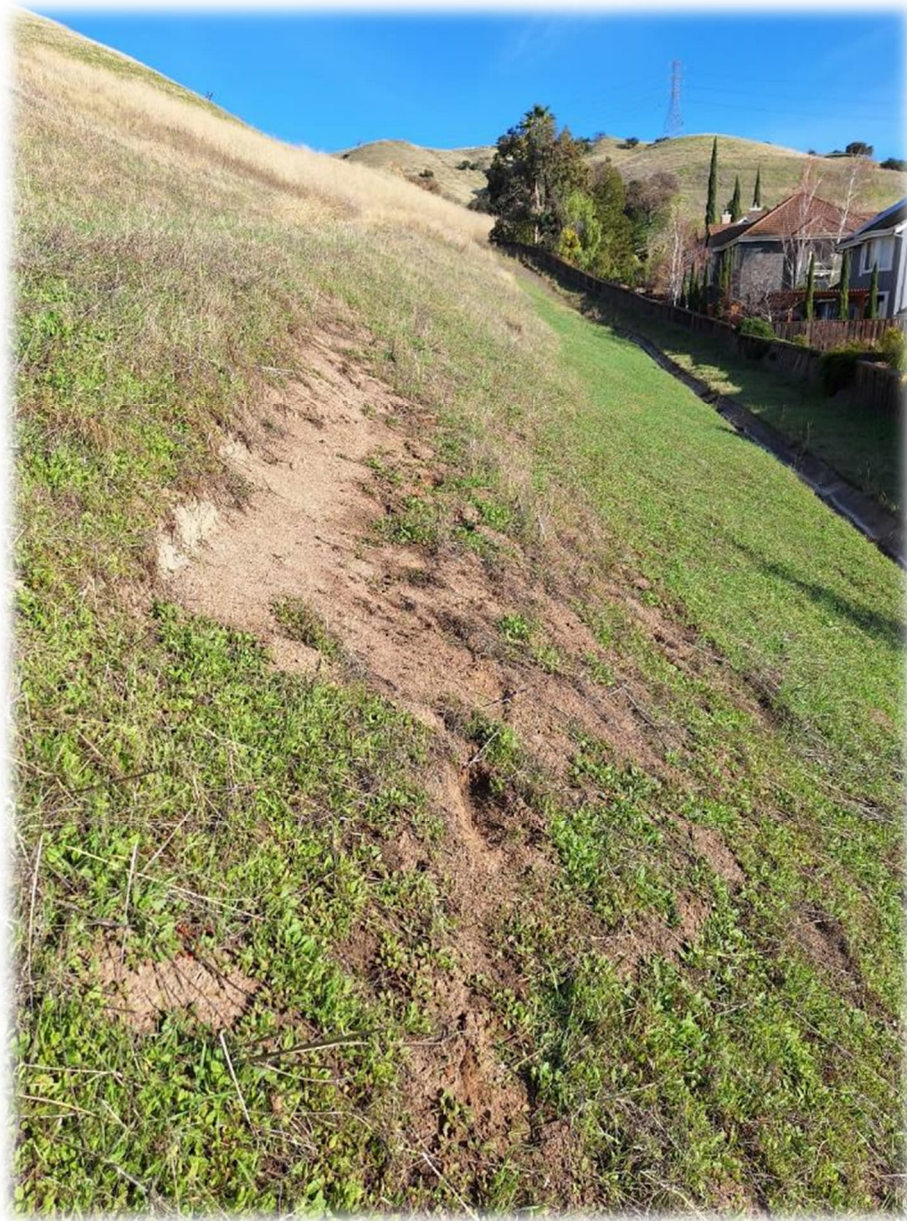
Photograph 4 – Minor slump along slope immediately north of 3061 Windmill Canyon Drive. No movement or bulging observed at toe of slope near V-ditch.

- It is possible that the minor slump noted in Photograph 4 above could liquefy (i.e., become saturated and cause a mudflow downslope) during a long duration or heavy rainstorm. Therefore, we recommend that City staff or BSK visit this location during or immediately after a long duration or heavy rainstorm to check the slope condition.

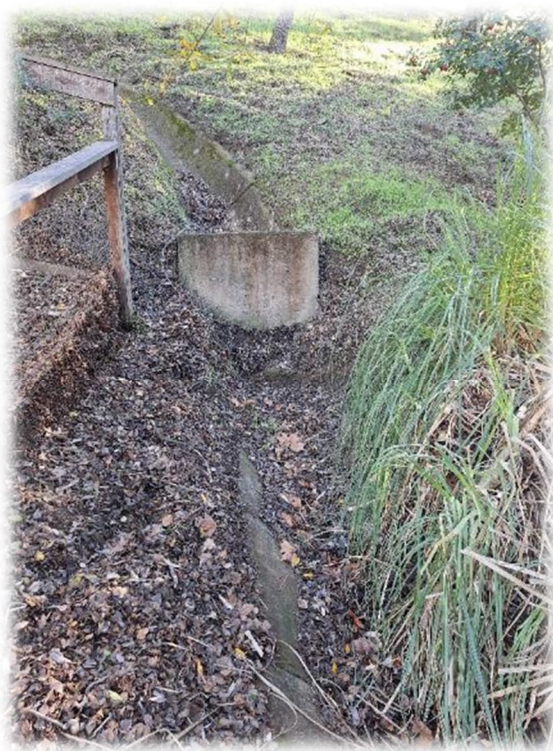
Photograph 5 – Drop inlet and V-ditch require cleaning at 321 Windmill Canyon Place.

- V-ditch and drop inlet maintenance should be continued and inspections of the drainage system, slopes and pavements should be continued. We recommend that drainage system maintenance occur prior to the onset of the rainy season each year. Inspections should take place prior to maintenance.

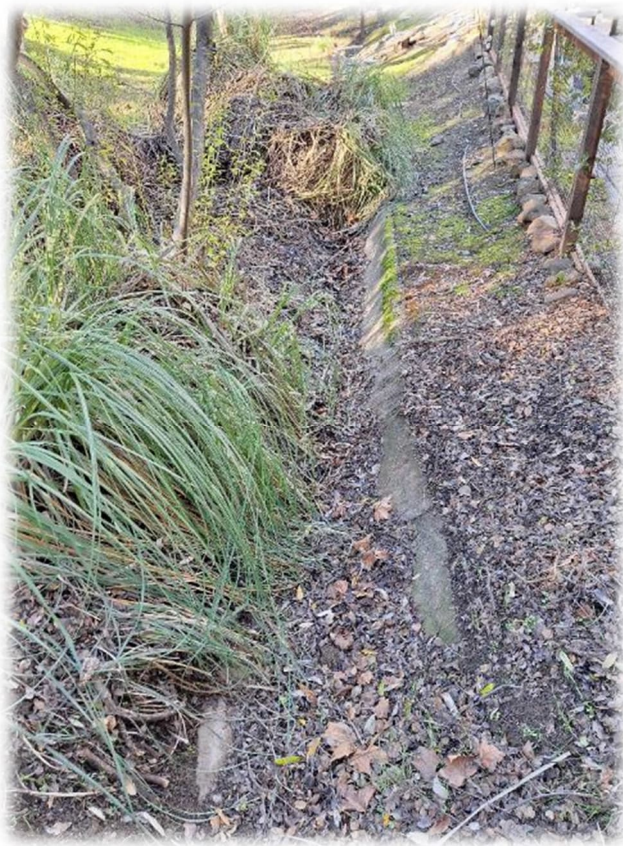
Photograph 6 – V-ditch at 321 Windmill Canyon Place. All remaining V-ditches and drop inlets in the area should be checked and cleaned.

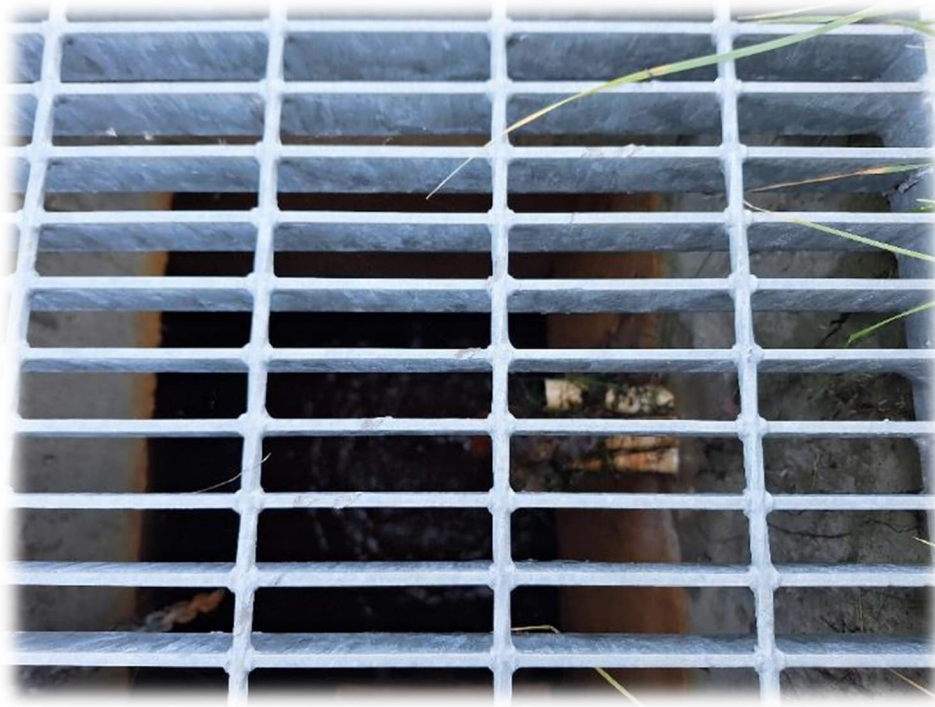
Photograph 7 – Drop inlet at toe of slope at North Valley Park. Pipes are draining but should be cleaned out.

- The inlet west of and adjacent to 8049 Kelok Way should be cleaned out/unclogged.
- The horizontal outlet drain pipes located along the slope at North Valley Park should be cleaned on a regular basis to remove any sludge or silt build up. We recommended that a video survey of these pipes be conducted to check if the pipes are clogged or damaged. If the pipes are found to be clogged or damaged, they should be cleaned via hydrauger or another suitable method. Otherwise, there is an increased risk that water/hydrostatic pressure could be building up behind the landslide at Kelok Way if the drains are not working properly. This could eventually reactive the landslide and cause severe damage to the surrounding properties and slope.

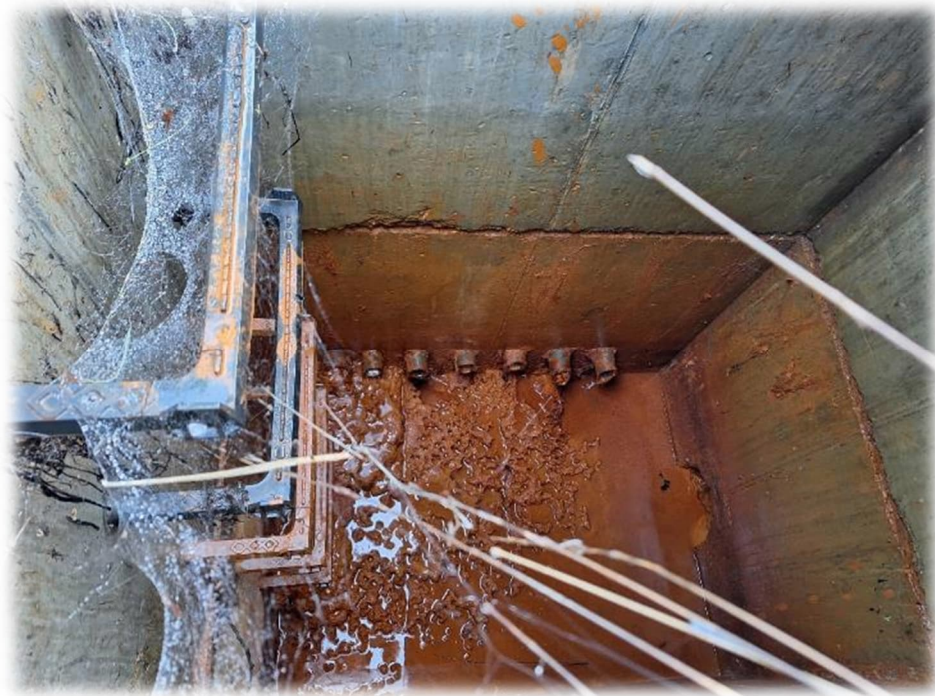
Photograph 8 – Horizontal outlet drain pipes at North Valley Park. Water was discharging from the rightmost pipe only.

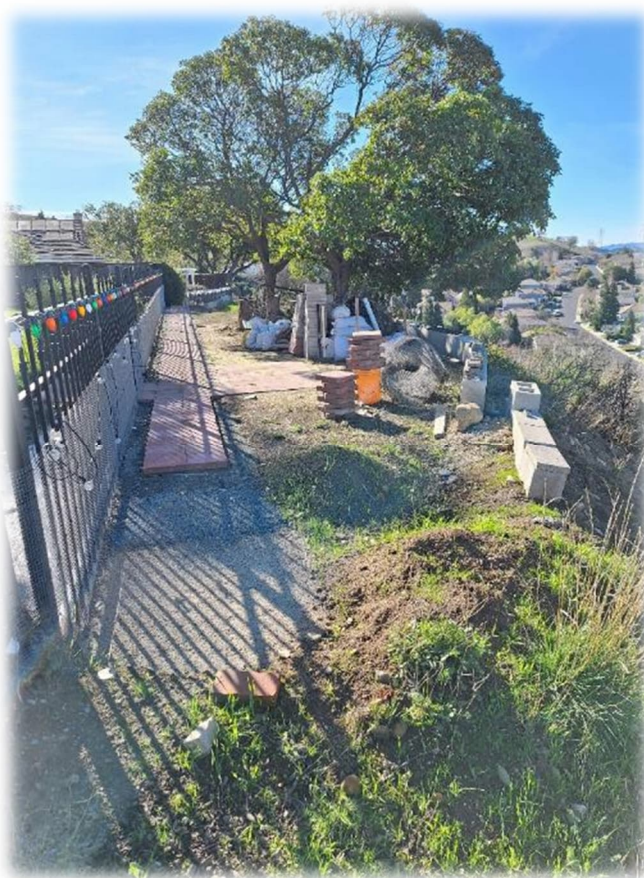
Photograph 9 – Property owner renovating top of slope outside parcel limits at 717 Acorn Drive.

- Residents going beyond their fence line, altering the existing slopes, could adversely impact the shallow and global stability of such slopes. GHAD management should consider notifying those homeowners of their potential liability for the alterations made by them.

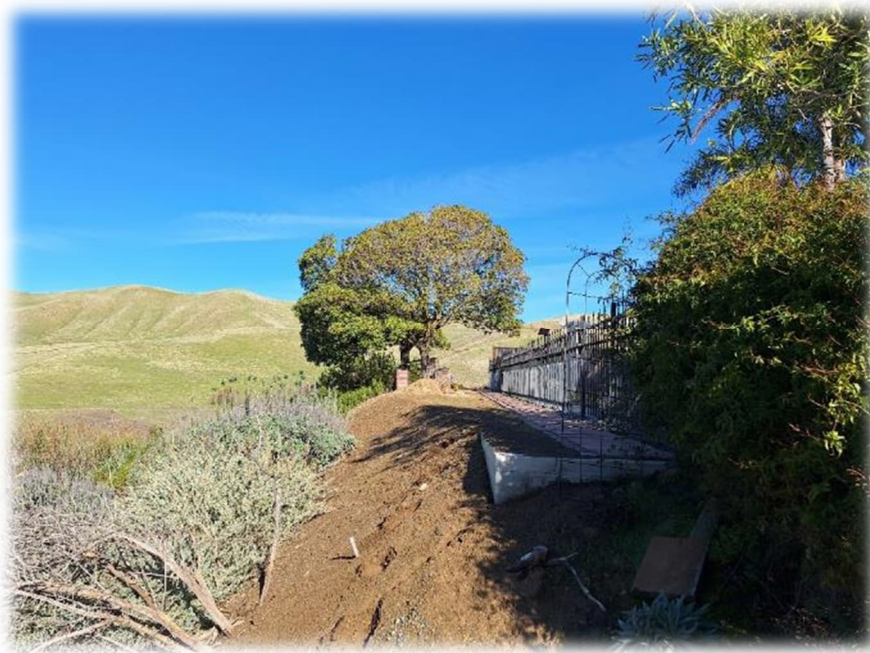
Photograph 10 – Northeastern view of rear of 717 Acorn Drive. Note significant slope disturbance.

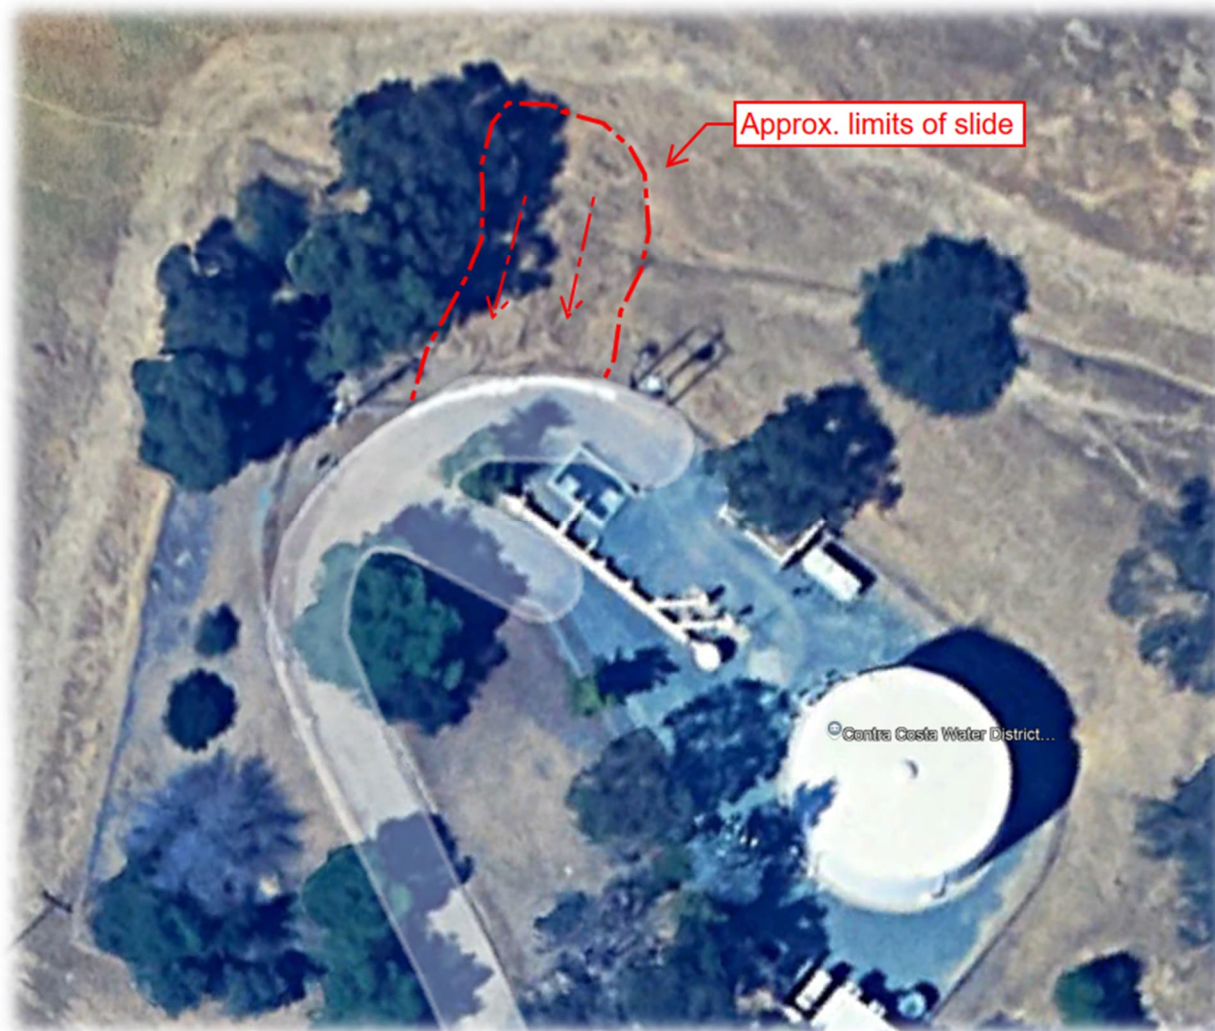
Exhibit 8 – Approximate limits of landslide at Seminary Reservoir and Pump Station

As requested, BSK observed the area of the recent small landslide that occurred along the northern slope at the Contra Costa Water District's (District) Seminary Reservoir and Pump Station located along the northern side of Marsh Creek Road, approximately 700 feet northwest of the intersection with Diablo Parkway. The approximate location and limits of the landslide is shown on Exhibit 8 below. At the time of our site reconnaissance on December 31, 2024, the landslide measured approximately 60 feet in length and approximately 35 feet or so in width. We understand that the District's consultant is in the process of conducting a field investigation to evaluate the landslide and provide recommendations for its repair. We also understand that the City and BSK will get an opportunity to review the geotechnical report for the landslide investigation because the upper portion (head scarp) of the landslide encroaches into the southern boundary of the Oakhurst GHAD open space, but primarily is within the District's parcel. The following photographs, 11 through 14, depict the conditions at the landslide area during our site reconnaissance on December 31, 2024.

- The landslide at the Seminary Reservoir and Pump Station is currently being addressed by the Contra Costa Water District and its consultant.
- Consideration should be given to filling the cracks noted on the roadway along Torrey Pines Place with crack filler.
