March 9, 2023

BSK Project No. G00000499

**SUBJECT:      Geological and Geotechnical Site Review  
                 Oakhurst Geologic Hazards Abatement District (GHAD)  
                 Clayton, CA**

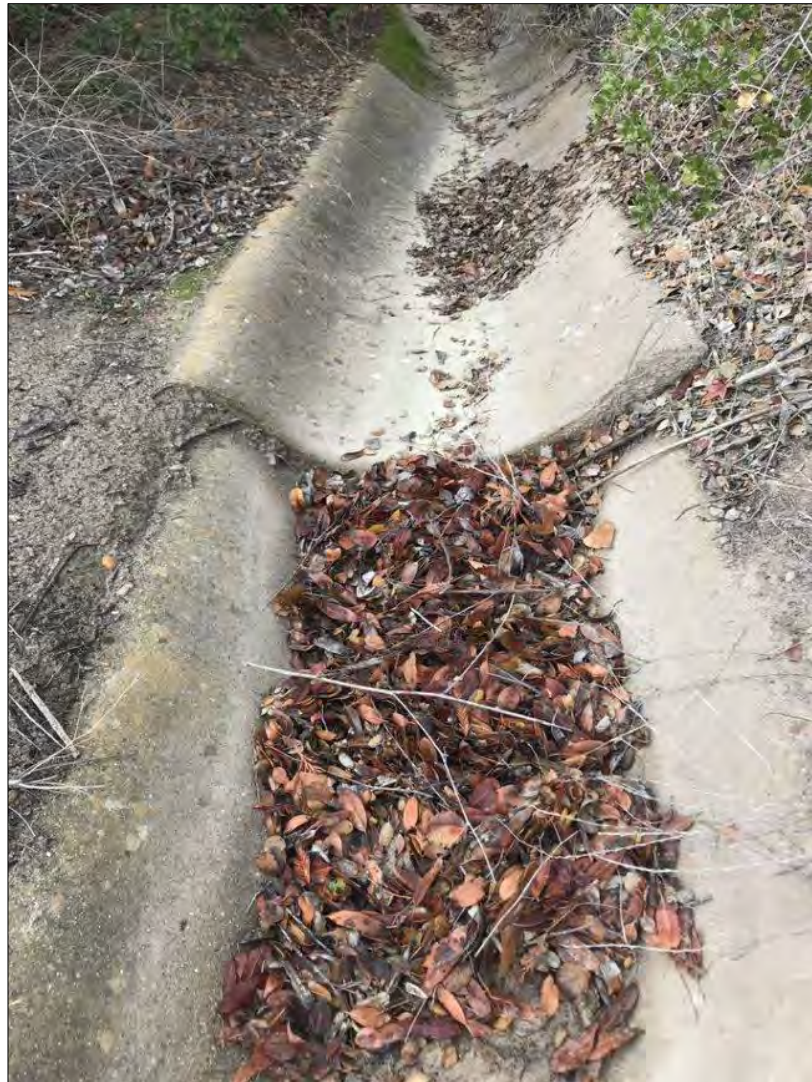
*Photo A – V-ditch offset uphill from Crow Place.*

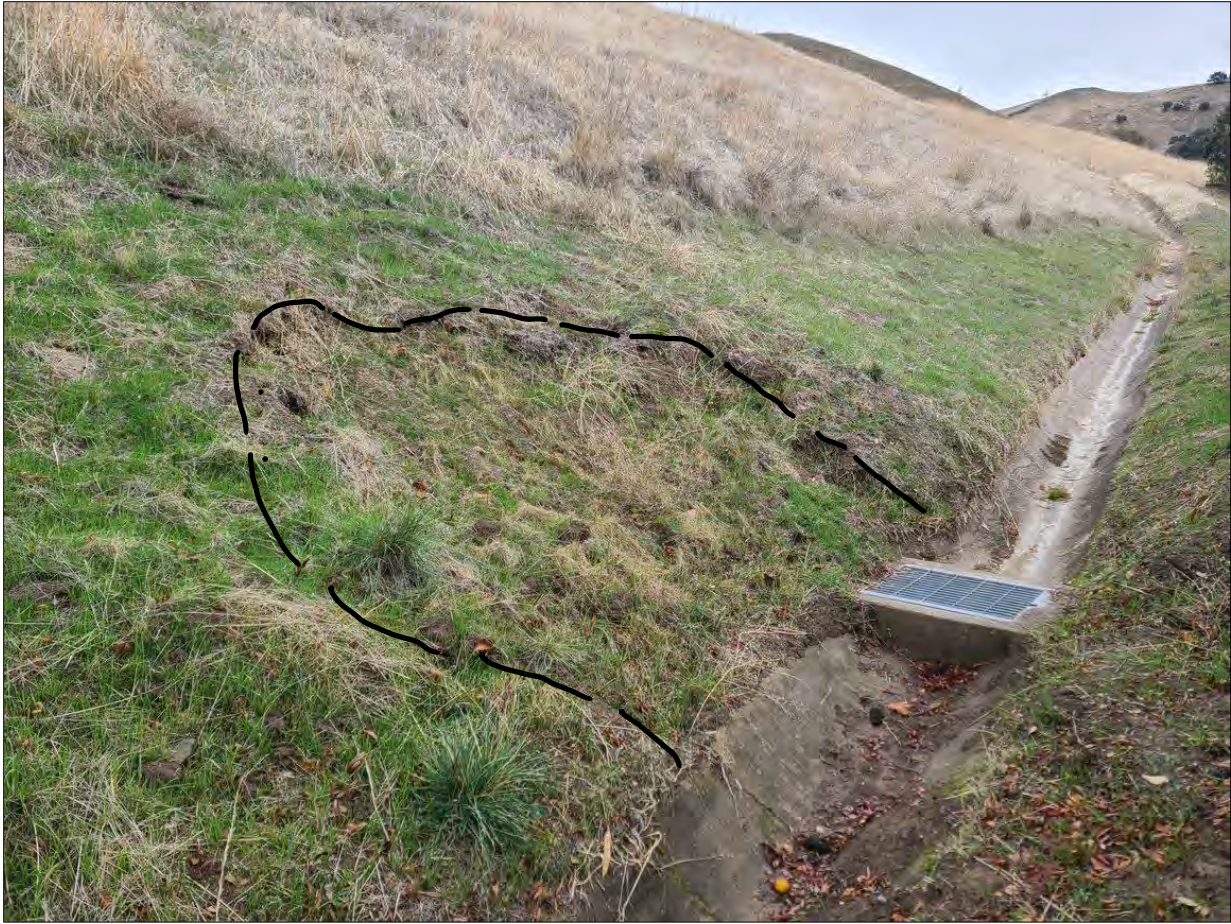
*Photo B – Shallow raveling above a drop inlet uphill from Windmill Canyon Drive. Based on our communication with the City, we understand that movement of the uphill from this drop inlet blocked the drop inlet of an uphill V-ditch during the early 2023 rain storms.*

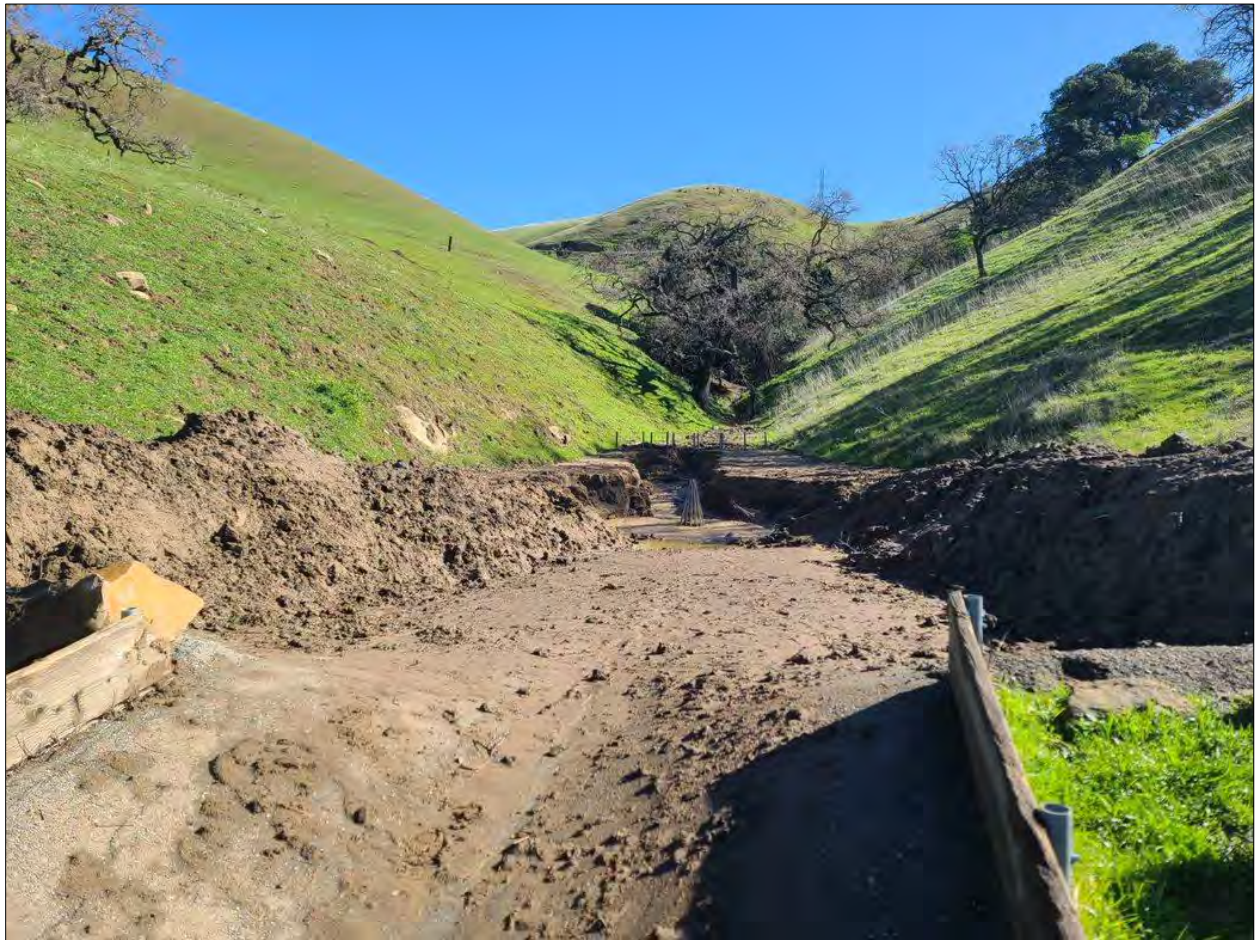
*Photo C – Overtopped and eroded debris-flow containment basin above drainage easement northeast of Windmill Canyon Drive. Based on our communication with the City, we understand the erosion and overtopping occurred during the early 2023 rain storms.*

**Note:** At the time of our initial site reconnaissance conducted on December 8th, 2022, the debris-flow containment structure appeared clear and in good repair. Damage and overtopping/erosion occurred during the intense rain events in early 2023. Muddy water from the failed containment structure flowed into the backyard of 3081 Windmill Canyon Drive, which is located immediately downhill from the structure.

- Storm damage debris retention basin above Windmill Canyon Drive is no longer able to stop and retain debris flow materials. The basin will require reconstruction of the earthen berm that was in-place to stop and retain flow.
- The Swale/V-ditch located upslope of Clayton Road and south of Peacock Creek Drive should be repaired and the drop inlet should be unclogged.

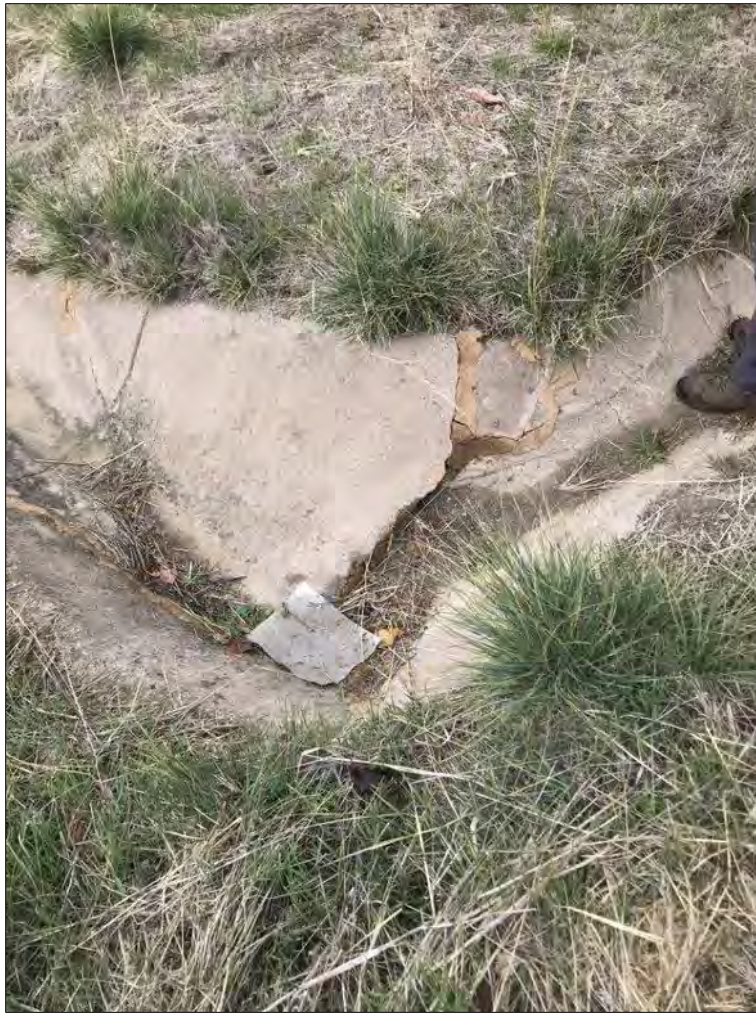
*Photo D – V-ditch cracking and displacement East of Windmill Canyon Drive, adjacent to high voltage power line easement.*

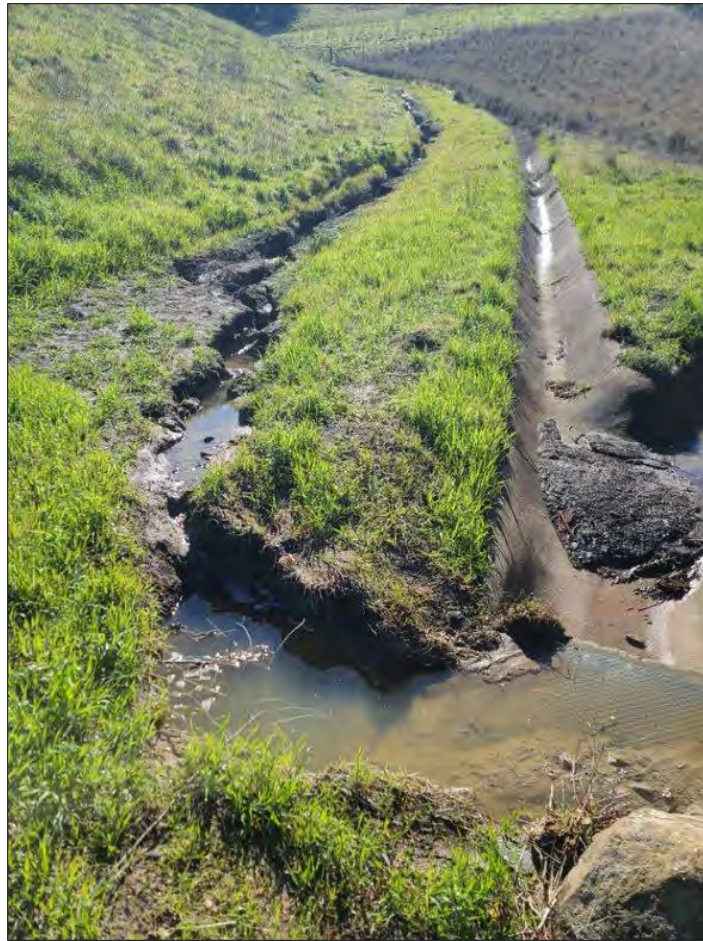
*Photo E – Incised gully flow above the V-ditch located East of Windmill Canyon Drive. Erosion and flow occurred during early 2023 storm events.*

**Note:** This photo was taken during our March 1st, 2023 site reconnaissance. At the time of our initial site reconnaissance conducted on December 8th, 2022, we did not observe the eroded, incised channel above the V-ditch. Erosion and gullyng occurred with intense rainfall events in early 2023.

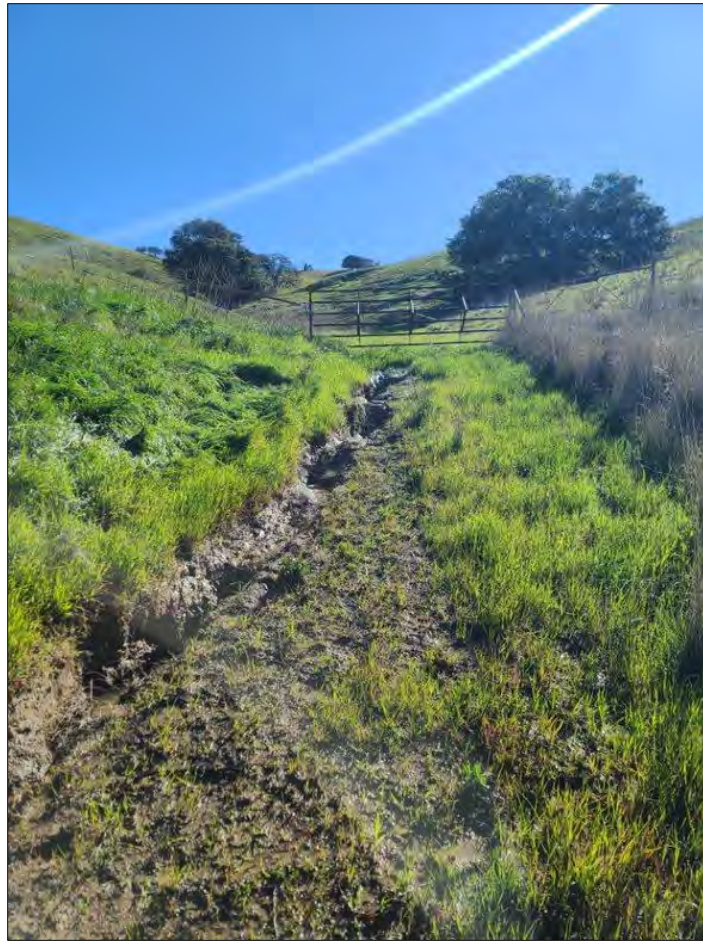
*Photo F – Upper reaches of the gully erosion East of Windmill Canyon Drive.*

This photo was taken during our March 1st, 2023 site reconnaissance. At the time of our initial site reconnaissance conducted on December 8th, 2022, we did not observe this gully erosion. Erosion and gullying occurred with intense rainfall events in early 2023.

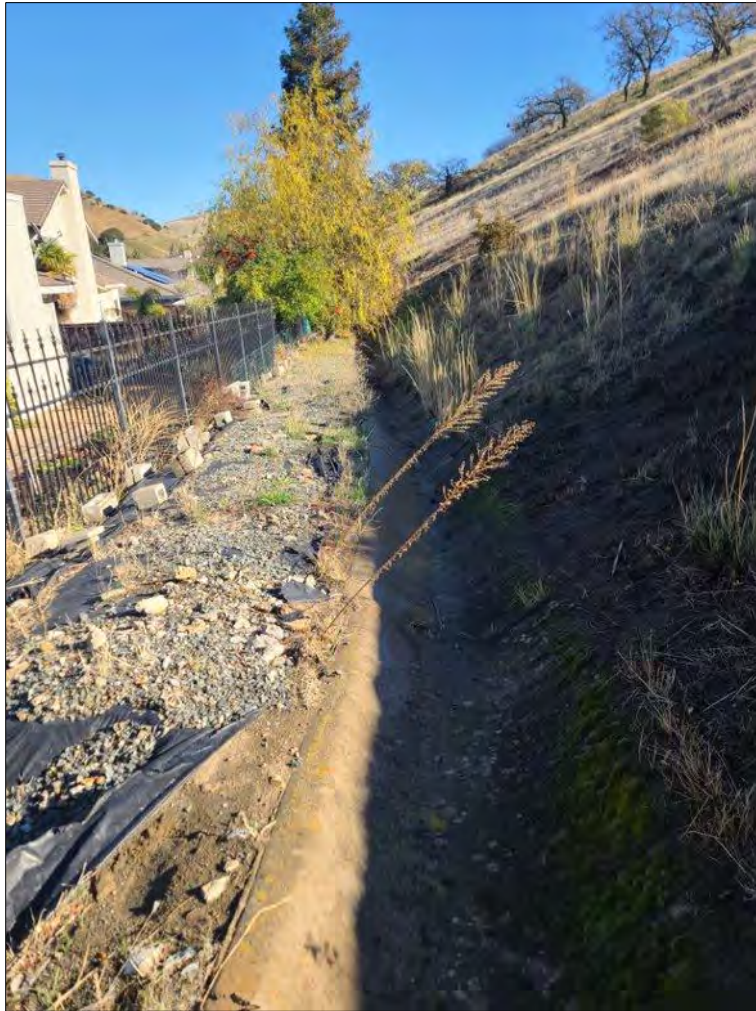
*Photo G – Slope creep depositing debris in V-ditch and resulting in minor cracking of V-ditch.*

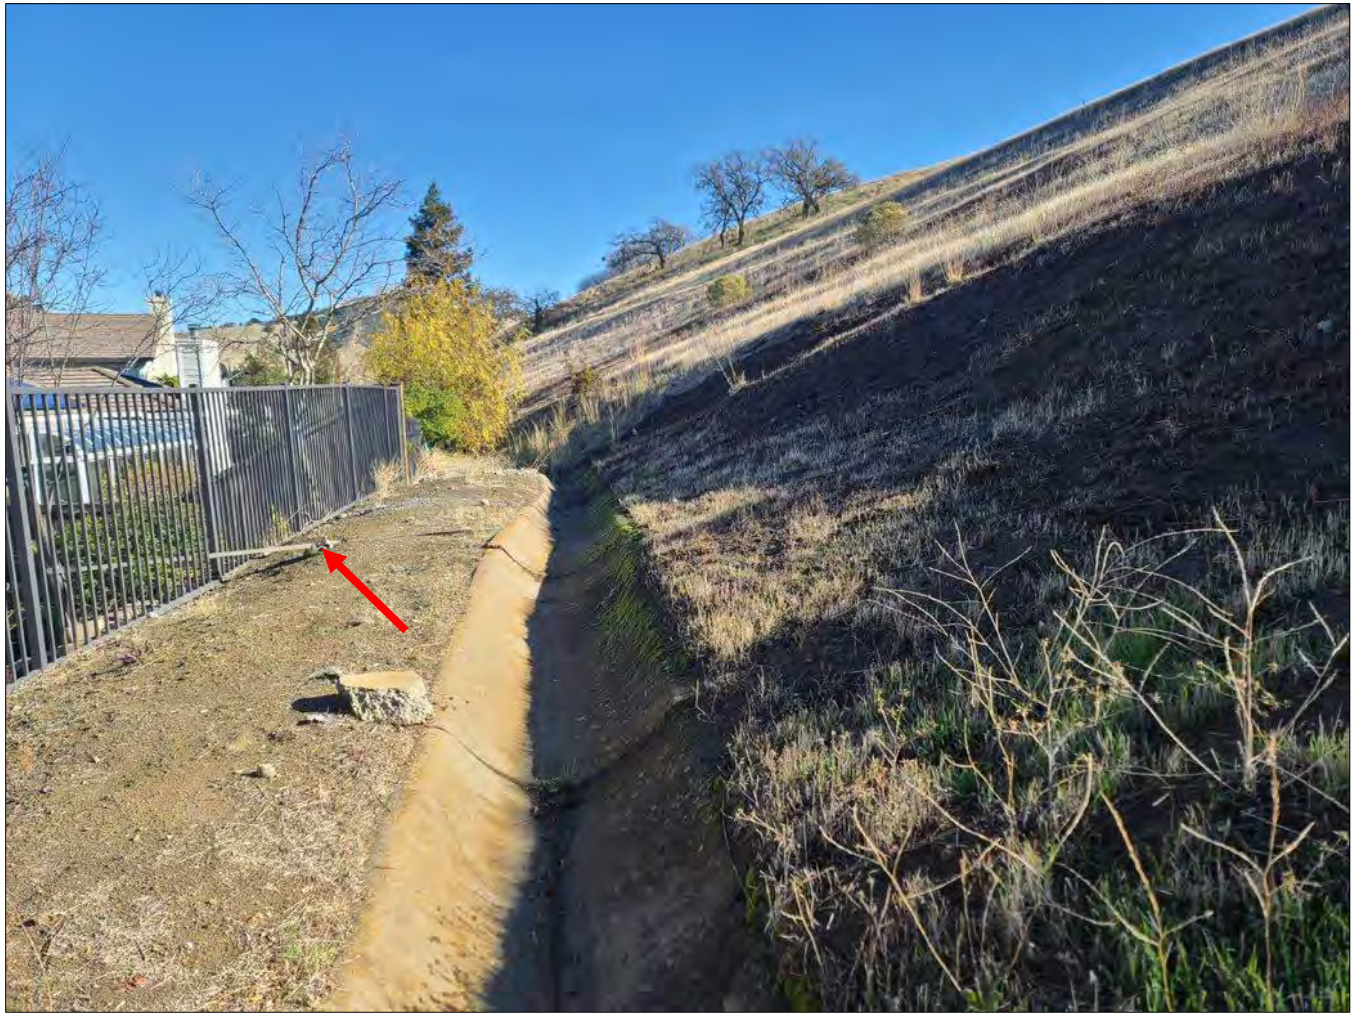
*Photo H – Slope creep overtopping edge of V-ditch. V-ditch offsets and shallow raveling uphill visible. Note that the homeowner has secured trees beyond property line (see red arrow), including a V-ditch panel (not depicted in this photo).*

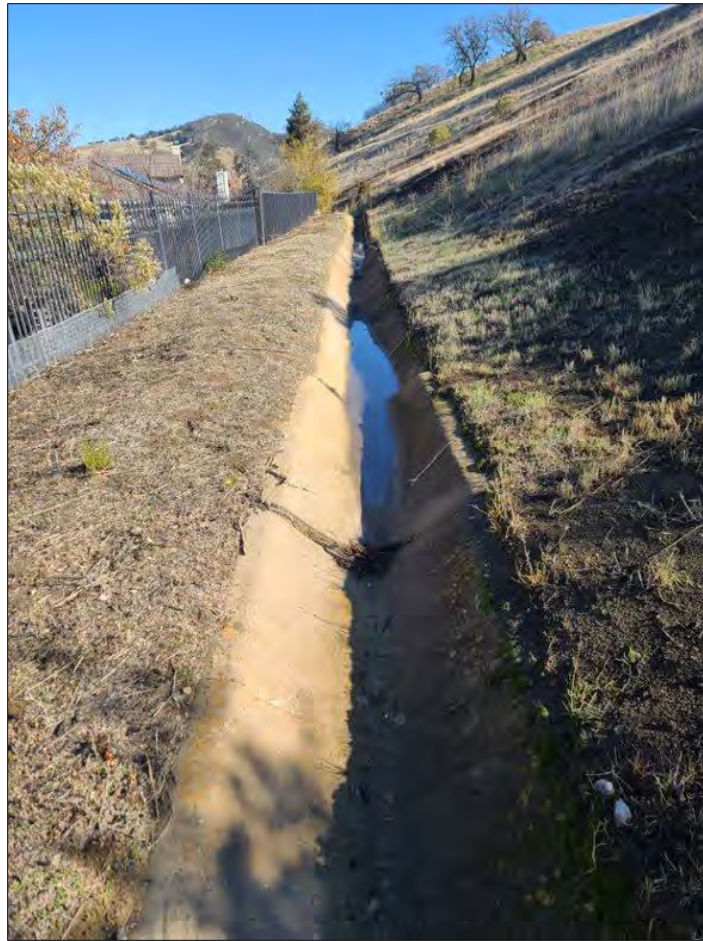
*Photo 1 – V-ditch offsets and ponded water. Slope creep is overtopping and possibly offsetting V-ditches.*

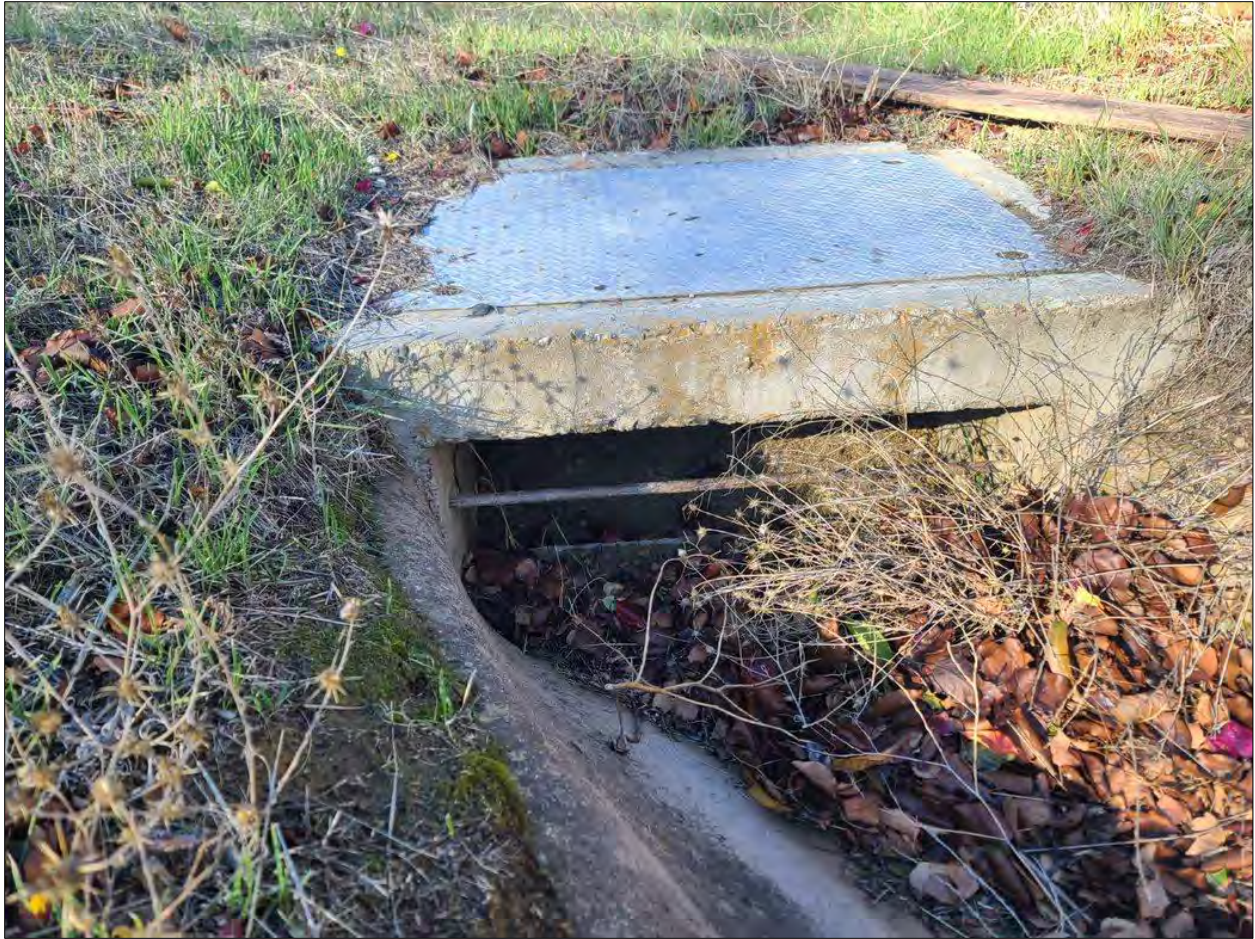
*Photo J – Catch basin blocked by soil and debris.*

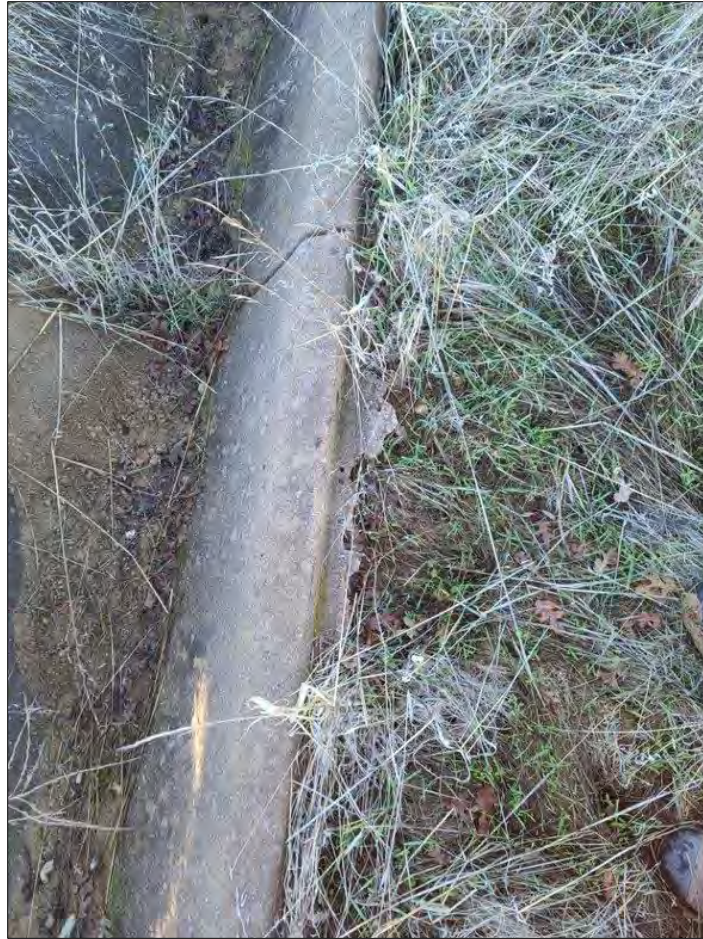
*Photo K – Slope creep towards Kelok Way as evidenced by separation of soil from the downhill side of the V-ditch.*

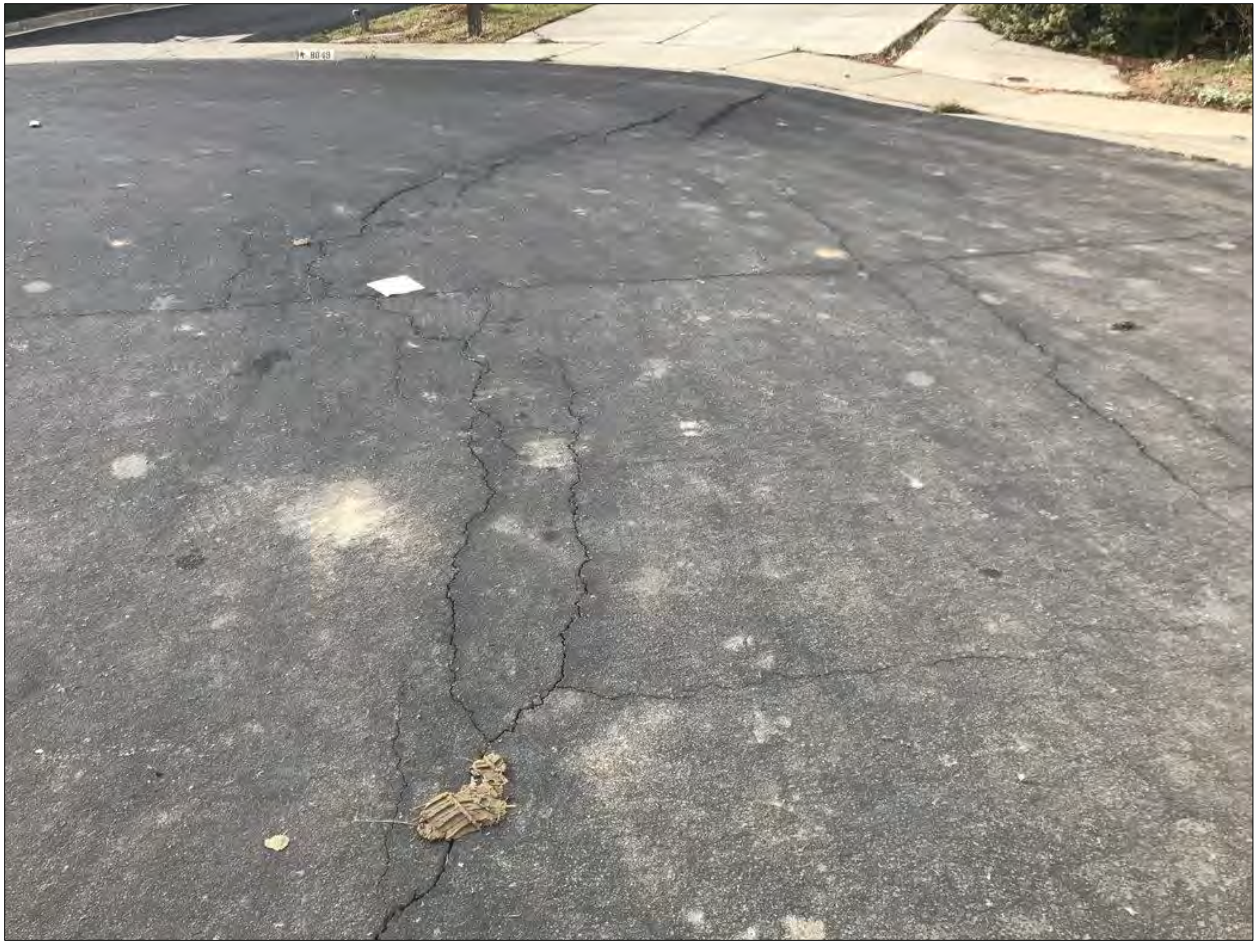
*Photo 1 – Settlement/incipient crown scarp impacting the residence (8053 Kelok Way) at the end of the cul-de-sac on Kelok Way.*

Ongoing slope movement north of, and impinging on the cul-de-sac at the west end of Kelok Way has resulted in damage to the roadway (see Photo L, above) and to the residence at 8053 Kelok Way. Damage has been documented for both the residence and the roadway according to Steven, Ferrone & Bailey (2016)<sup>2</sup>. The inclinometer that was used to monitor rate and depth of movement has been distorted, via horizontal shearing, to the extent that the inclinometer is no longer useable. We understand that the home at 8053 Kelok Way was “red-tagged” and is no longer eligible for inhabitation.

Based on damage to the roadway and to the home at 8053 Kelok Way, it is clear that there is slope movement on the north facing slope adjacent to the home and the cul-de-sac. We do not know the rate of movement at this time, but based on the amount of movement in the roadway and damage to the home, we anticipate that underground utilities may become damaged and, if water bearing, could accelerate the movement considerably. Further, the potential danger in accelerated movement from a seismic event is also considerable. Based on the current data and our understanding of minimal investigation efforts on this area of instability, we cannot predict the impact of seismicity, increased pore water pressure, and decreases in shear strength with continued movement on the timing or extent of movement in the future.

- Significant settling and downslope movement on the north side of the Cul-de-sac at Kelok Way is likely to result in failure of the pavement, failure of utilities traversing the area of instability, and continue to cause damage to the residence at 8053 Kelok Way. It is unclear how much the incipient landslide mass may have moved, and at what rate it is moving, since the inclinometer that was used to gauge movement has been compromised. We strongly recommend that a replacement inclinometer be installed and, together with available piezometers that have been installed during previous investigations, monitoring of both the inclinometer and piezometers should be resumed. If possible, additional inclinometers should be considered to better isolate stable ground versus landslide mass.

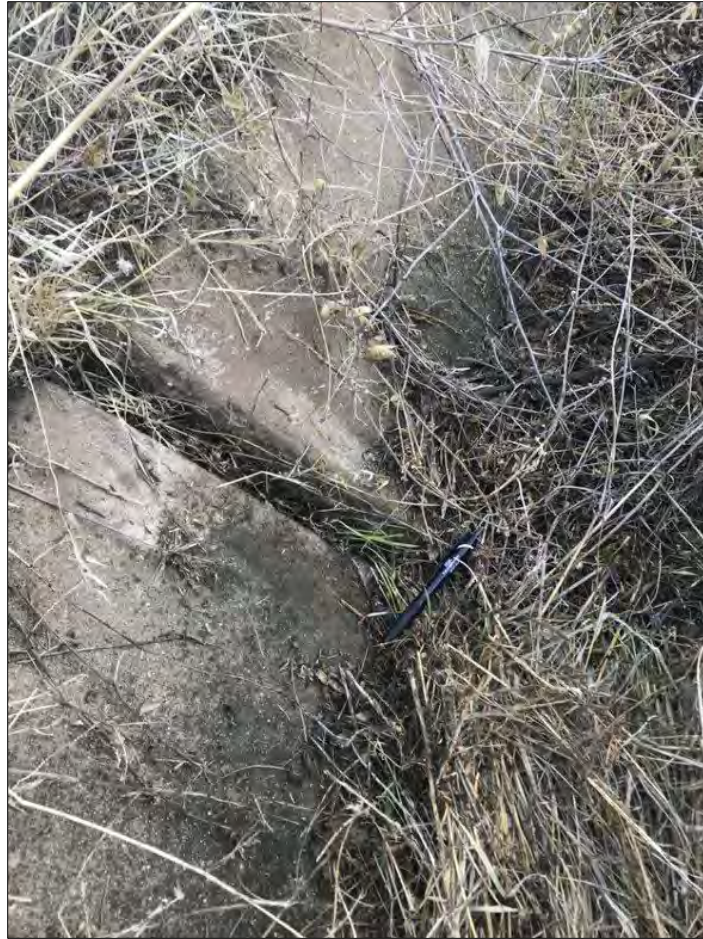
*Photo M – Offset and debris in V-ditch northwest of the cul-de-sac at Kelok Way.*

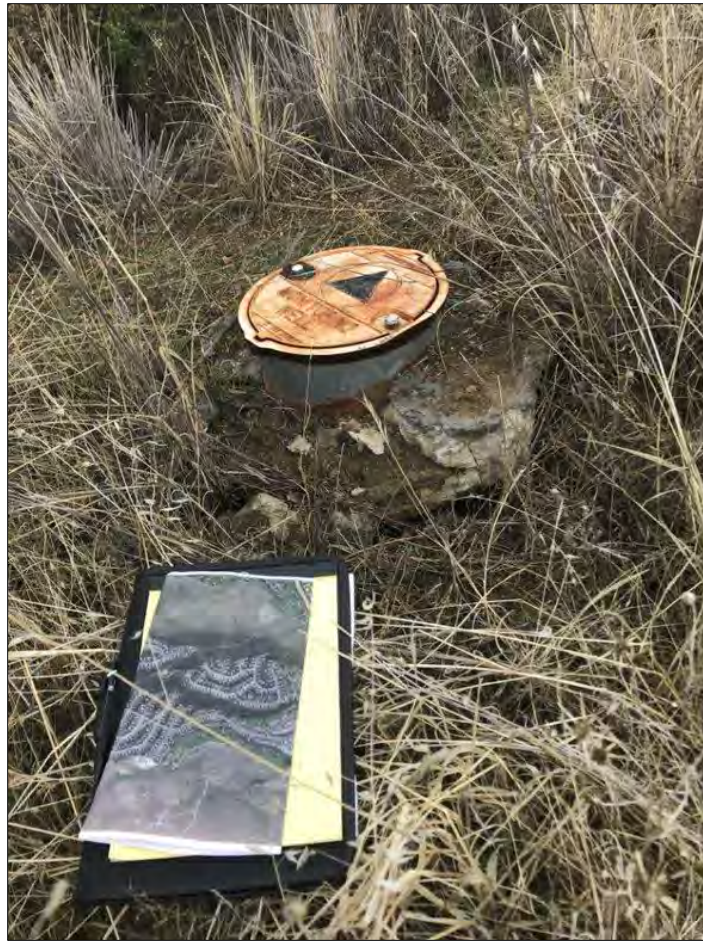
*Photo N – Wellhead north (downhill) of the cul-de-sac at Kelok Way. Note that the slope has settled several inches relative to the wellhead.*

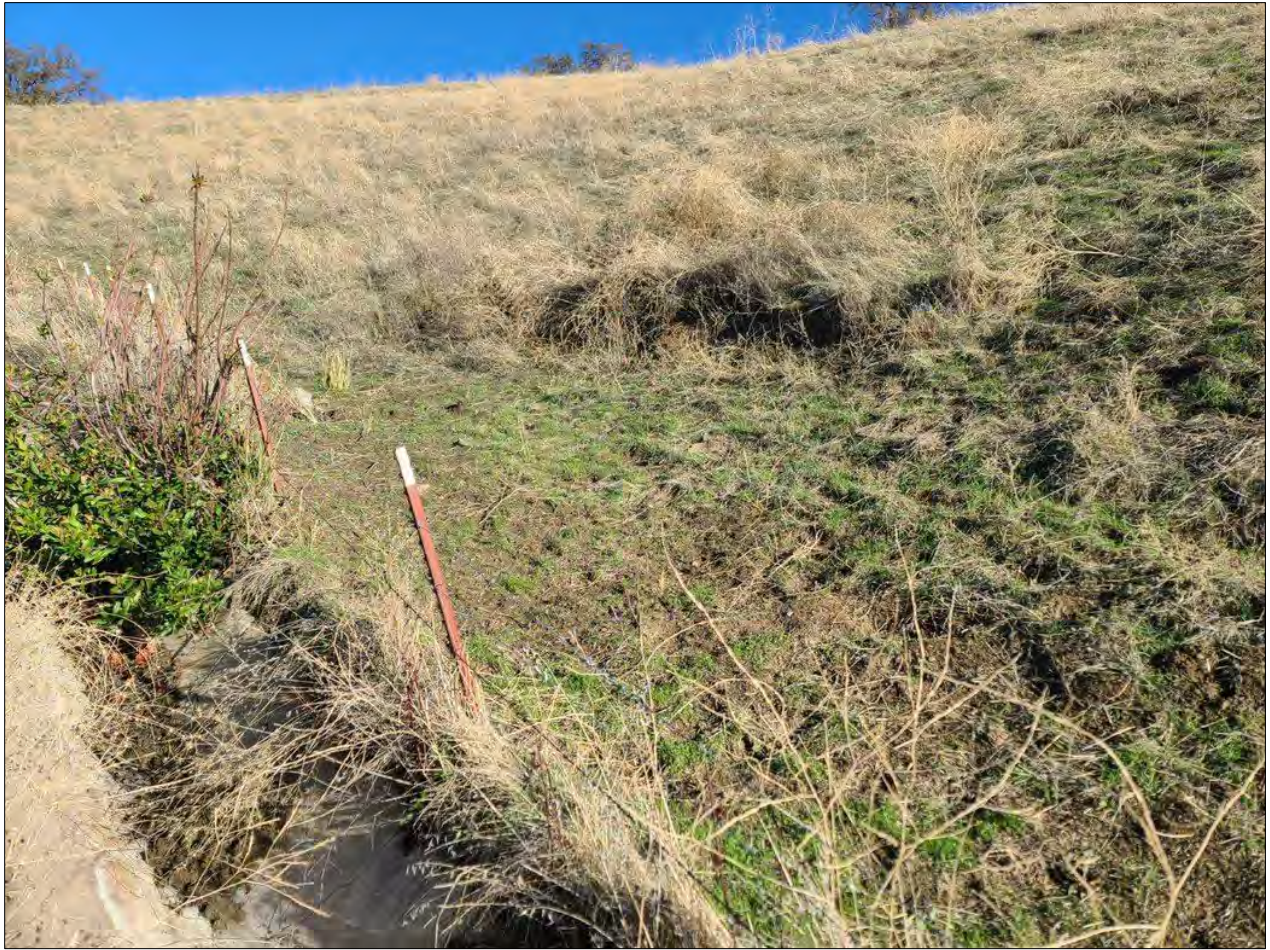
*Photo O – Slope creep and minor sloughing adjacent to V-ditch*

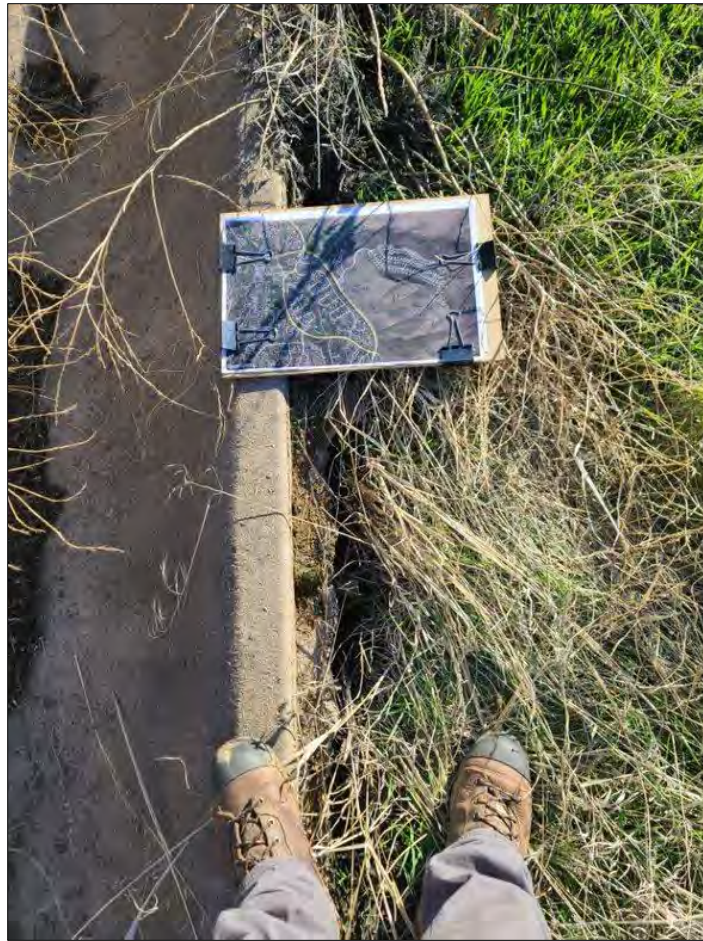
*Photo P – Slope creep or expansion cracking adjacent to the edge of the V-ditch.*

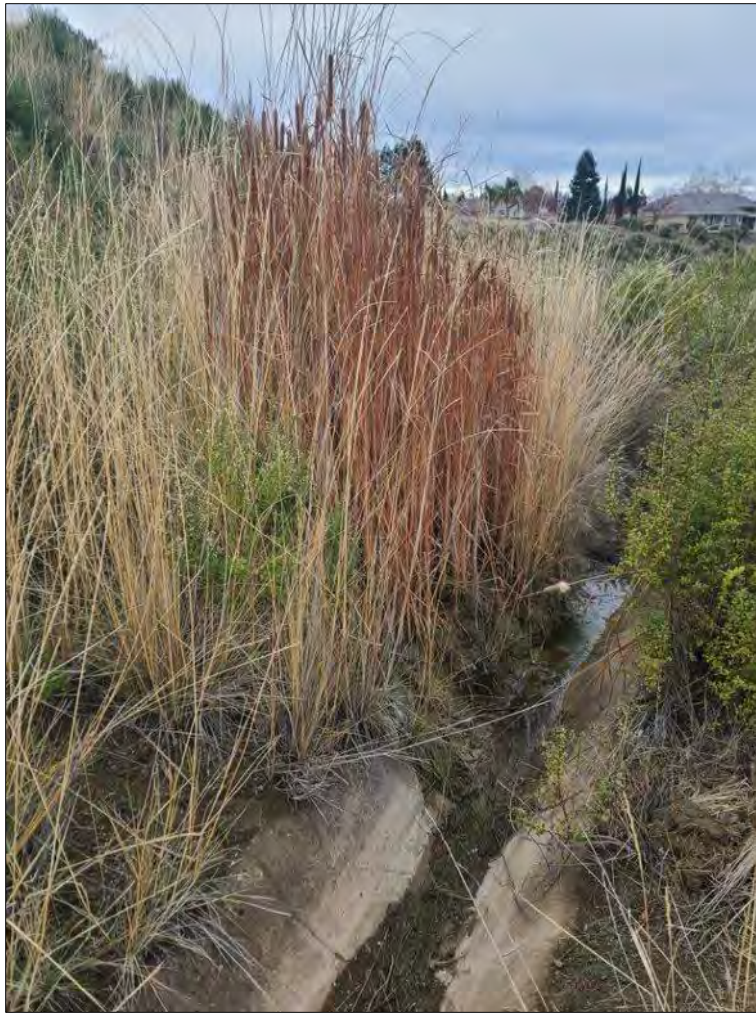
*Photo Q – Moist ground and seepage from the slope. Note the marsh grasses and standing water in the ditch.*

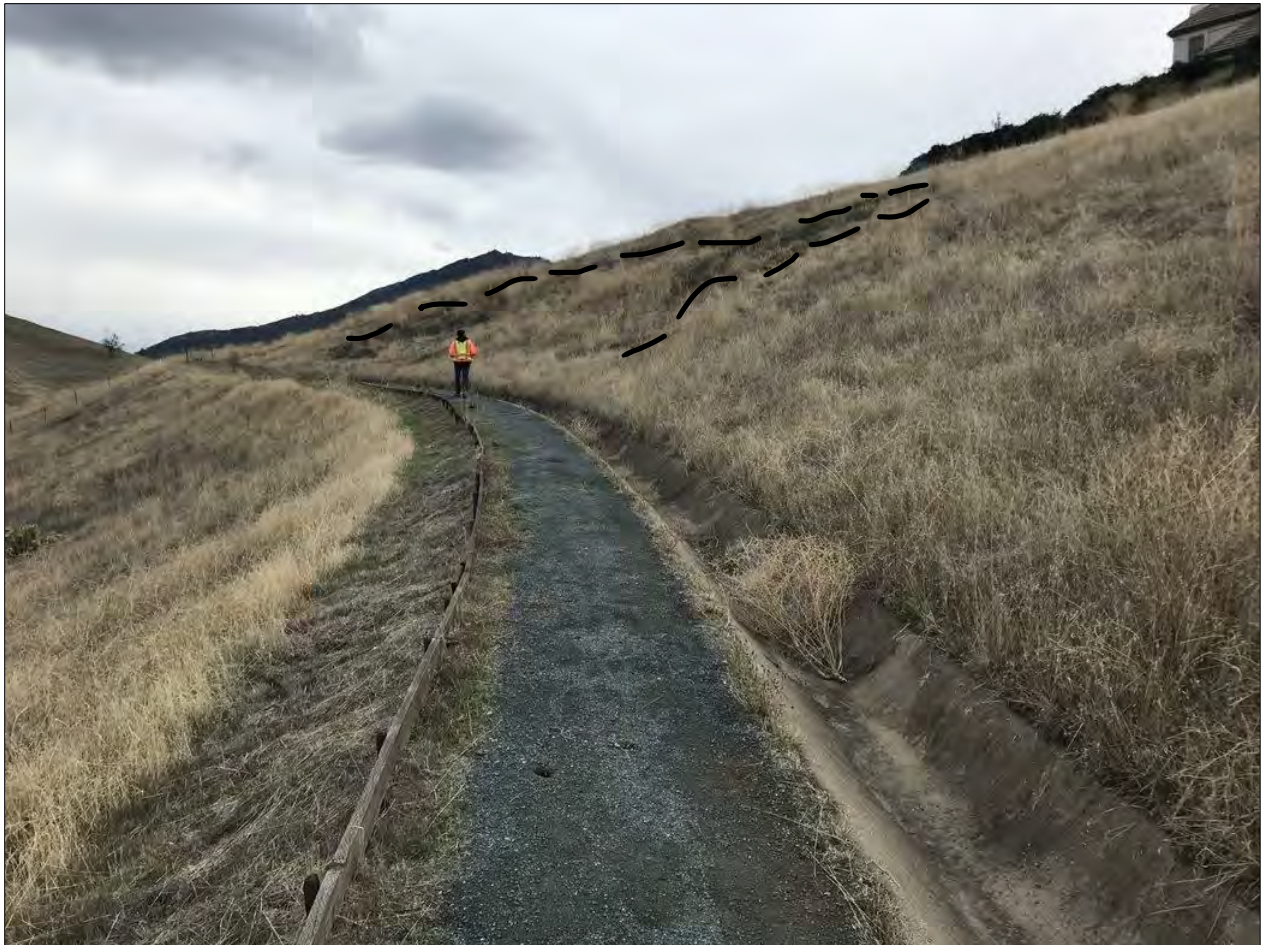
*Photo R – Moist slope with shallow sloughing. Note the scarp at the upper end of the movement.*

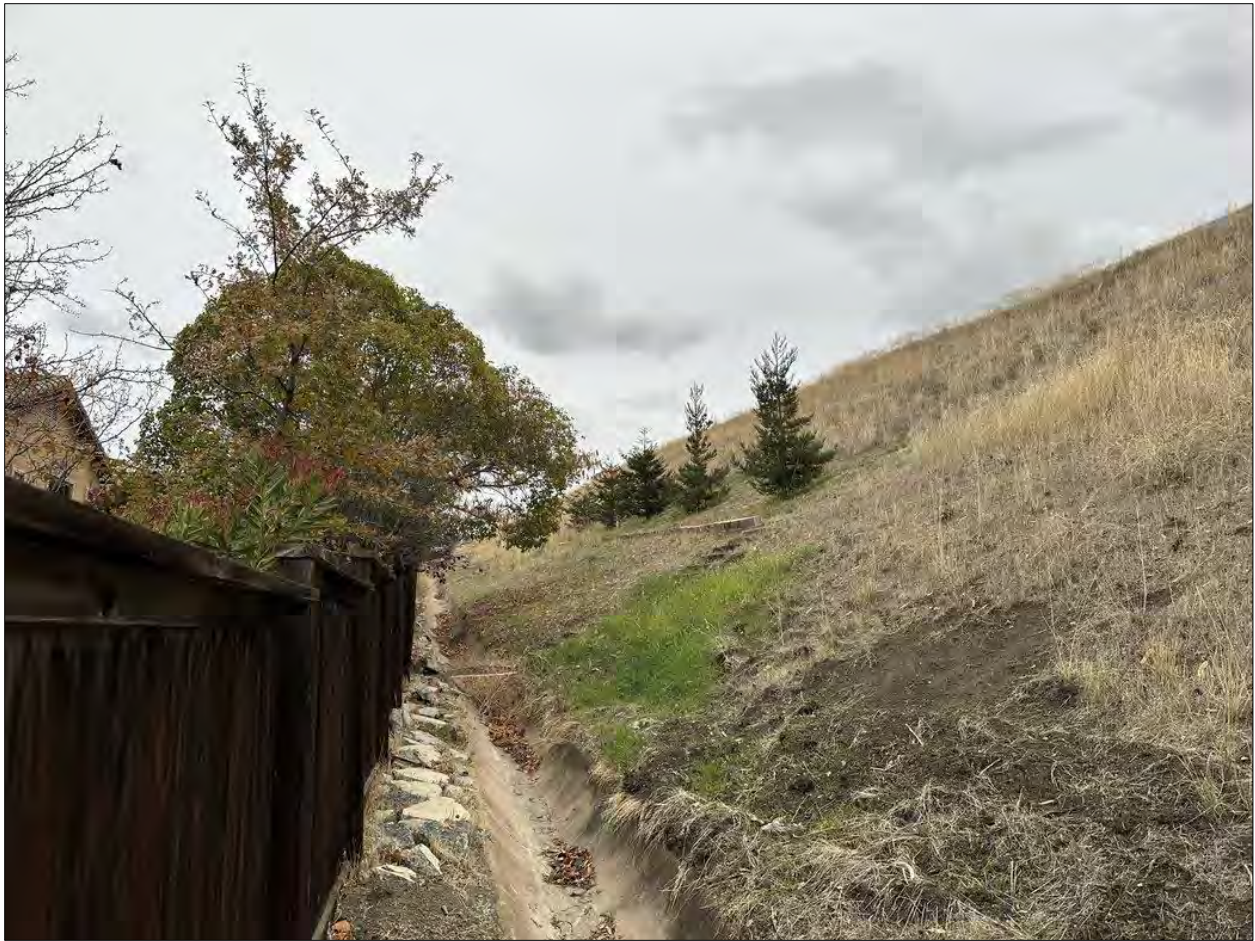
*Photo S – Resident has planted trees and built a short keystone-type retaining wall uphill from the V-ditch. Note soil erosion from the disturbed slope sloughing into the ditch.*

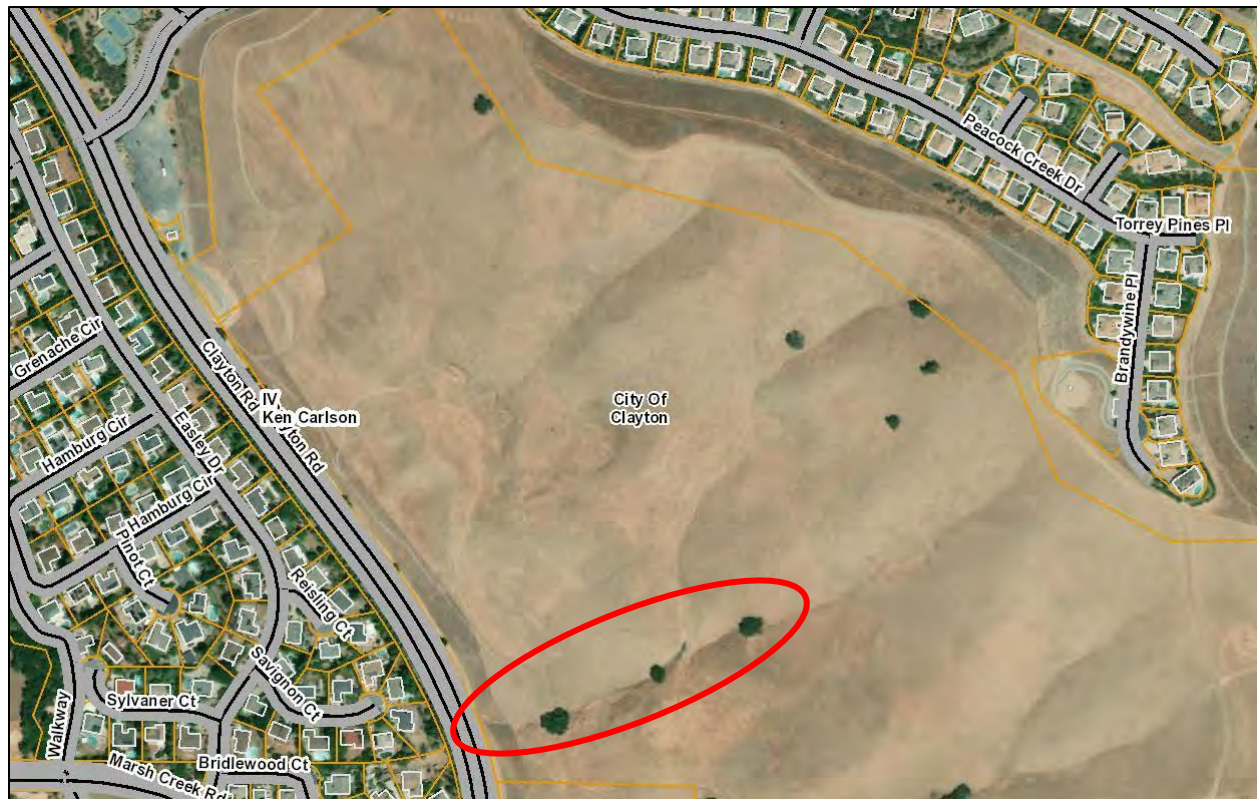
*Based on our communication with the City, we understand that during the early 2023 rain storms, a debris-flow occurred within a swale/V-ditch located upslope of Clayton Road and south of Peacock Creek Drive (circled in red), which clogged a drop inlet and caused water to overflow onto Clayton Road.*

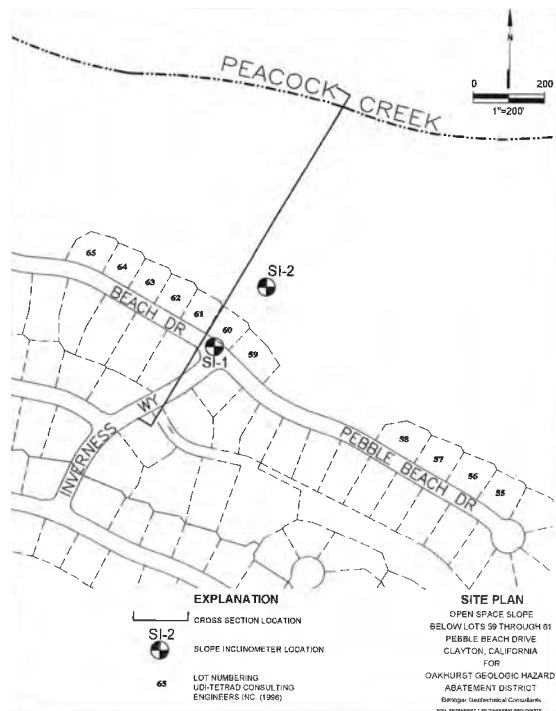
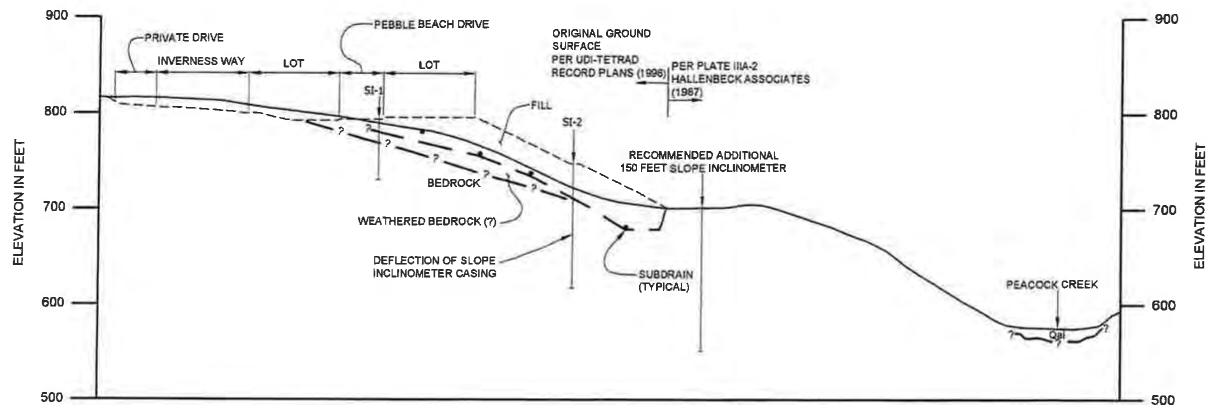
**LANDSLIDE REPAIR CROSS SECTION**  
**Pebble Beach Drive/Peacock Creek**

The area underlying the subject slope was, in part, a landslide prior to mass grading for the subdivision. Figure 4 presents a cross section showing the repair efforts made prior to placing fill to accommodate the home sites. Of note is, the landslide was only partially removed, but the current depth of movement is significantly below the mapped slide plane as presented on the cross section.

- It is crucial that the inclinometer on the north slope between Pebble Beach Drive and Peacock Creek be replaced. Monitoring of movement on this slide, as well as monitoring of piezometric surface is necessary to judge the status of the slope.
- All horizontal drain discharge points, and all subdrain clean-outs and discharge points should be located and it should be determined if they are providing any subdrainage from beneath the fill and landslide repair.
