May 1, 2024

BSK Project No. G00001941

SUBJECT: Geological and Geotechnical Site Reconnaissance
Oakhurst Geological Hazards Abatement District (GHAD)
Clayton, CA

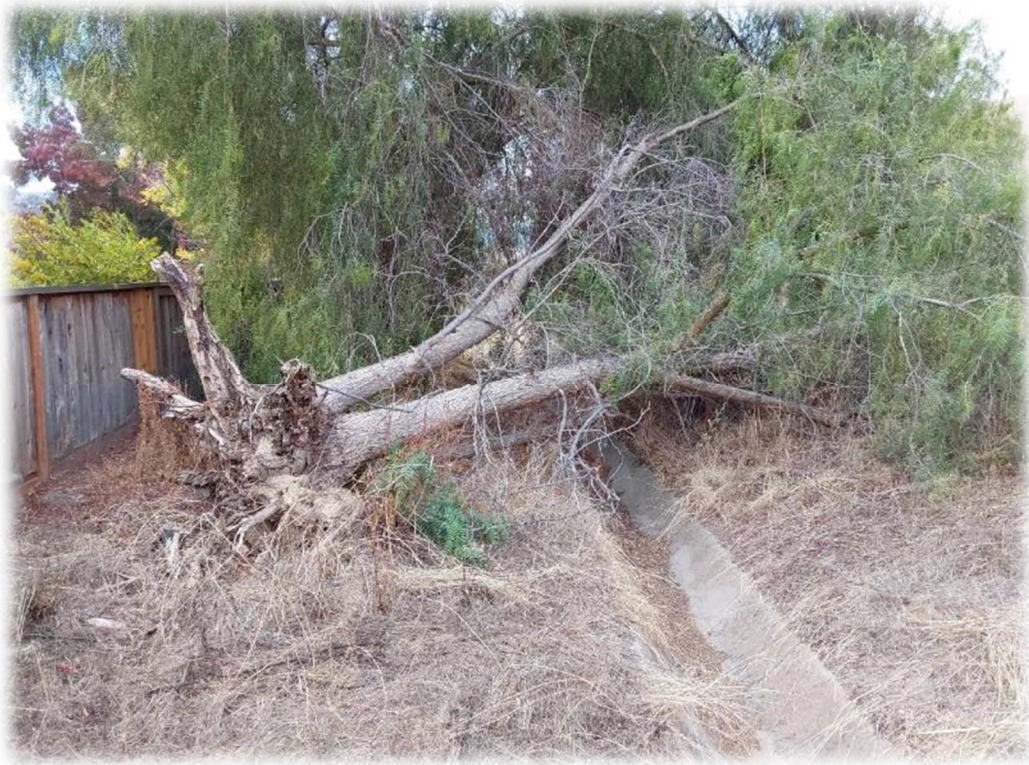
Photograph 1 – Fallen tree across V-ditch behind 3039 Windmill Canyon Drive.

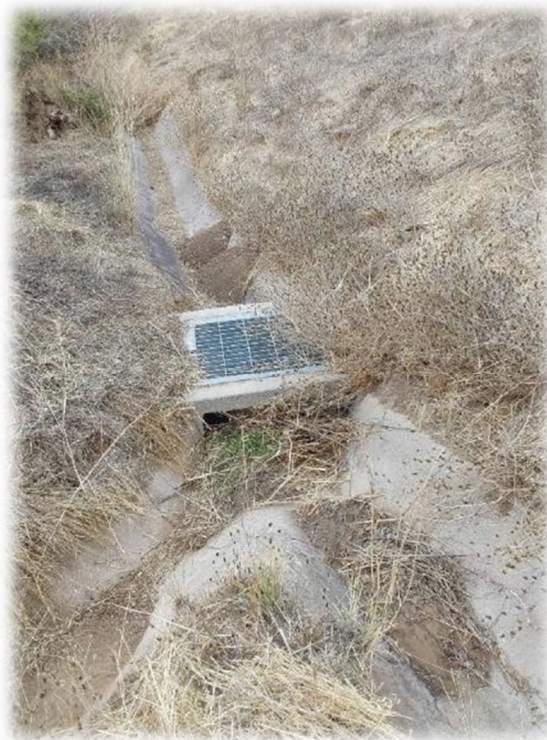
Photograph 2 – V-ditch filled with soil and vegetation behind 3041 Windmill Canyon Drive. Throughout this area, V-ditches contain soil and debris originating from burrowing animal activity, vegetation, etc. Additional V-ditch cleaning should be performed.

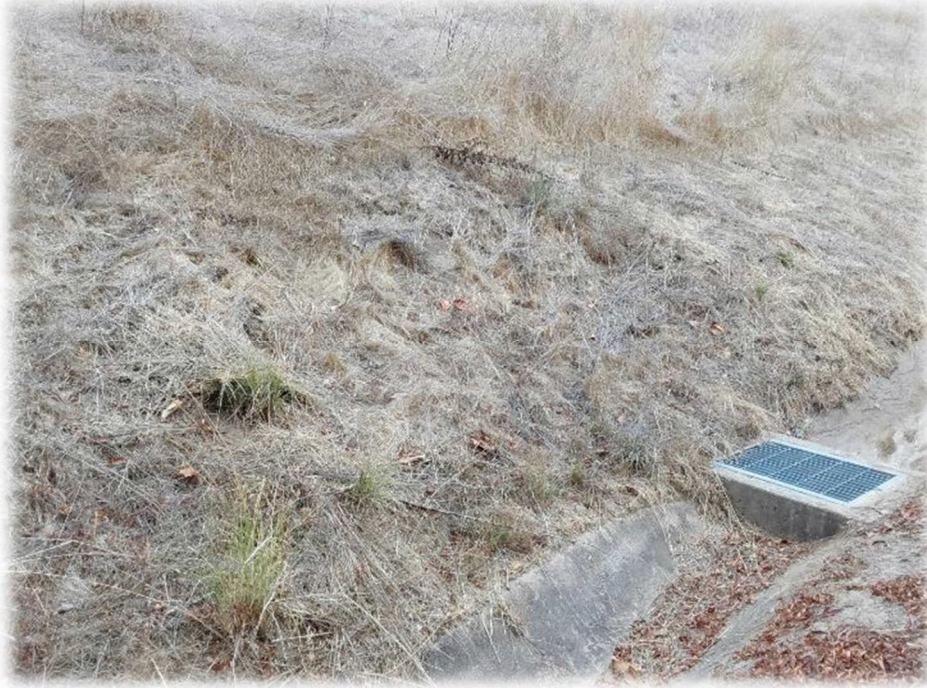
Photograph 3 – Shallow raveling/settlement above a drop inlet uphill from 3053/3055 Windmill Canyon Drive. Condition remains the same as observed in early 2023 (see Photo B in letter dated March 9, 2023). There is a pipe coming downhill into inlet, likely from upper V-ditch. Possibly, this area experienced some settlement.

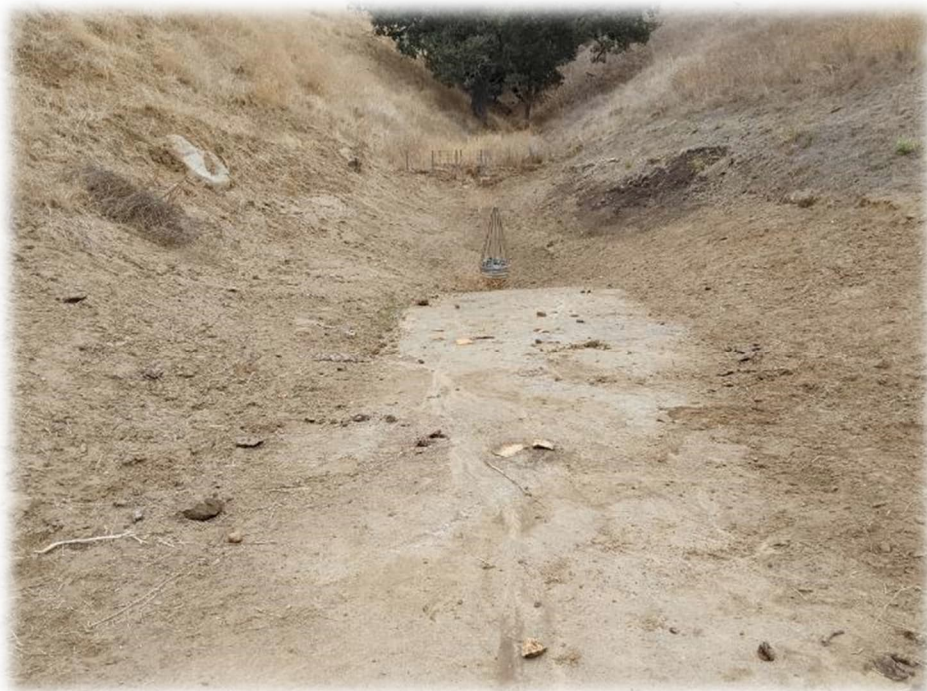
Photograph 4 – Current condition of containment basin northeast of Windmill Canyon Drive. The vertical corrugated metal pipe (CMP) riser contains some soil within it that has accumulated over time. Cleaning of this pipe should be performed.

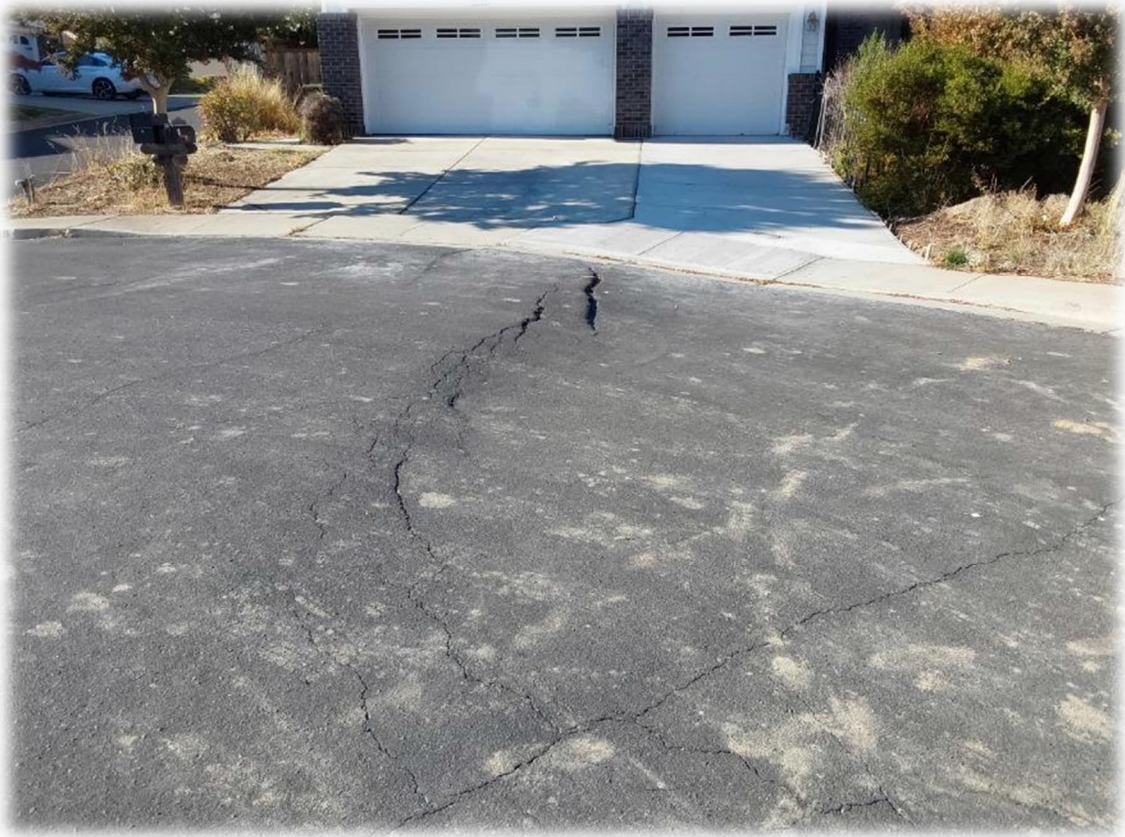
Photograph 5 – Current conditions at 8053 Kelok Way. The cracks have expanded a little and concrete in the driveway/sidewalk has been repaired since we last visited this location (see Photograph 6 below).

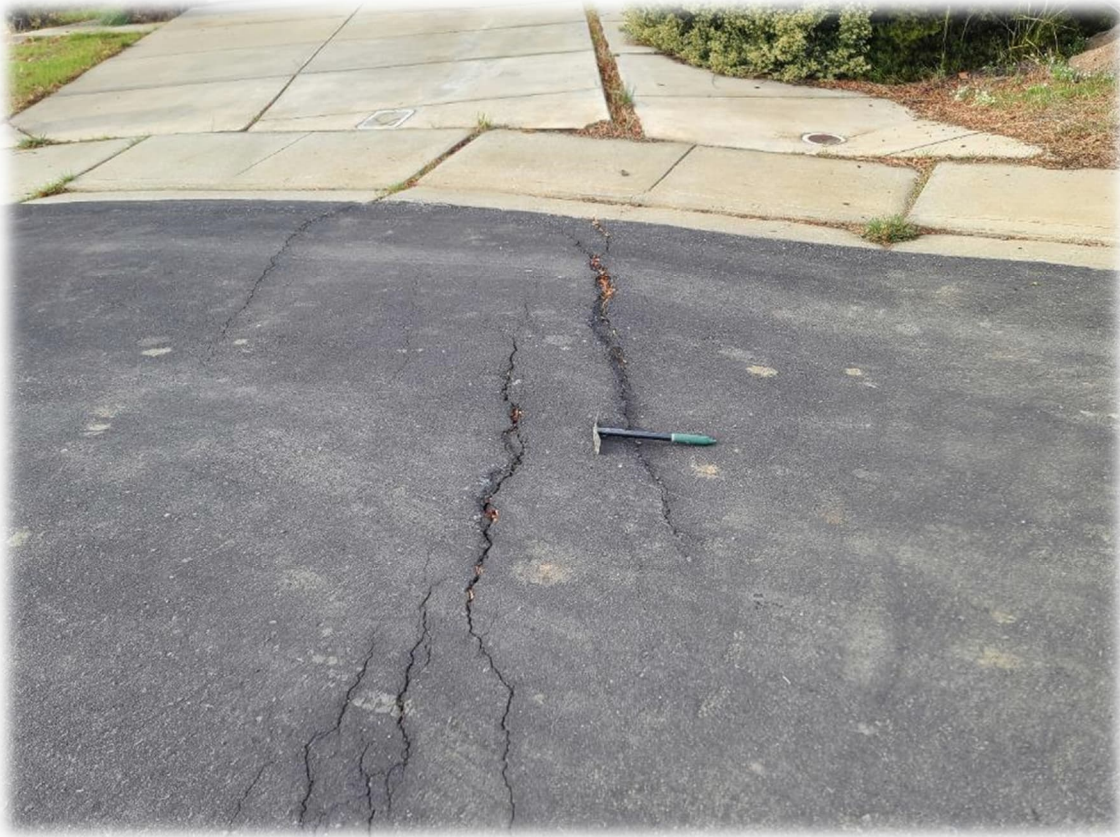
Photograph 6 – Previous conditions at 8053 Kelok Way on December 8, 2022.

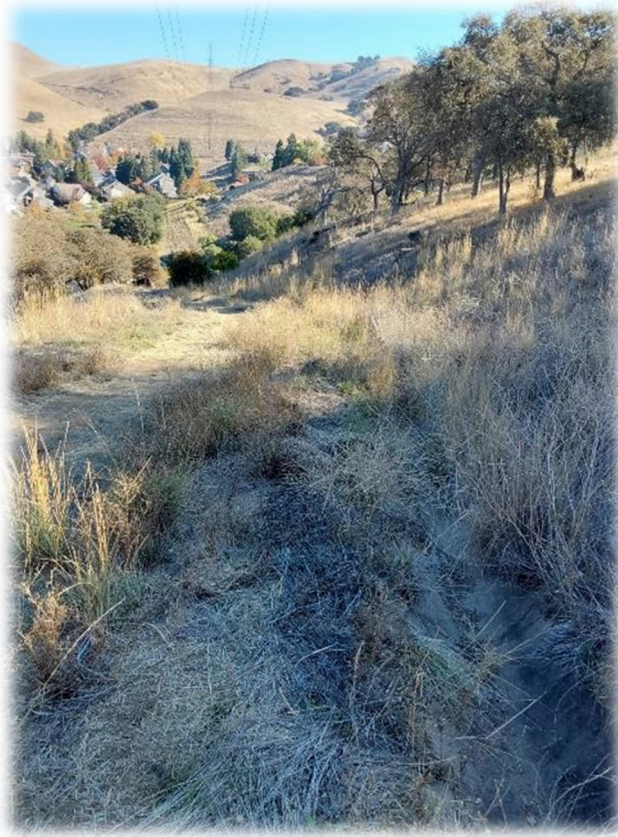
Photograph 7 – V-ditches located along the slope north of Kelok Way contain debris and cracking. Additional V-ditch cleaning and repairs should be performed.

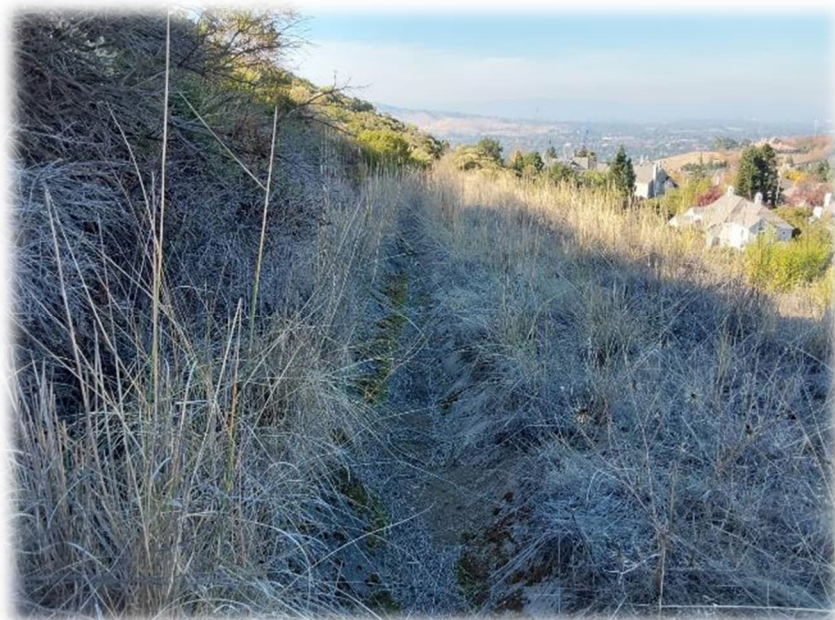
Photograph 8 – V-ditches located along the slope north of Kelok Way contain debris and cracking. Additional V-ditch cleaning and repairs should be performed.

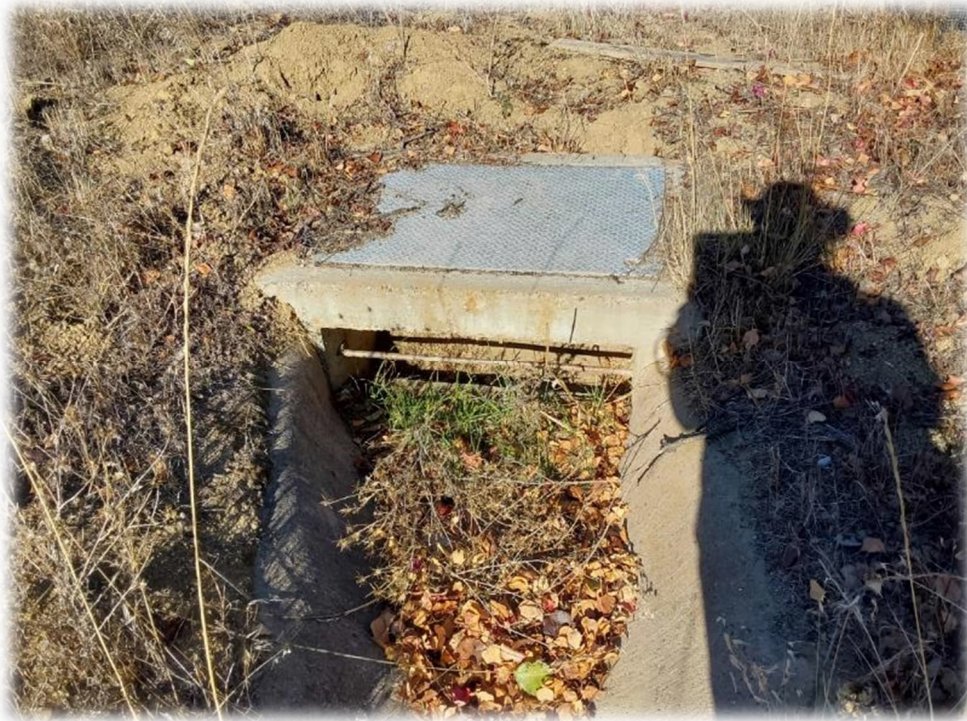
Photograph 9 – Condition of this inlet remains similar to that noted in Photo J of our March 9, 2023 letter: filled with soil/debris. Located west of 8049 Kelok Way. Additional cleaning of this inlet should be performed.

- The inlet west of and adjacent to 8049 Kelok Way should be cleaned out/unclogged.
- The horizontal outlet drain pipes located along the slope at North Valley Park should be cleaned on a regular basis to remove any sludge or silt build up. We recommended that a video survey of these pipes be conducted to check if the pipes are clogged or damaged. If the pipes are found to be clogged or damaged, they should be cleaned via hydrauger or another suitable method.

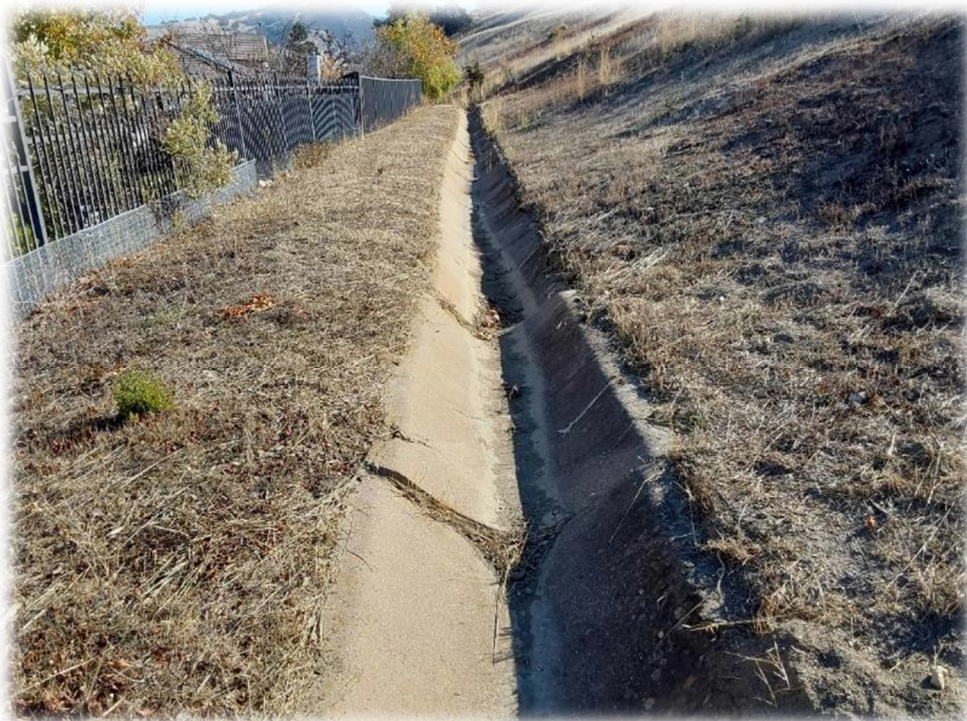
Photograph 10 – ditch condition remains similar as Photo I noted in March 9, 2023 letter: cracked and offset. V-ditch repairs should be performed.

- Cracked and/or offset V-ditch panels, while not numerous, can result in drainage obstructions, overflow, and erosion to slopes. Patches and/or replacement of V-ditch panels should be prioritized and undertaken on a regular basis.

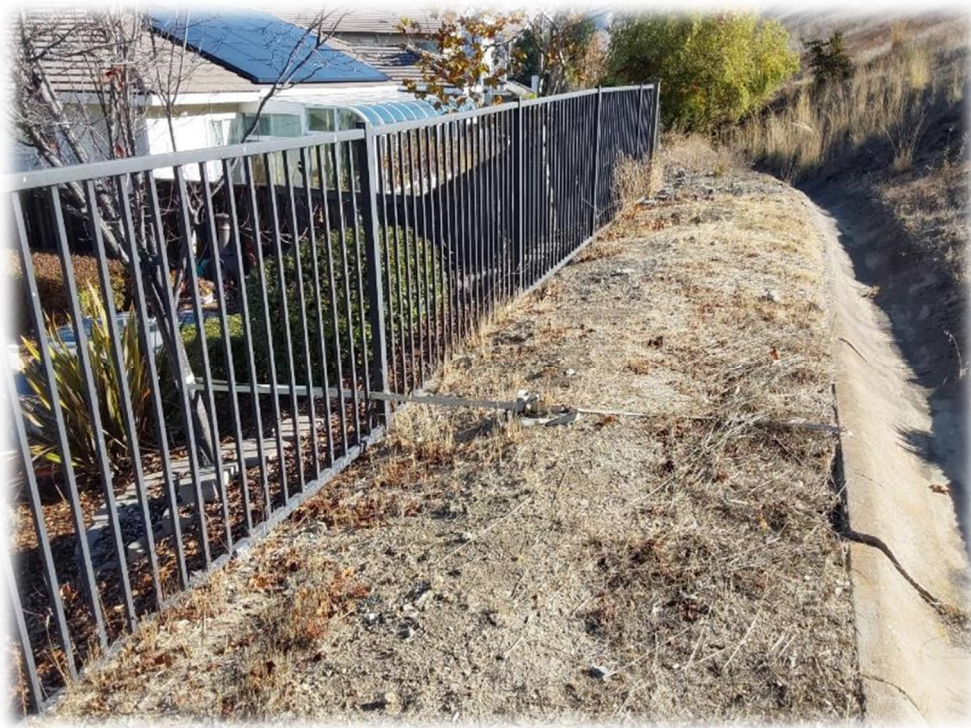
Photograph 11 – Similar conditions observed as noted in March 9, 2023 letter, Photo H: the homeowner has secured trees to the V-ditch beyond property line.

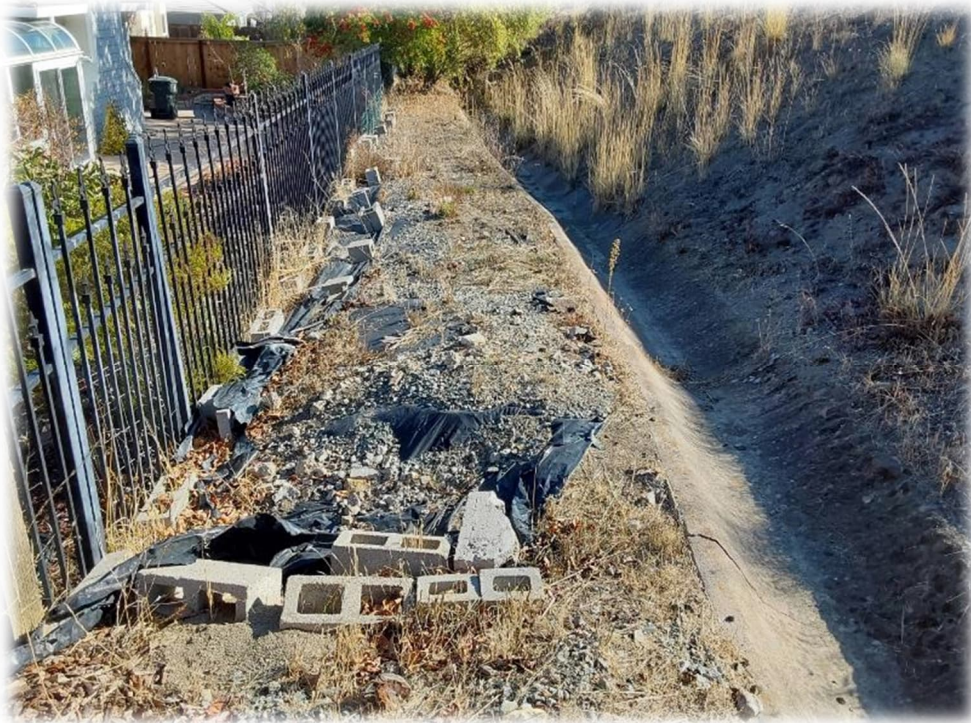
Photograph 12 – Similar conditions observed as noted in March 9, 2023 letter, Photo G: Slope creep depositing debris in V-ditch and resulting in minor cracking of V-ditch. Additional V-ditch cleaning and repairs should be performed.

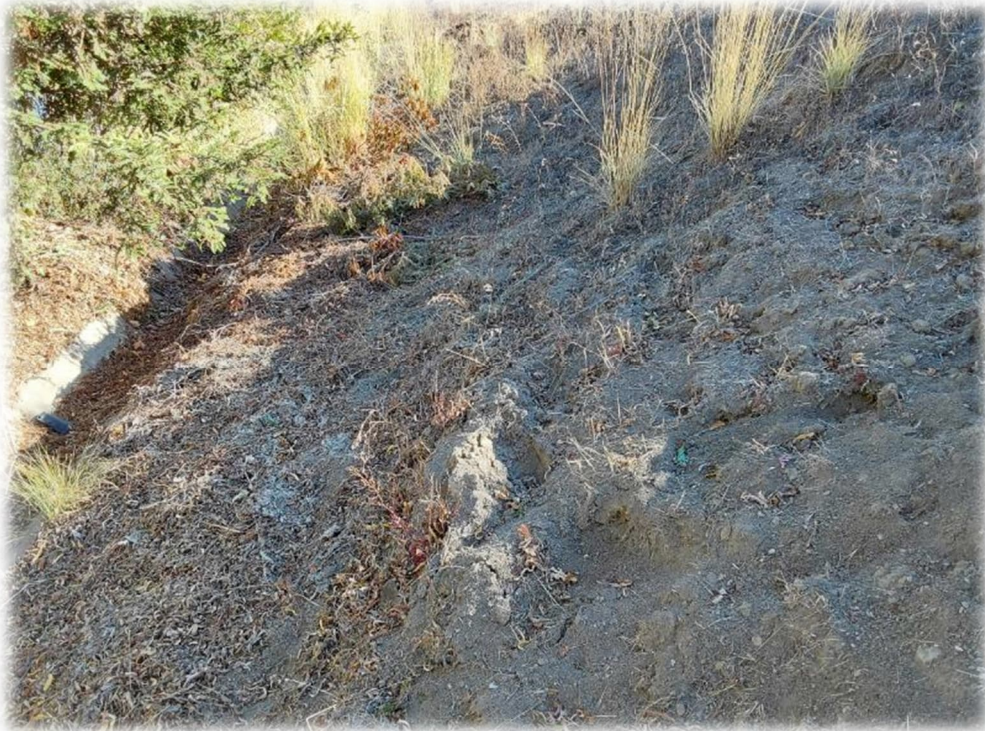
Photograph 13 – Some slope erosion/creep behind 5229 Keller Ridge Drive along with debris within V-ditch. Additional V-ditch cleaning should be performed.

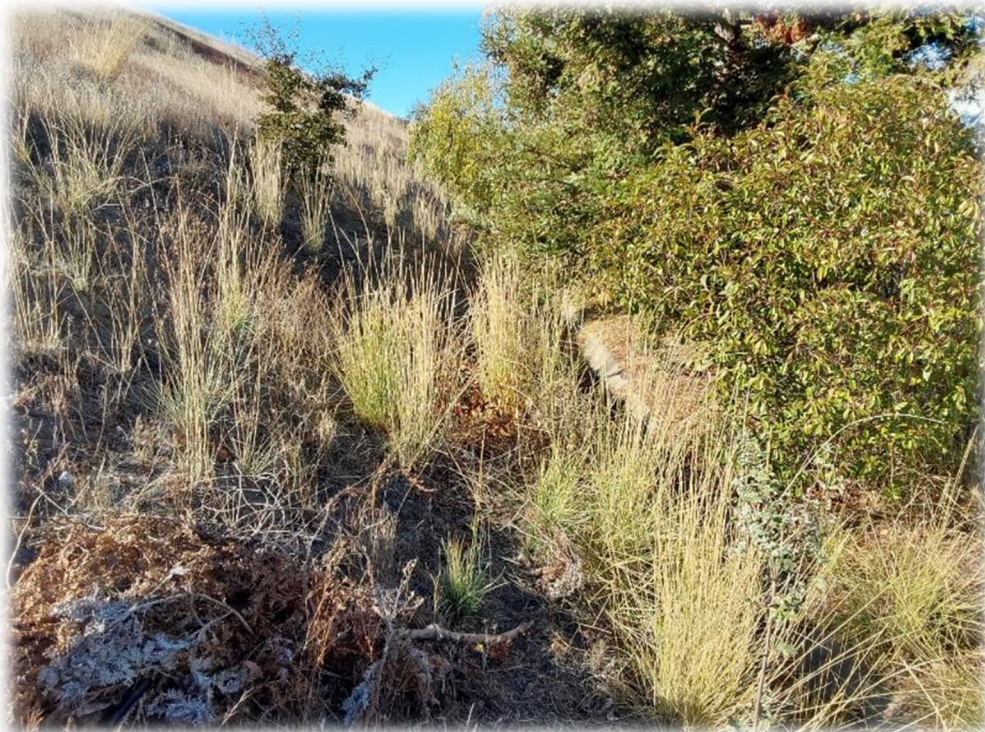
Photograph 14 – Just east of Photograph 12. Additional V-ditch cleaning should be performed.

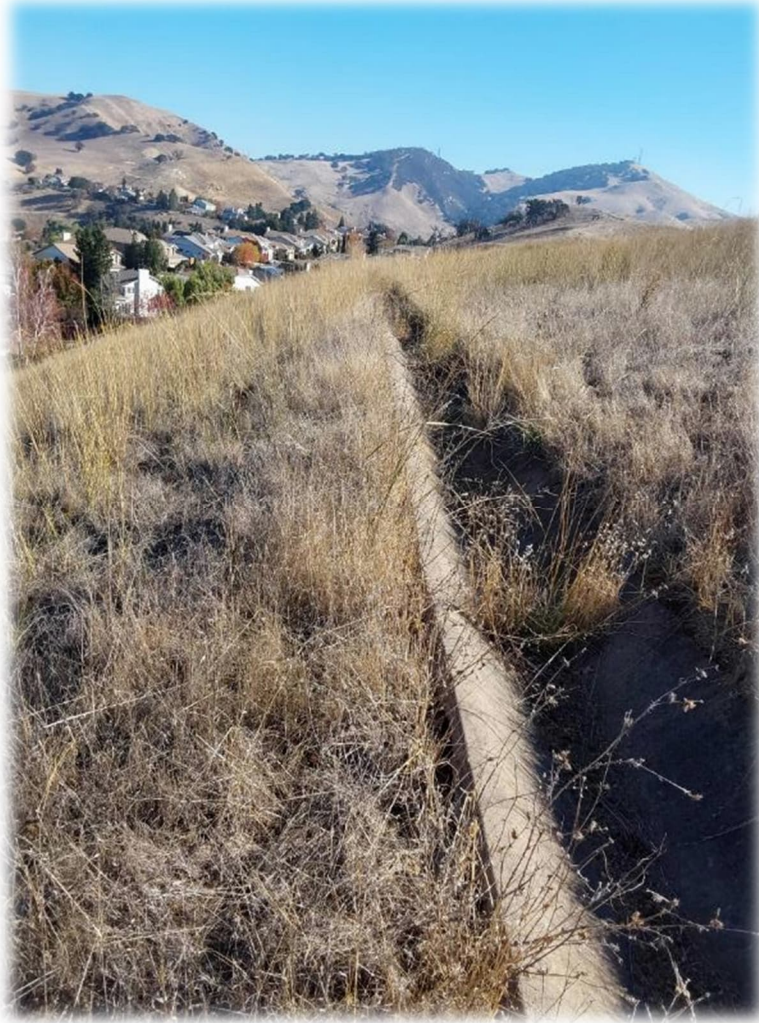
Photograph 15 – Similar conditions observed in the area as noted in March 9, 2023 letter, Photo K: separation of soil from the downhill side of the V-ditch due to slope creep.

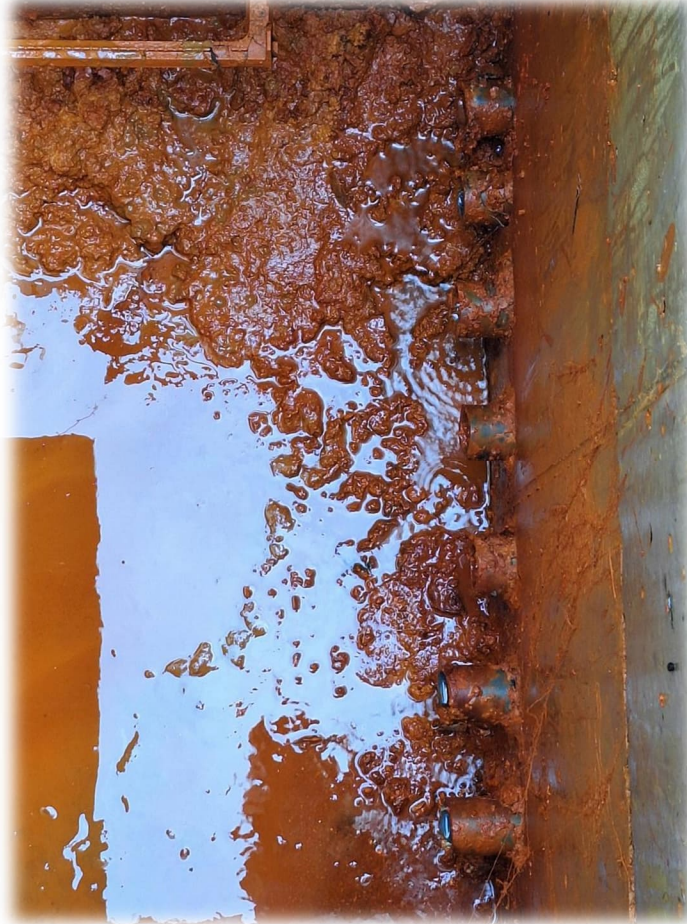
On March 5, 2024, we visited the site to observe flows from the vertical wells and horizontal outlet drain pipes located at North Valley Park (see Photograph 16 below). The drain outflow pipes terminate in a vault which is then drained to the storm drain system. There are seven (7) drain pipes terminating into the vault, six of which drain the vertical drain wells on Kelok Way. Based on the location of the vault and the location of the wells located along Kelok Way, we estimate that the pipes measure approximately 350 to 450 feet in length. One of the seven drain pipes that terminates into the vault is reported to be from one of the subdrains underlying the upslope fill in the area (we do not know which one). At the time of our visit, only two pipes out of seven pipes were discharging water. Based on our review of previous monitoring data for the GHAD, this appears to have been the case since installation of this drain system. Therefore, we have concerns about the condition of the horizontal drainage pipes. While we did not measure depth to groundwater depth in the vertical wells, historically, the depth to groundwater is significantly above the horizontal drain inlets near the bottom of the vertical wells. The cause of incomplete drainage from the vertical wells should be investigated by a video survey for damaged pipes, air locks, or other obstructions. Hydrauger or another suitable method may be needed to clean out the pipes.

Photograph 16 – Horizontal outlet drain pipes at North Valley Park. Only two of the seven pipes were discharging water on March 5, 2024.

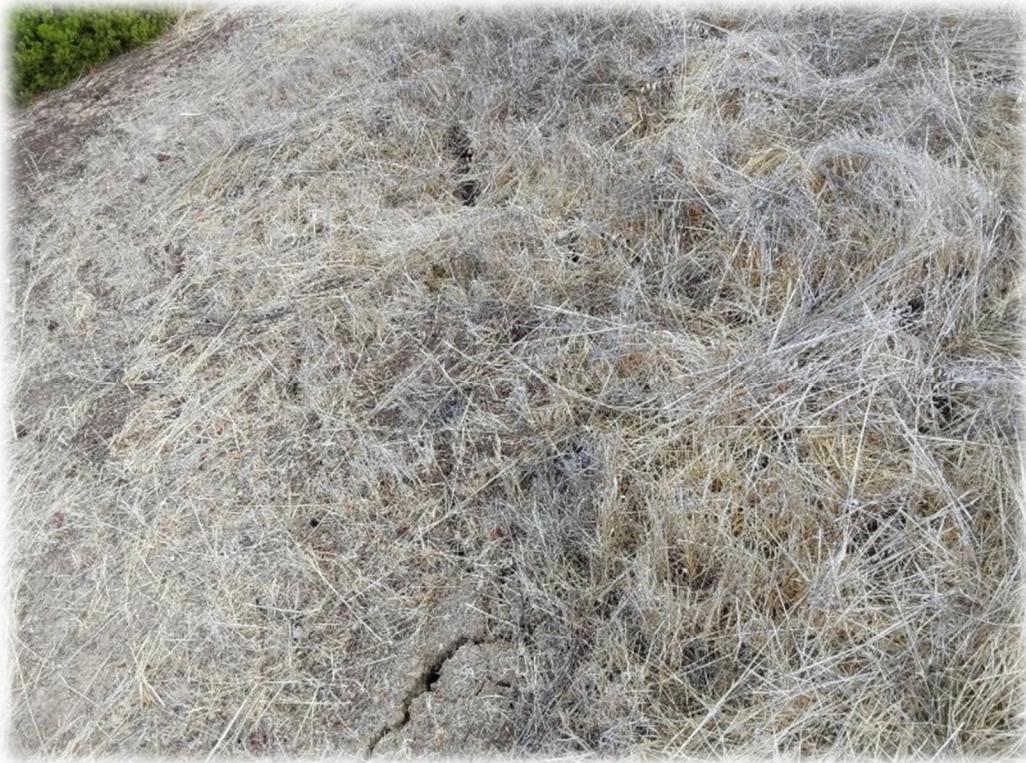
Photograph 17 – Possible slope creep/shrinkage cracks formed along the slope adjacent to/east of Peacock Creek Drive (approximately 40 feet from roadway).

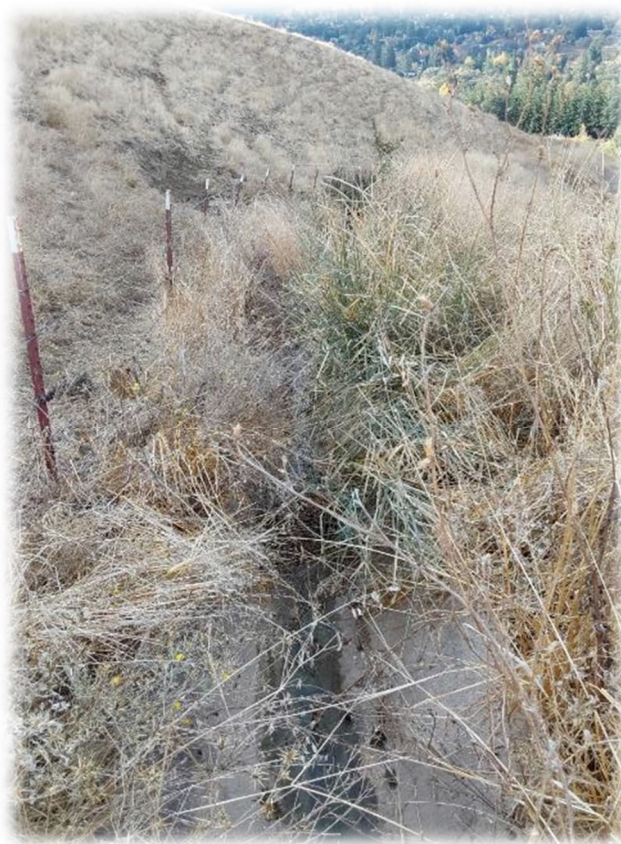
Photograph 18 – Additional cleaning of V-ditches along the slope should be performed.

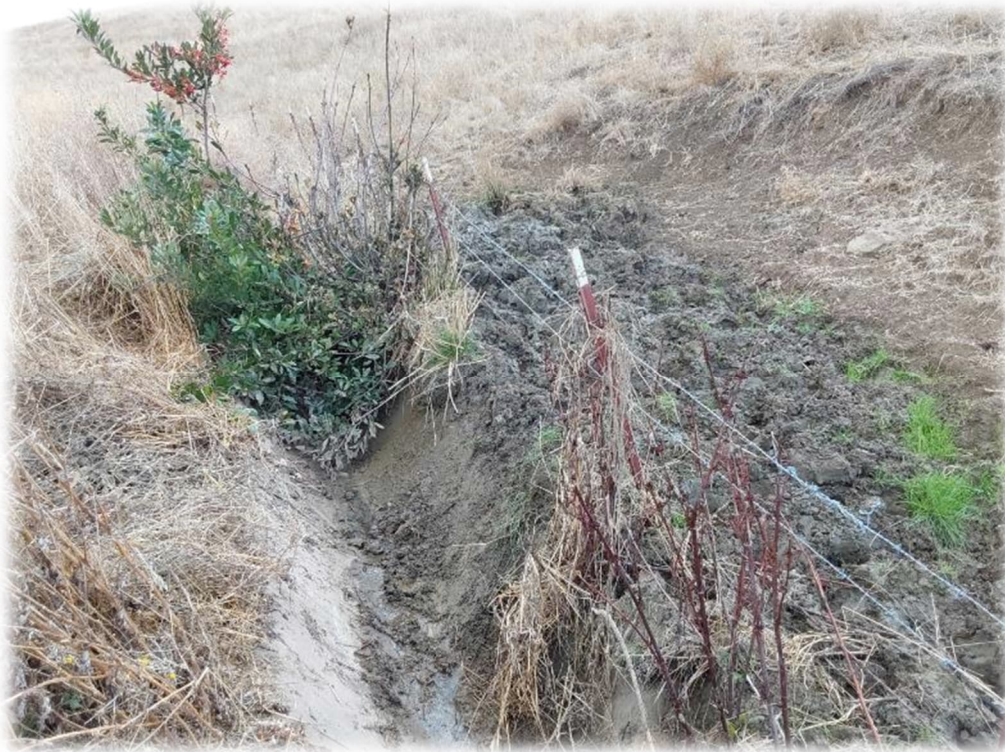
Photograph 19 – Similar conditions as noted in March 9, 2023 letter, Photo O: slope creep and minor sloughing adjacent to V-ditch.

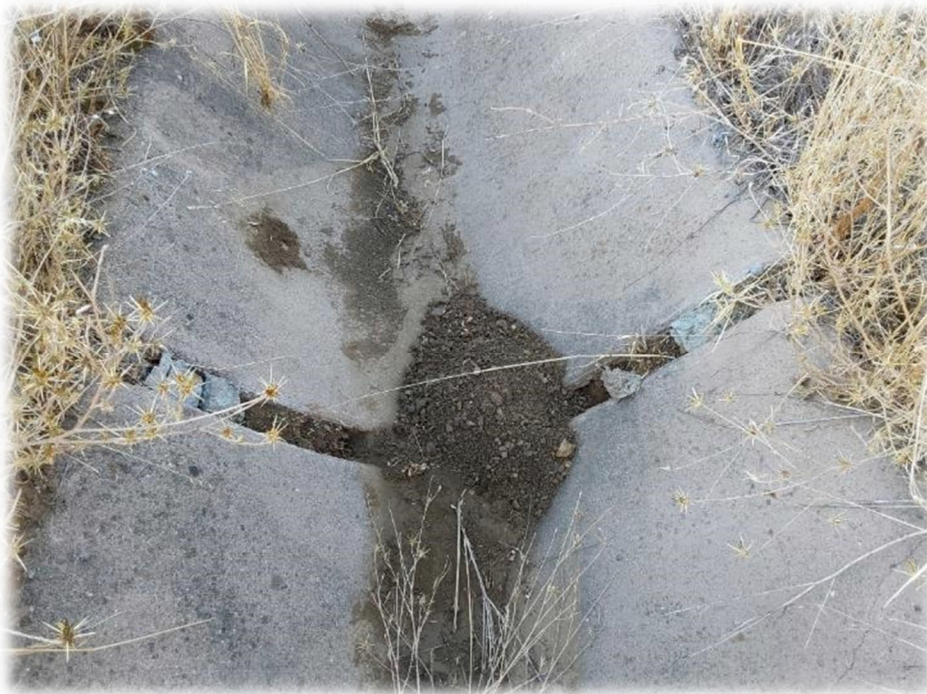
Photograph 20 – V-ditch separated at joint in the area of Photo 19. V-ditch should be repaired.

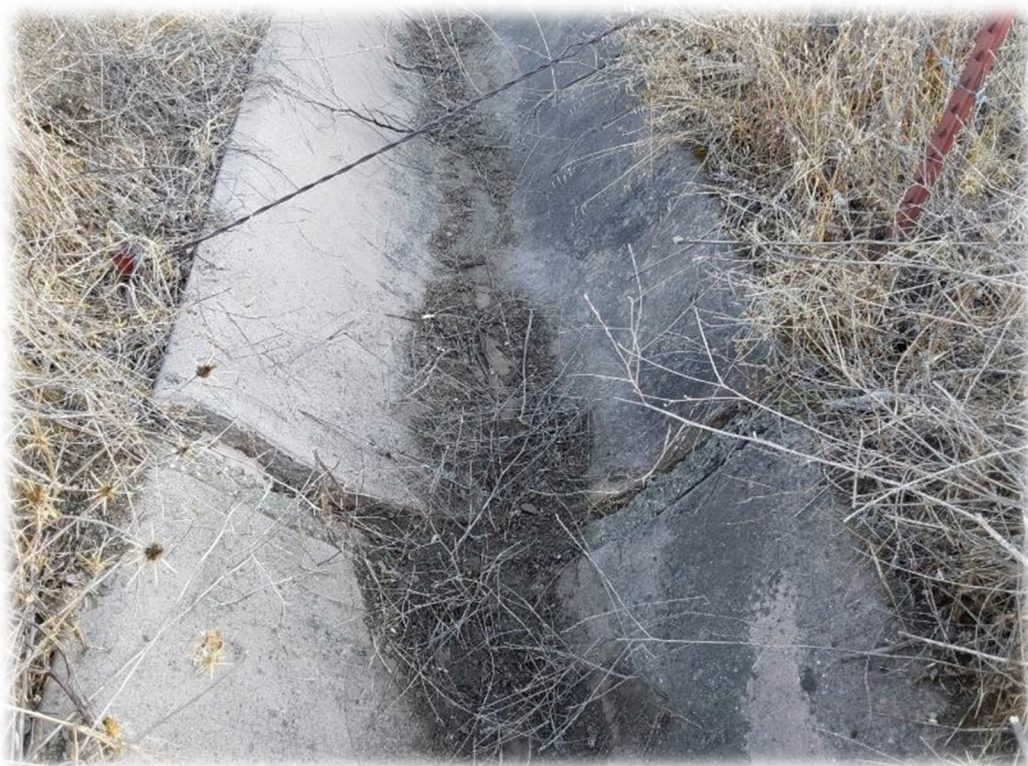
Photograph 21 – V-ditch separated at joint in the area of Photo 18. V-ditch should be repaired.

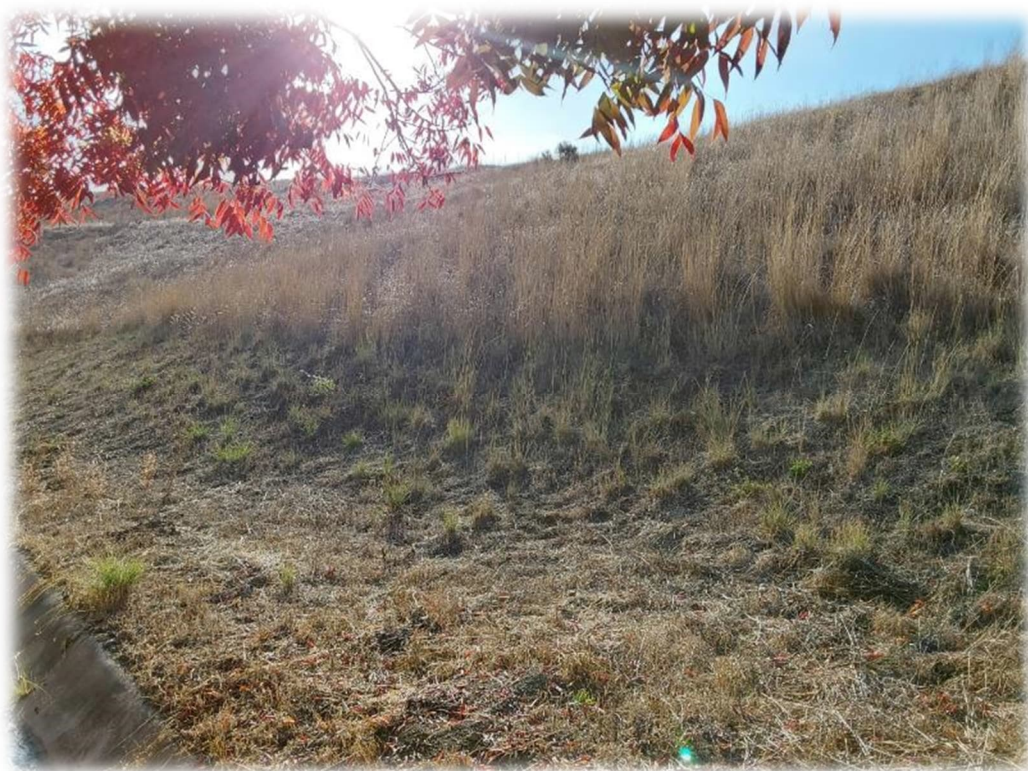
Photograph 22 – Slope creep behind 1116 Peacock Creek Drive.

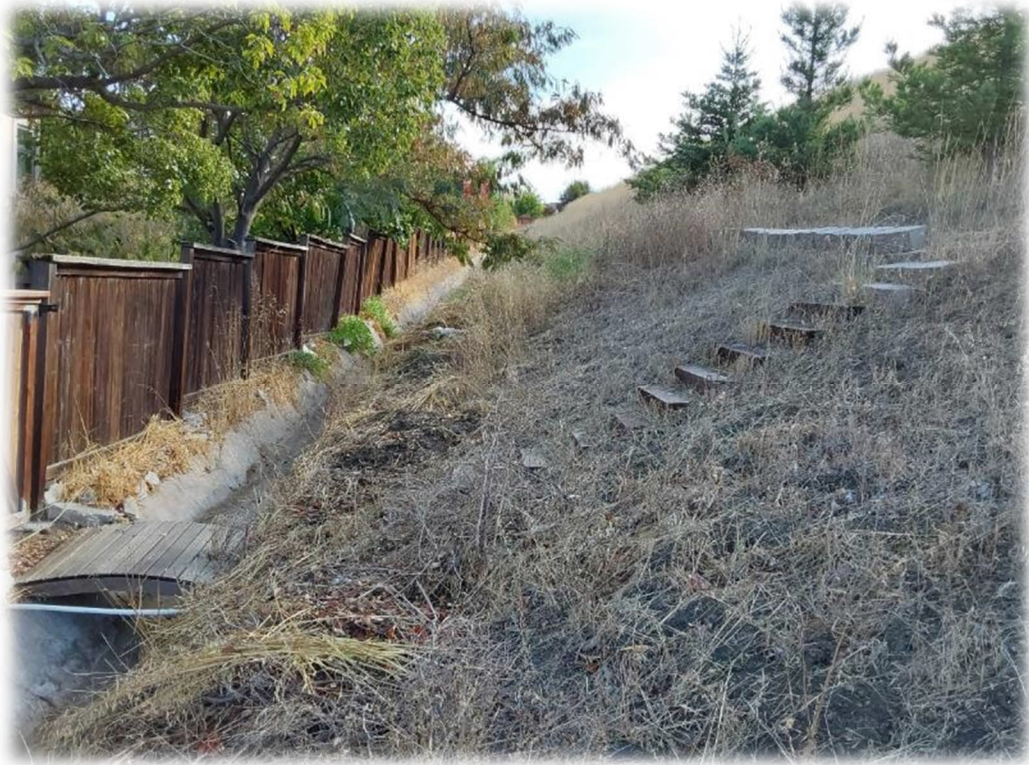
Photograph 23 – Similar conditions as noted in March 9, 2023 letter, Photo S, behind 1122 Peacock Creek Drive: Resident has planted trees and built a short keystone-type retaining wall uphill from the V-ditch.

- Residents going beyond their fence line, altering the existing slopes, which could adversely impact the shallow and global stability of such slopes.

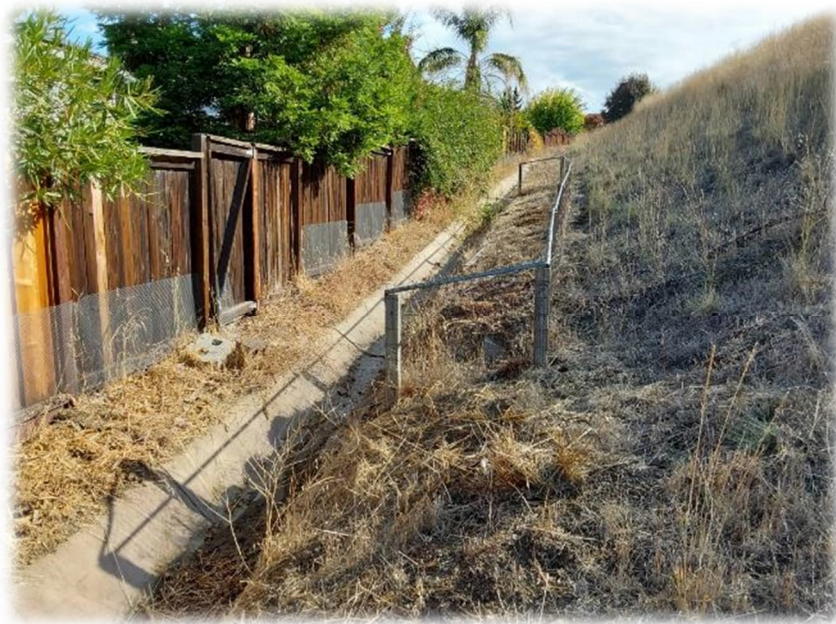
Photograph 24 – Wire fence installed by resident at 1126 Peacock Creek Drive.

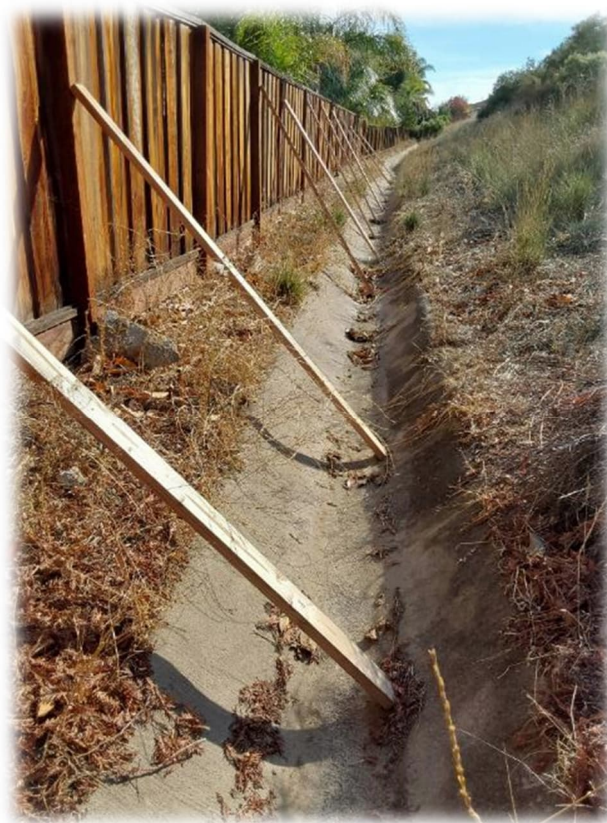
Photograph 25 – Resident has added fence supports within v-ditch near 1146/1148 Peacock Drive.

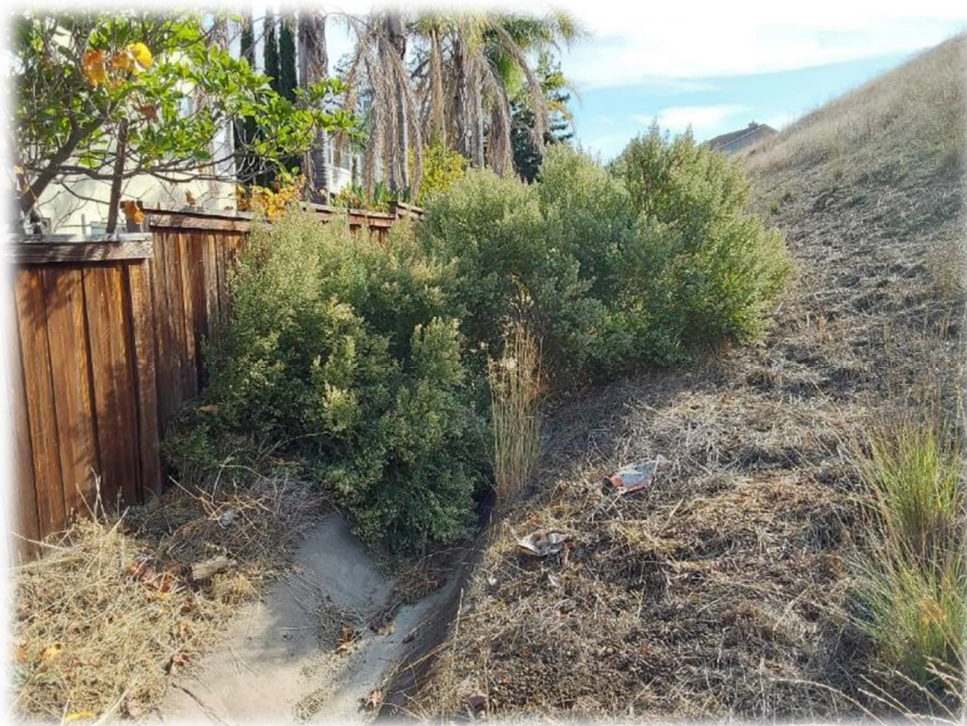
Photograph 26 – Vegetation within V-ditch present just east of Photograph 25 nearly blocks the V-Ditch. Vegetation should be removed from the V-ditch.

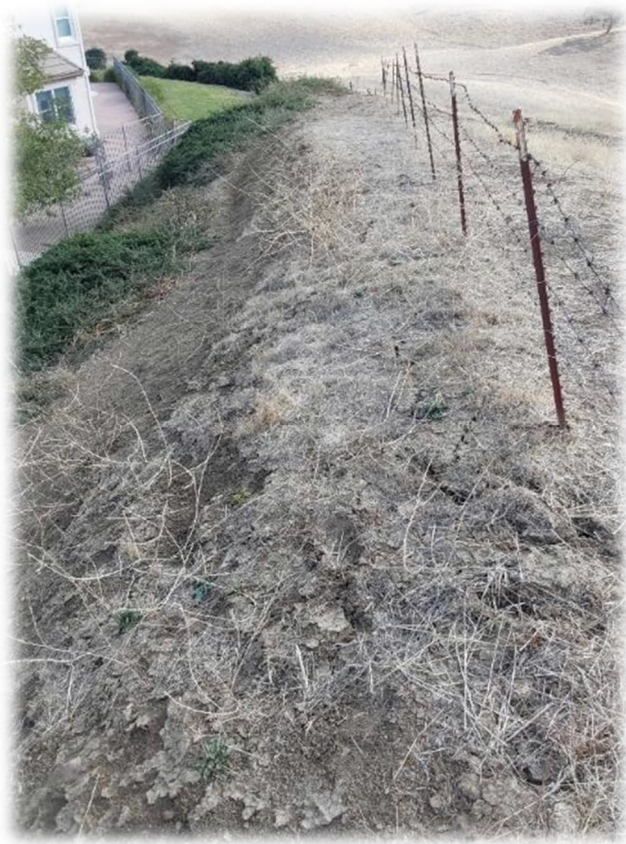
Photograph 27 – Possible slope creep/shrinkage cracks along top of slope south of 185 Brandywine Place.

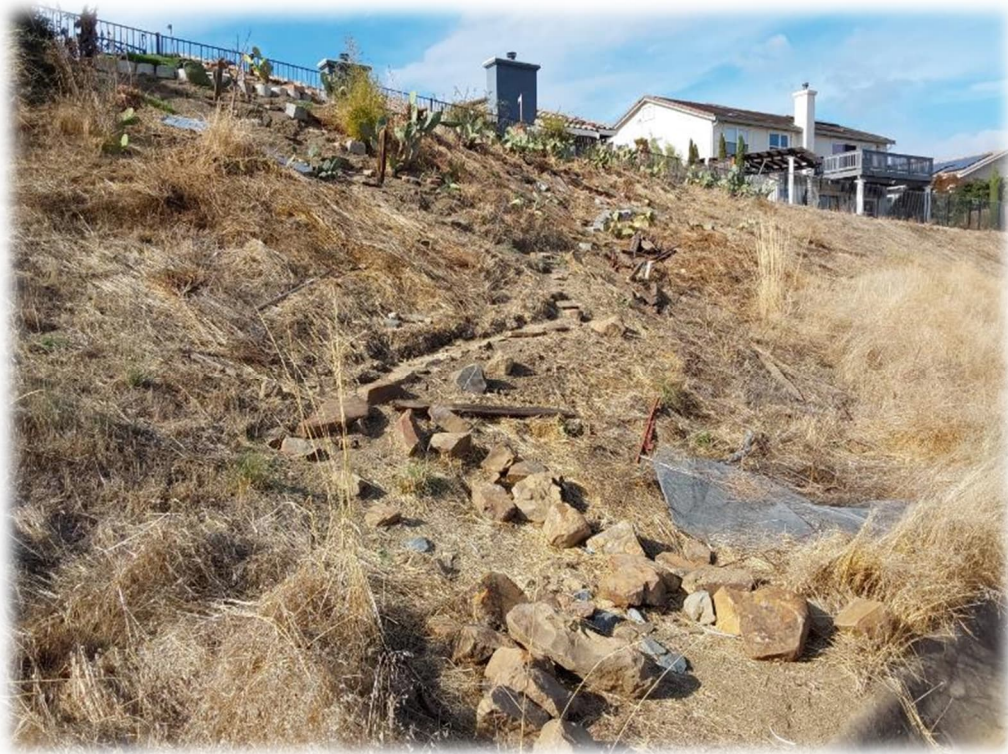
Photograph 28 – Resident at 183 Brandywine Place has added boulders and vegetation to the slope along with creating a pathway, possibly for landscaping purposes. It is not an ideal situation to regrade the slope.

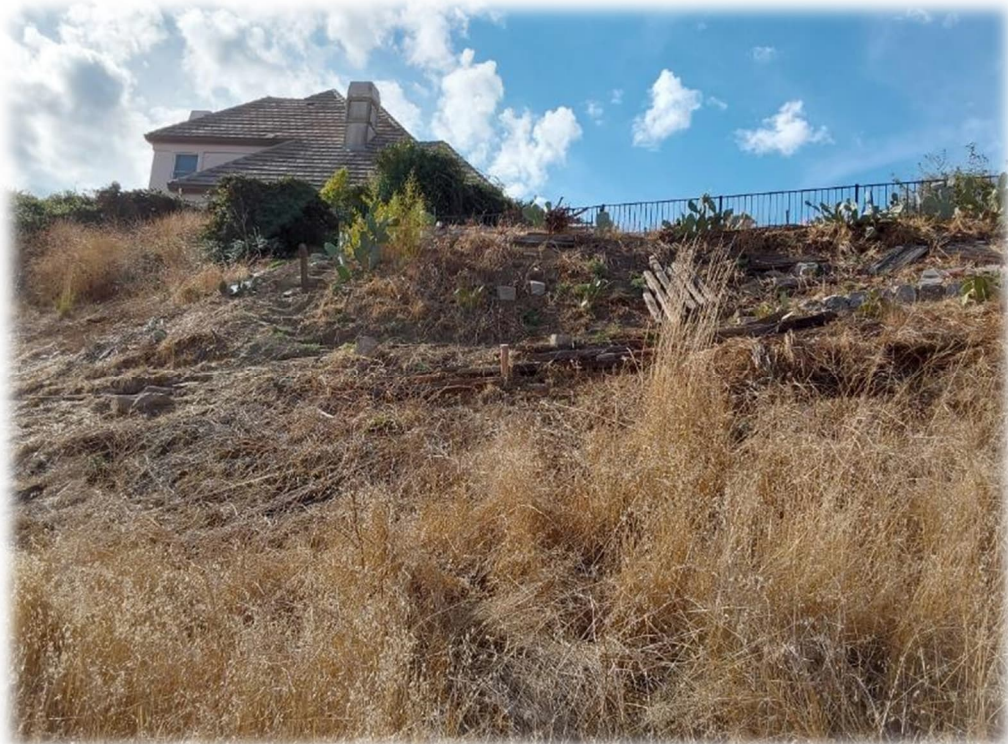
Photograph 29 – 183 Brandywine Place. See note in previous photograph.

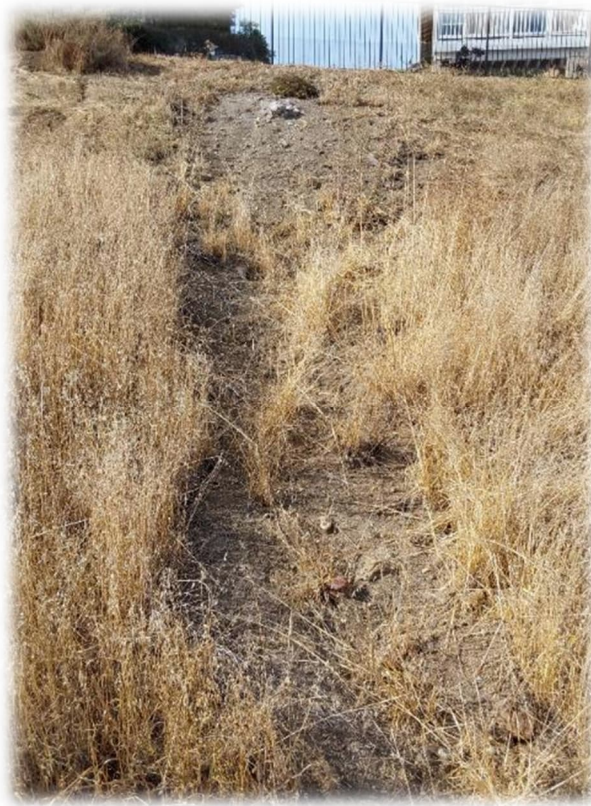
Photograph 30 – Minor slope wash along slope at 179 Brandywine Place.

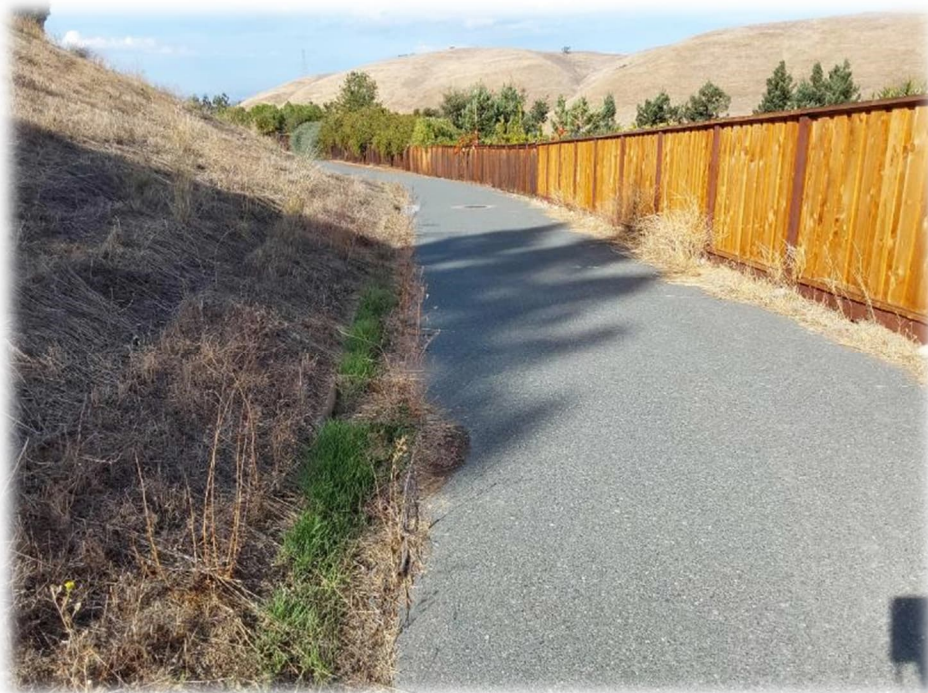
Photograph 31 – Vegetation/debris along toe of slope east of 140 Inverness Way blocking water flow. Area should be cleaned.
