May 1, 2024

BSK Project No. G00001941

SUBJECT: Geological and Geotechnical Site Reconnaissance
Oakhurst Geological Hazards Abatement District (GHAD)
Clayton, CA

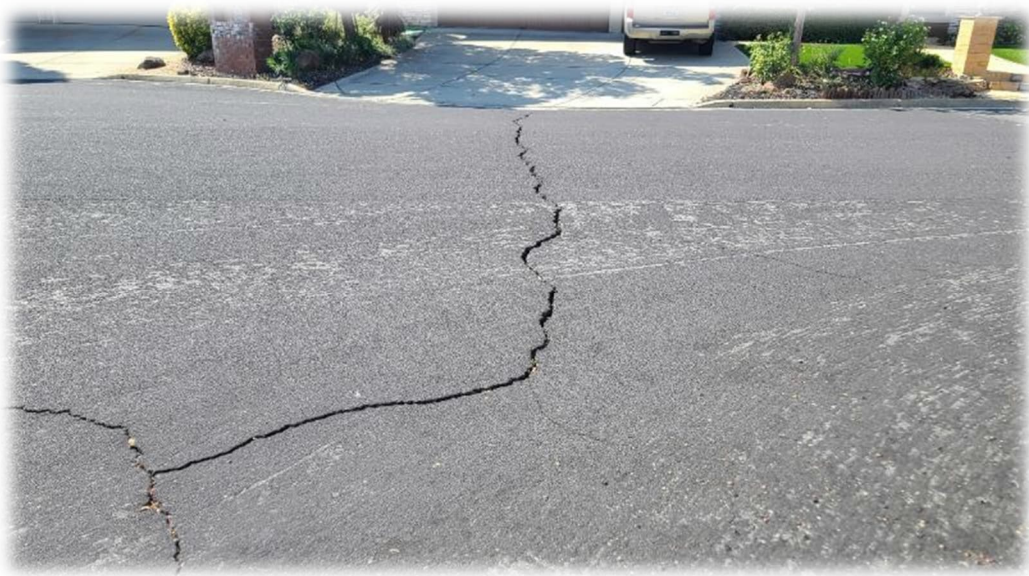
Photograph 32 – Numerous cracks observed within pavement along Torrey Pines on 8-31-2023. No cracks observed by residents within homes. No cracks observed along slope east of Torrey Pines.

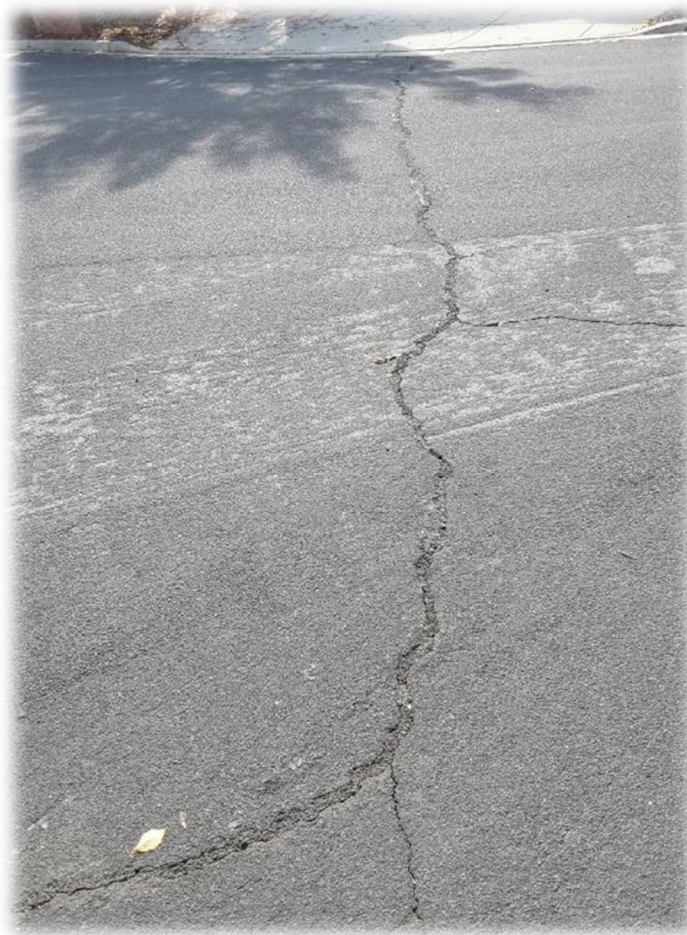
Photograph 33 – Cracks had been filled by City crew within pavement along Torrey Pines as of 11-17-2023.

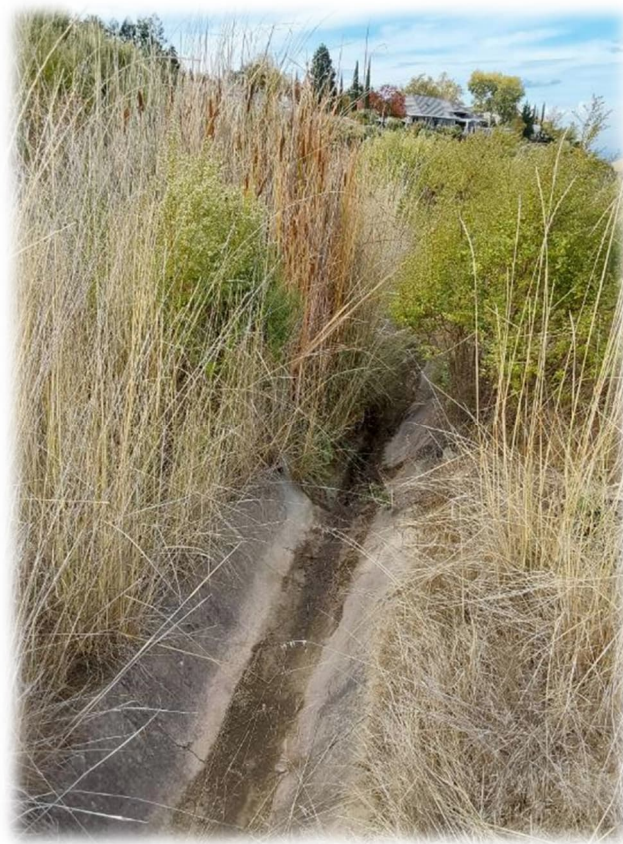
Photograph 34 – Similar conditions observed as noted in March 9, 2023 letter, Photo Q: moist ground and seepage from the slope.

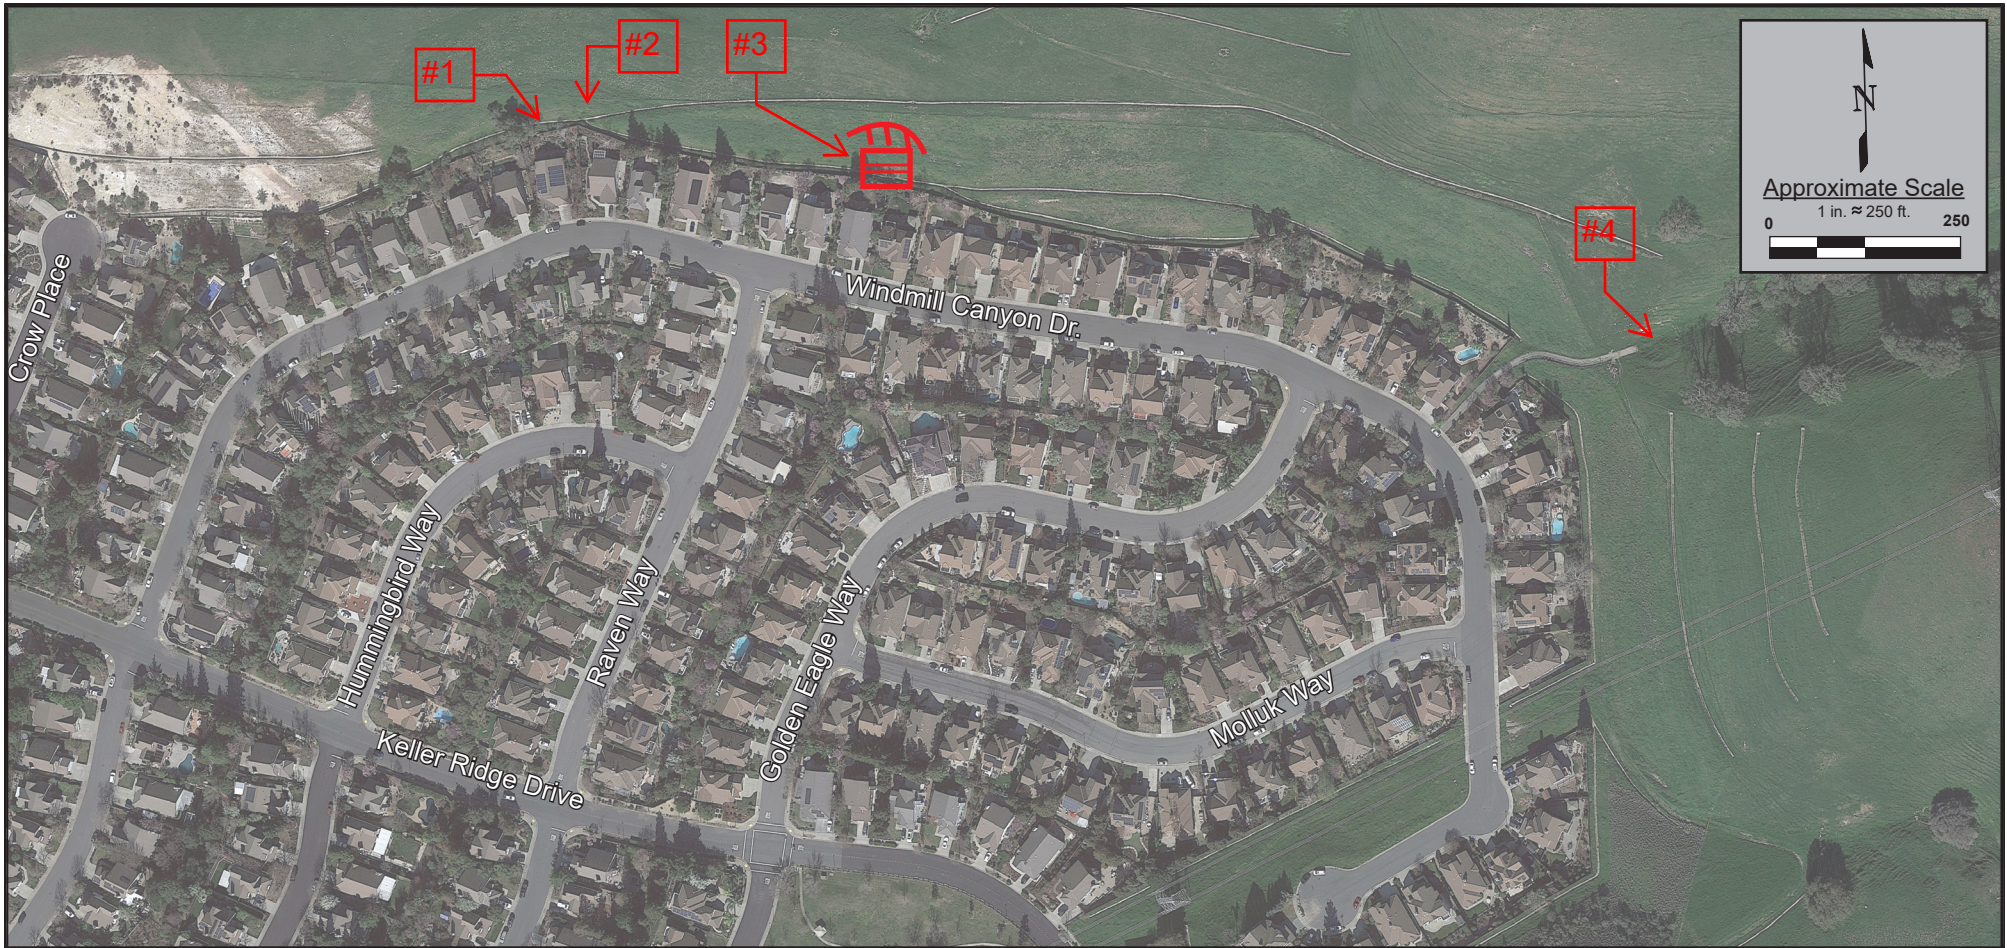
SITE PLAN **North Area**

In general, we observed surface creep¹ above most V-ditches, particularly in areas where slopes are mowed (presumably for fire control). Periodic maintenance should be sufficient to prevent soil from entering into and disrupting flow in the ditches. We also observed shallow slope sloughing and raveling in various areas, which are also identified on Figure 3A. Overall, conditions observed remain similar to those observed and noted in our March 9, 2023 letter.

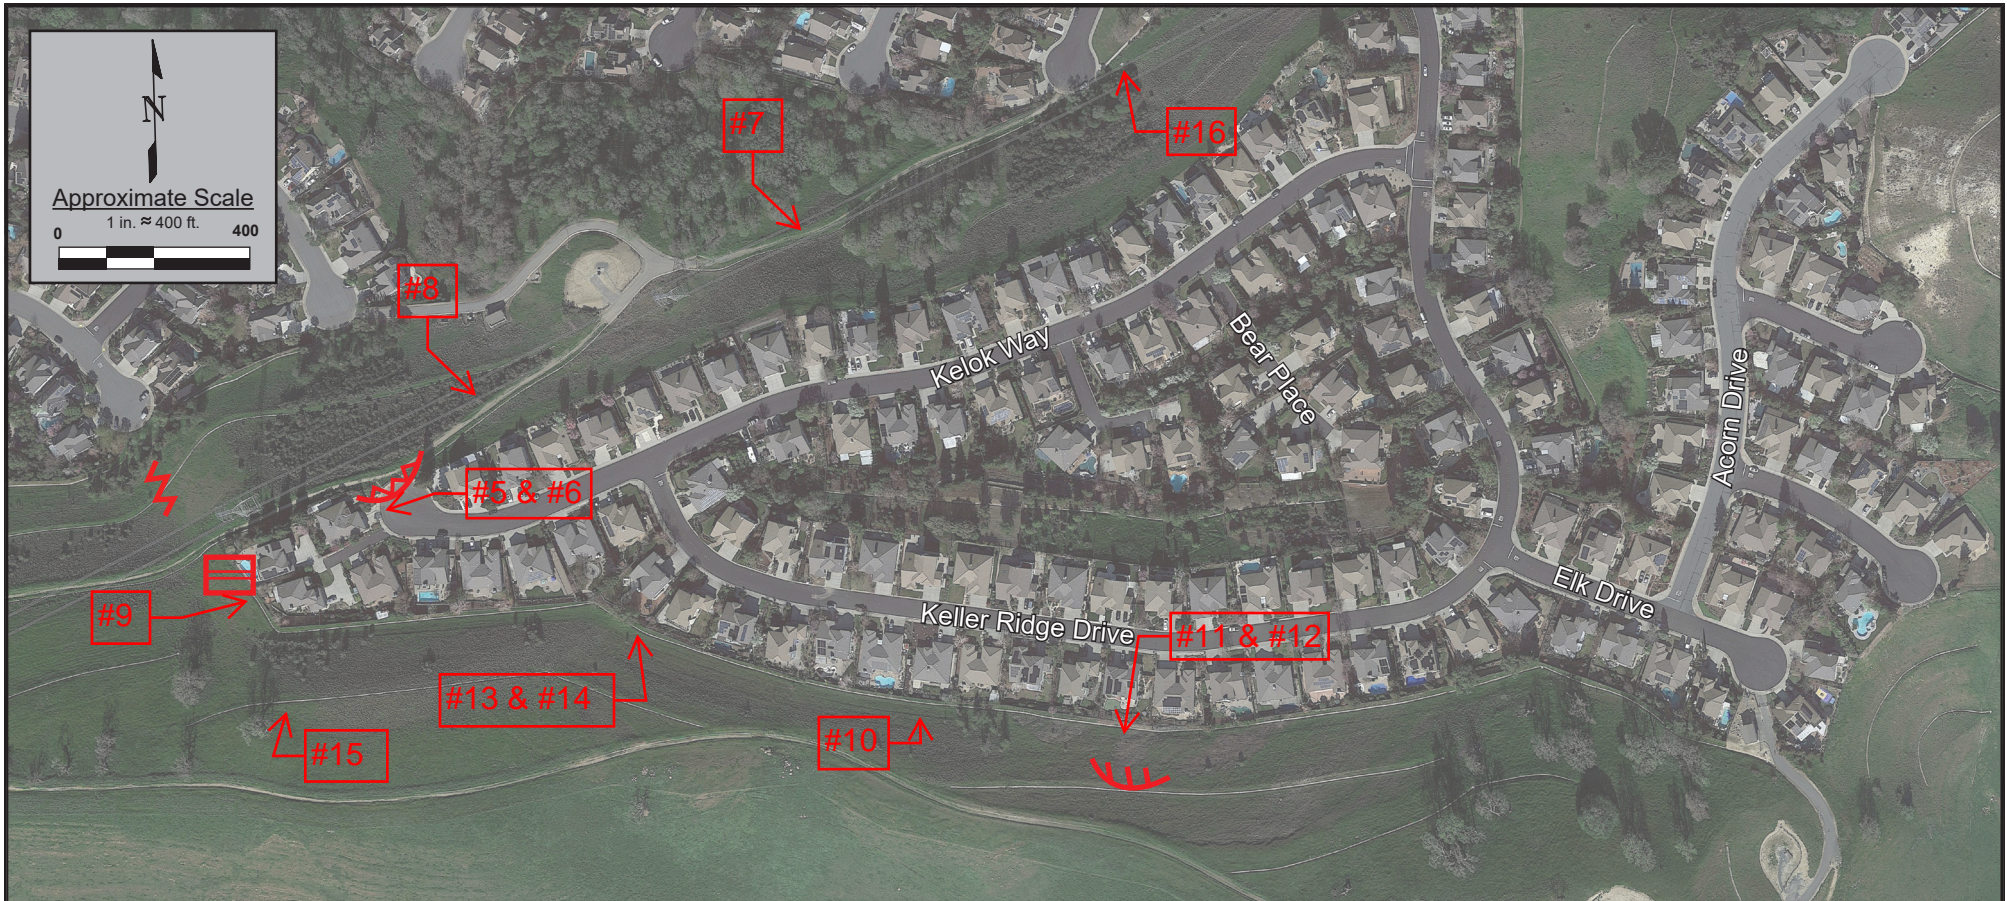
SITE PLAN **Kelok Way Area**

In general, we observed surface creep above most V-ditches. Periodic maintenance should be sufficient to prevent soil from entering into and disrupting flow in the ditches. We also observed shallow slope sloughing and raveling in various areas, which are also identified on Figure 3B. Overall, conditions remain the similar to those observed in our March 9, 2023 letter. The V-ditches in the area could use additional cleaning/maintenance. The following photographs depict the conditions documented during our site review. The approximate photograph locations are presented on Figure 3B.

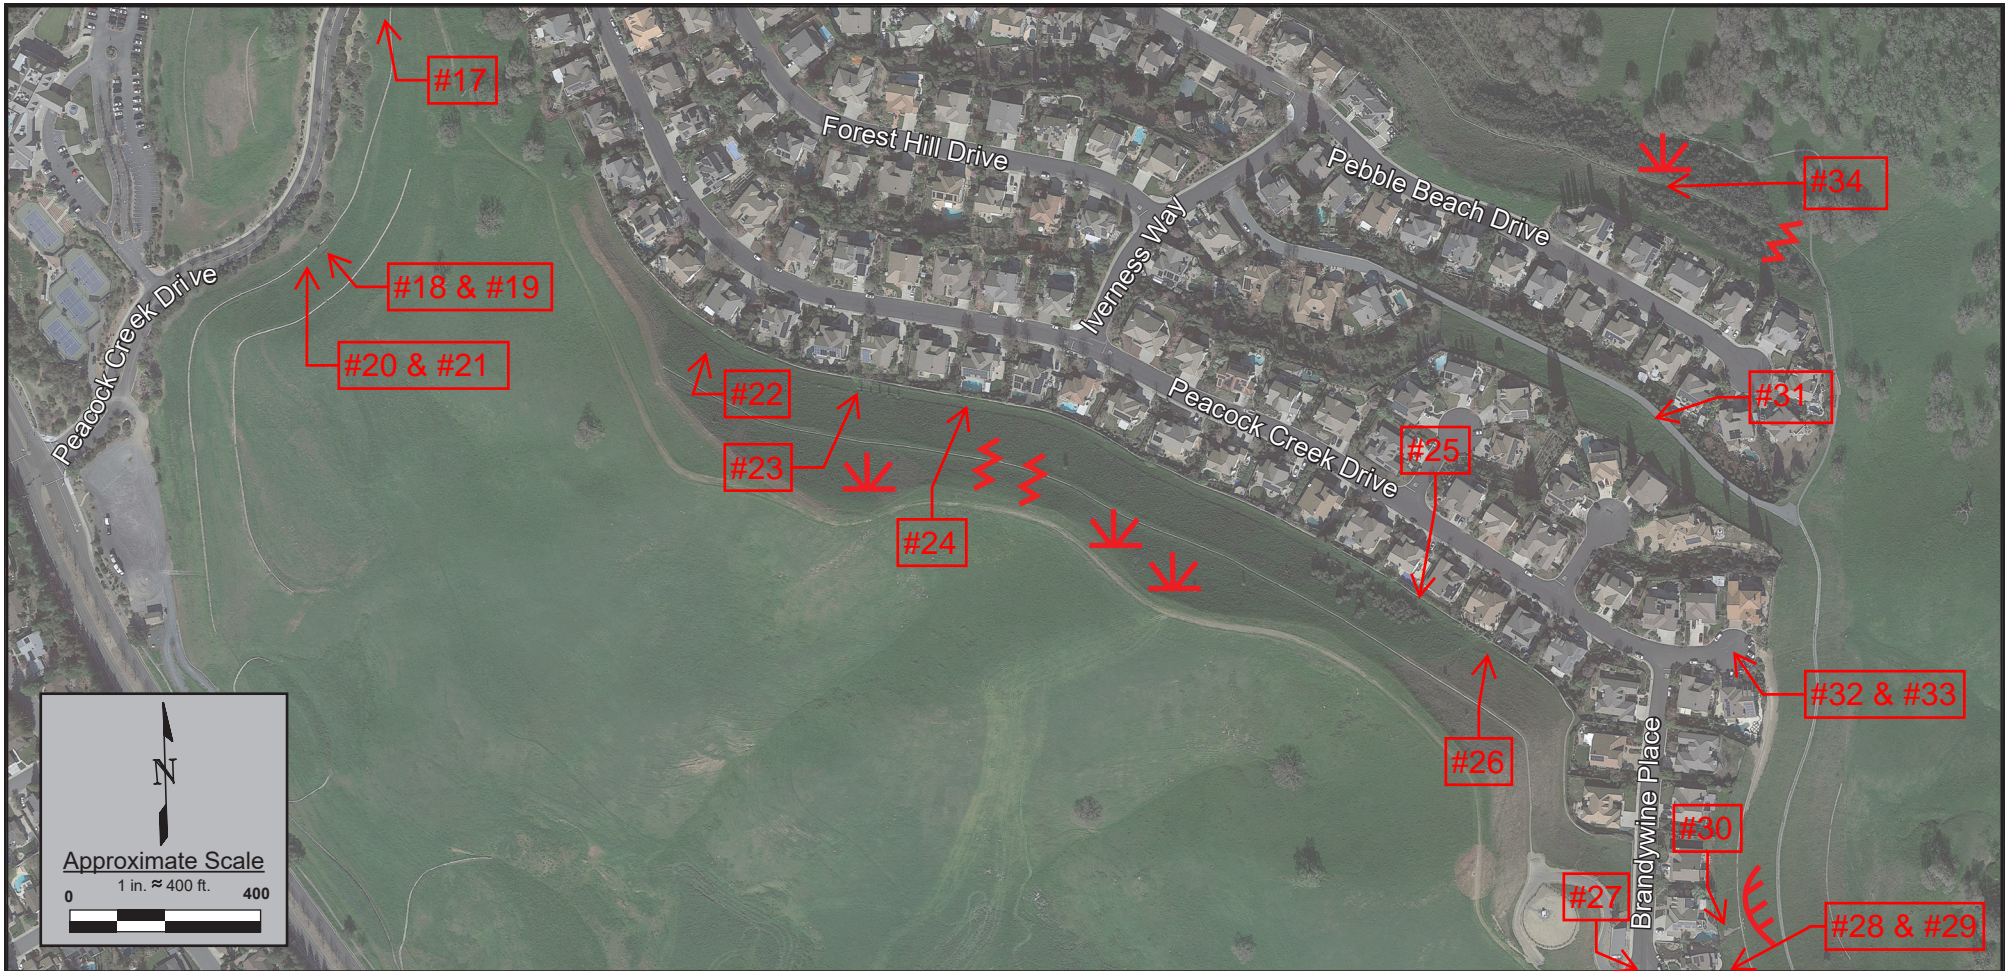
SITE PLAN **South Area**

In general, we observed surface creep above most V-ditches. Periodic maintenance should be sufficient to prevent soil from entering into and disrupting flow in the ditches. We also observed shallow slope sloughing and raveling in various areas, which are also identified in Figure 3C. Overall, conditions observed remain similar to those observed and noted in our March 9, 2023 letter.
