INTERIM REPORT  
SLOPE INCLINOMETER INSTALLATION AND  
MONITORING PROGRAM  
OPEN SPACE SLOPE BELOW LOTS 59 THROUGH 61  
PEBBLE BEACH DRIVE  
CLAYTON, CALIFORNIA

FOR  
OAKHURST GEOLOGIC HAZARD  
ABATEMENT DISTRICT  
August 10, 2007

Job No. 2947.100

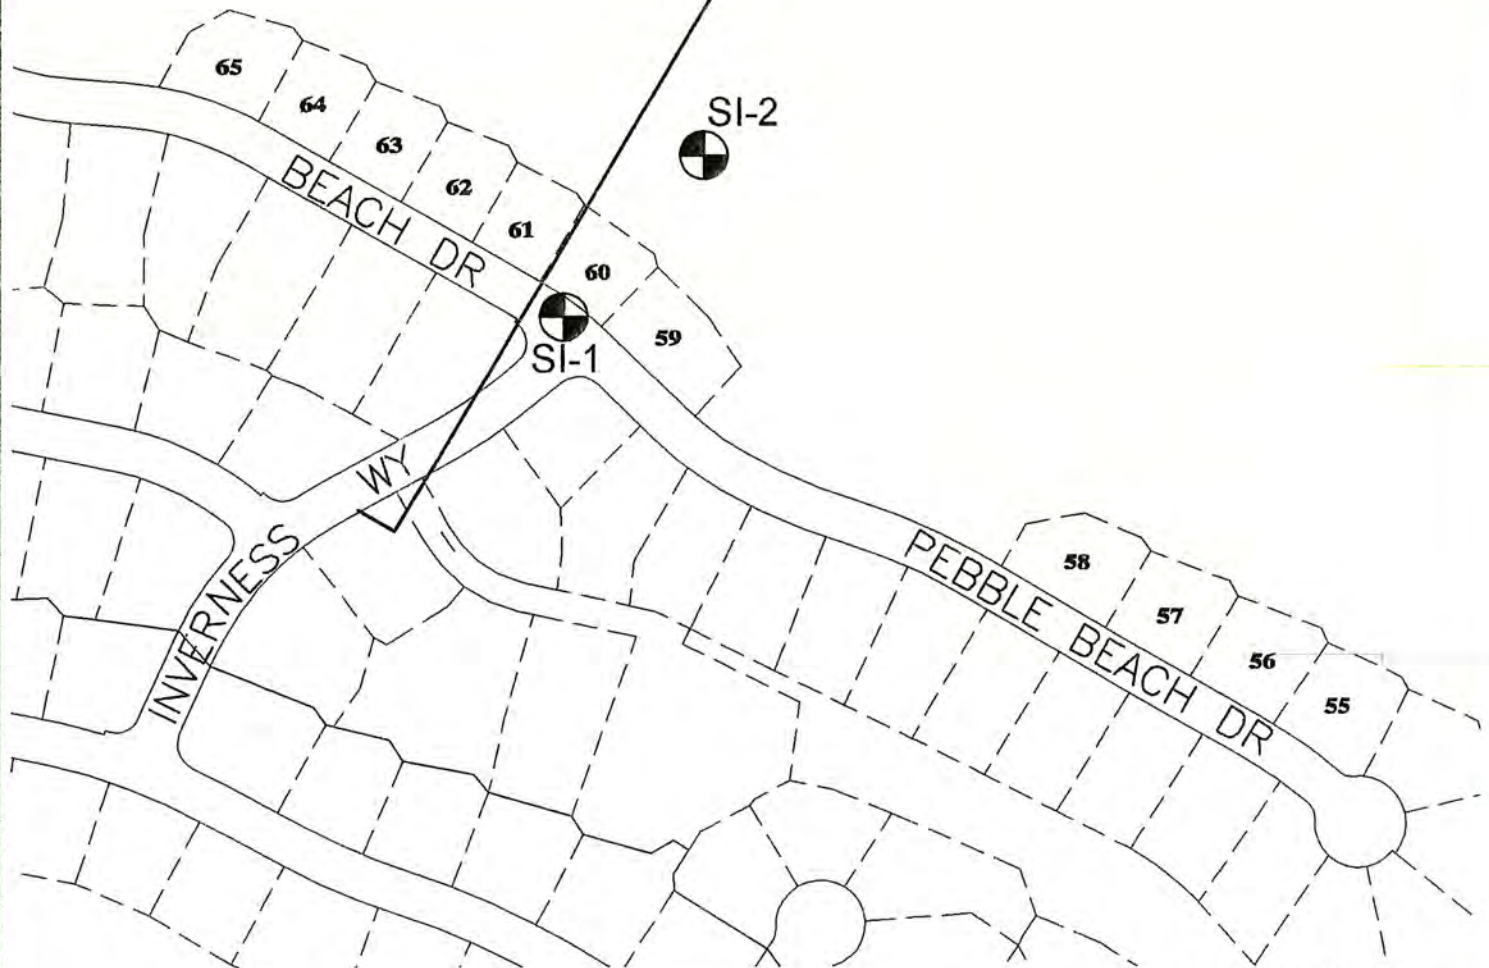
**SITE PLAN**

SI-2  
SLOPE INCLINOMETER LOCATION
-

OPEN SPACE SLOPE  
BELOW LOTS 59 THROUGH 61  
PEBBLE BEACH DRIVE  
CLAYTON, CALIFORNIA  
FOR  
OAKHURST GEOLOGIC HAZARD  
ABATEMENT DISTRICT  
Berlogar Geotechnical Consultants  
SOIL ENGINEERS \* ENGINEERING GEOLOGISTS

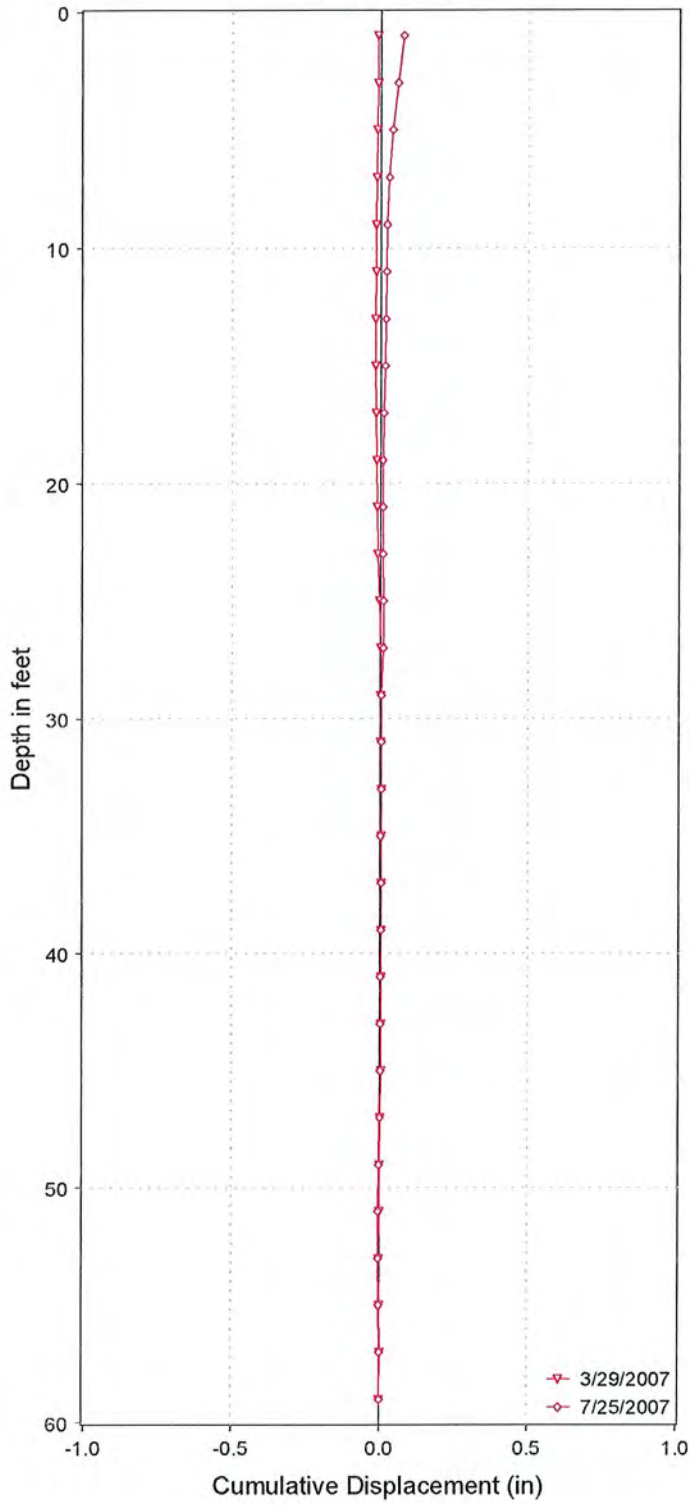
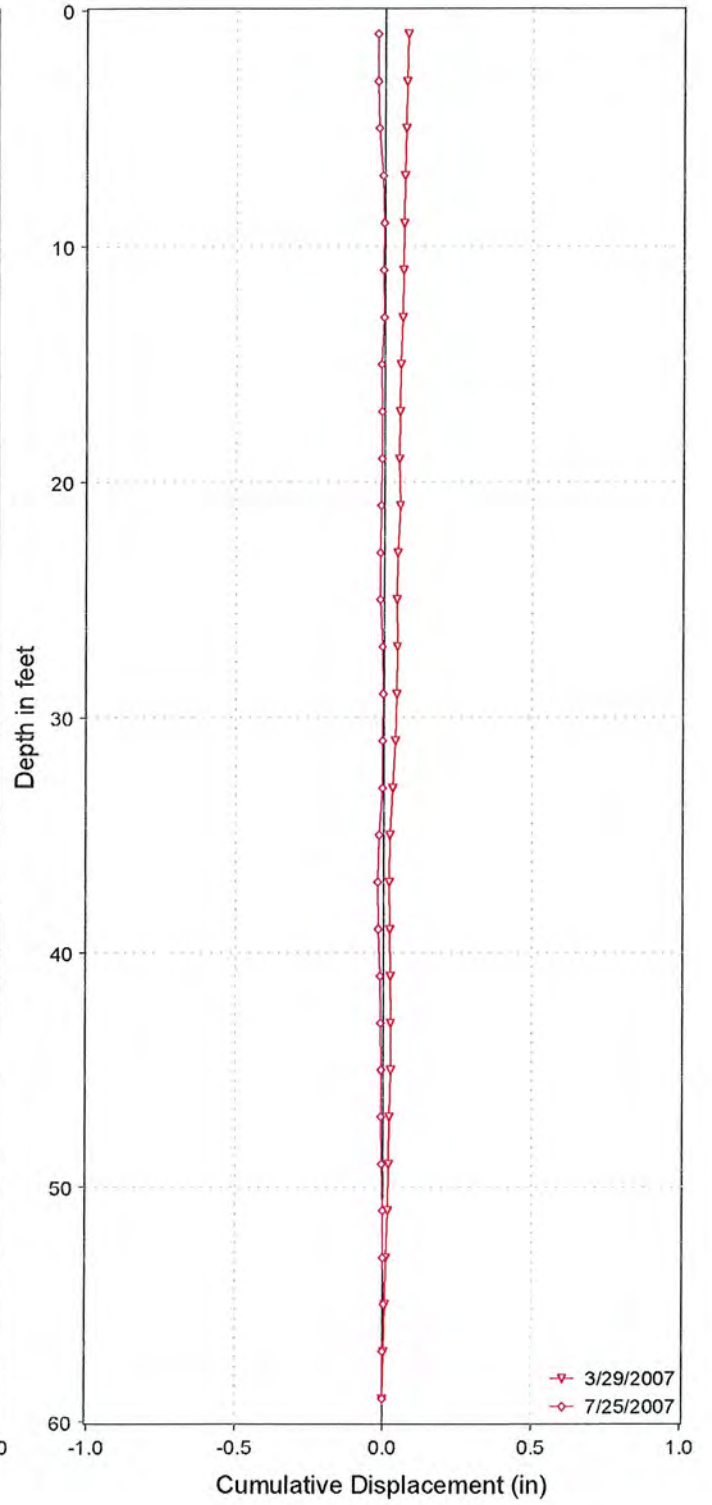
SI-1, A-Axis

In accordance with our proposal for the project dated October 25, 2006 we have began a three year monitoring program in which quarterly readings will be taken from the slope inclinometers SI-1 and SI-2 that were installed at the site as part of this project. Baseline readings of the two slope inclinometers were taken on February 20, 2007 and subsequent readings have been taken on March 29, 2007 and on July 25, 2007. The plots are provided on Plates 4 and 5.

2947.100 - Open space slope below  
lots 59 through 61  
Base Line Reading Date: 2/20/07  
A+= B+=

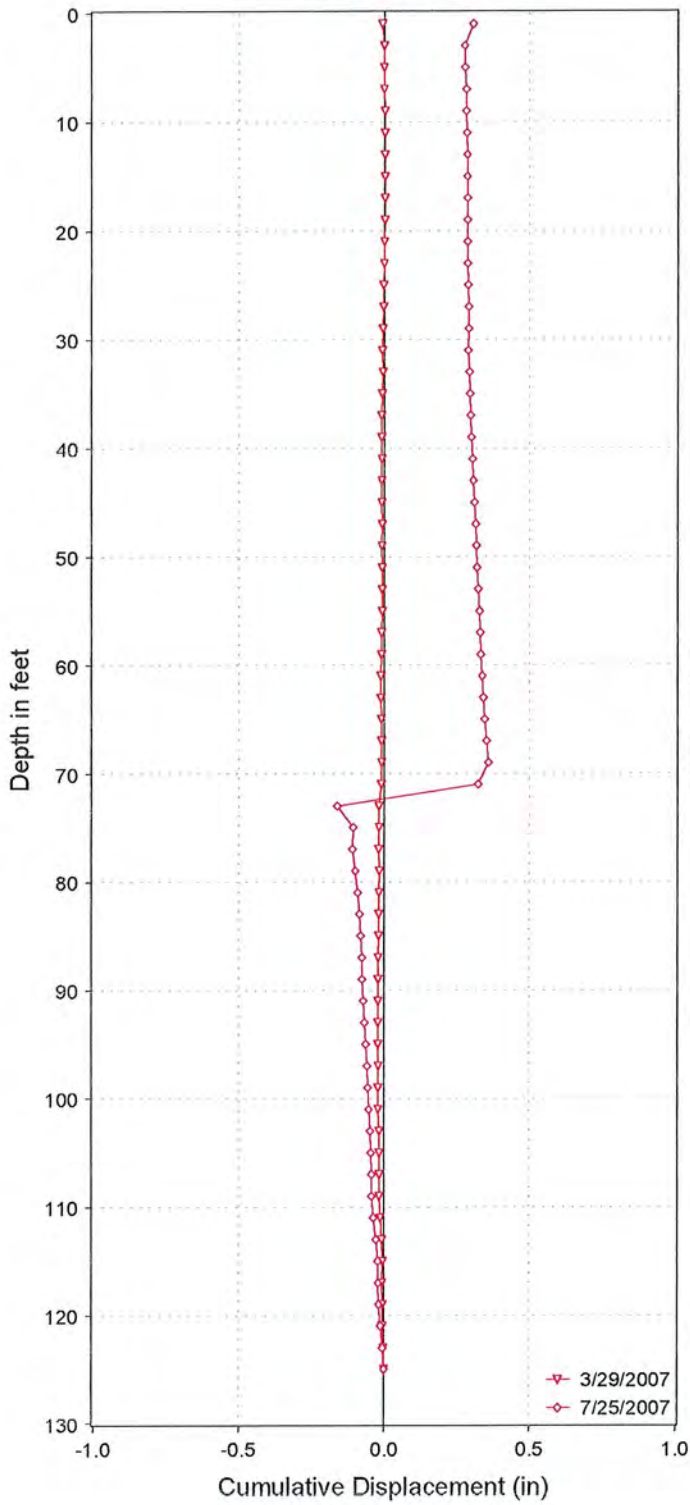
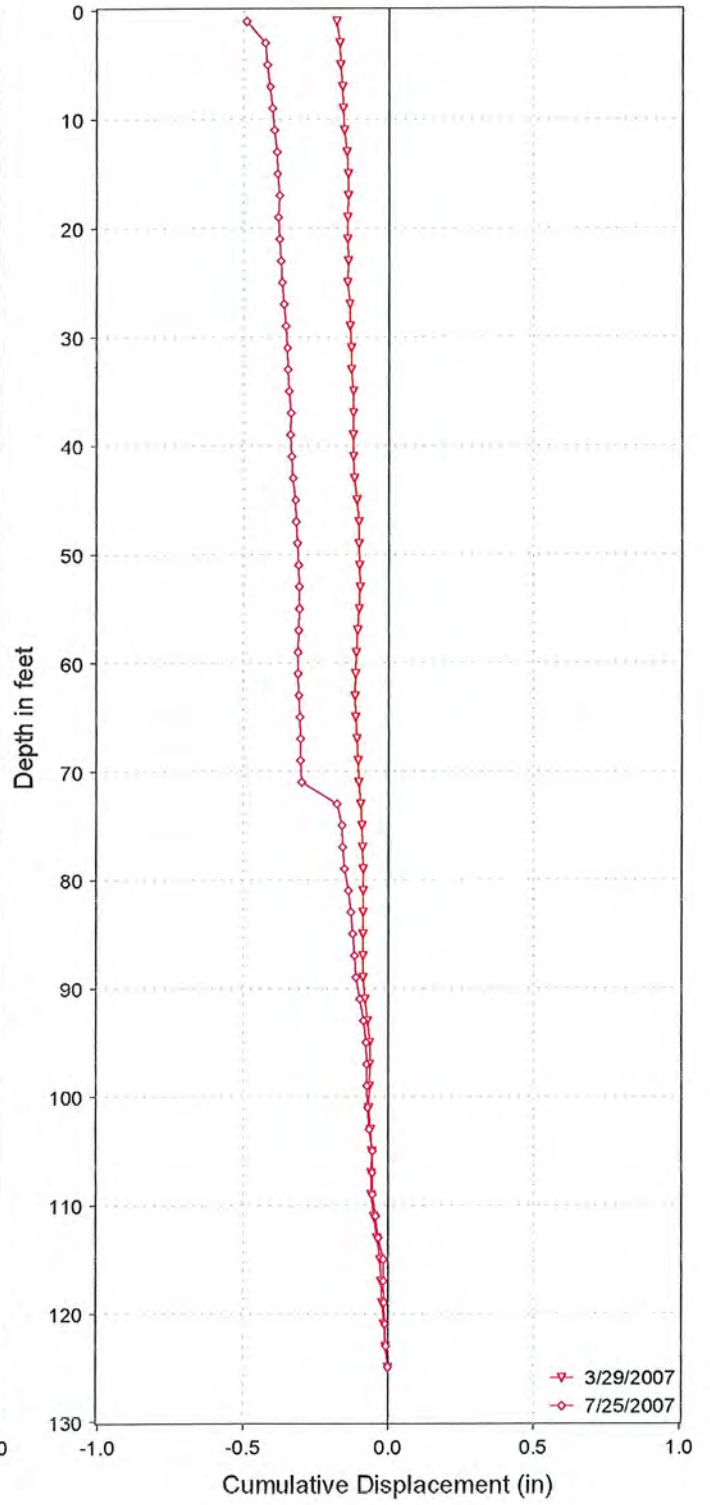
SI-2, A-Axis

To date, we have taken two readings after the baseline for the slope inclinometers we installed at the site. The readings indicate a deflection of the slope inclinometer casing at a depth of about 72 feet in SI-2. The casing has deflected about ½ inch since installation (about 5 months).

2947.100 - Open space slope below  
lots 59 through 61  
Base Line Reading Date: 2/20/07  
A+= B+=

Based on the depth and apparent rate of movement observed in SI-2, our aerial photograph interpretation and experience in the area, we recommend expanding the area of slope monitoring

by installing additional slope inclinometers. In order to correlate the subsurface conditions with slope inclinometer readings, the additional boreholes needed for slope inclinometer installation should be drilled and continuously sampled with a bedrock-coring rig. On a preliminary basis, we recommend the addition of three slope inclinometers at the following locations:

- One along the midslope bench about 175 feet north of SI-2, below Lot 63, to an approximate depth of 125 feet.
- One along the midslope bench about 175 feet south of SI-2, below Pebble Beach Drive, to an approximate depth of 125 feet.
- One along the toe of slope below SI-2, to an approximate depth of 150 feet.
