January 28, 2025 (revised 1/30/2025)

BSK Project No. G24001595

SUBJECT: Annual Geological and Geotechnical Site Reconnaissance – 2024-2025
Oakhurst Geological Hazards Abatement District (GHAD)
Clayton, CA

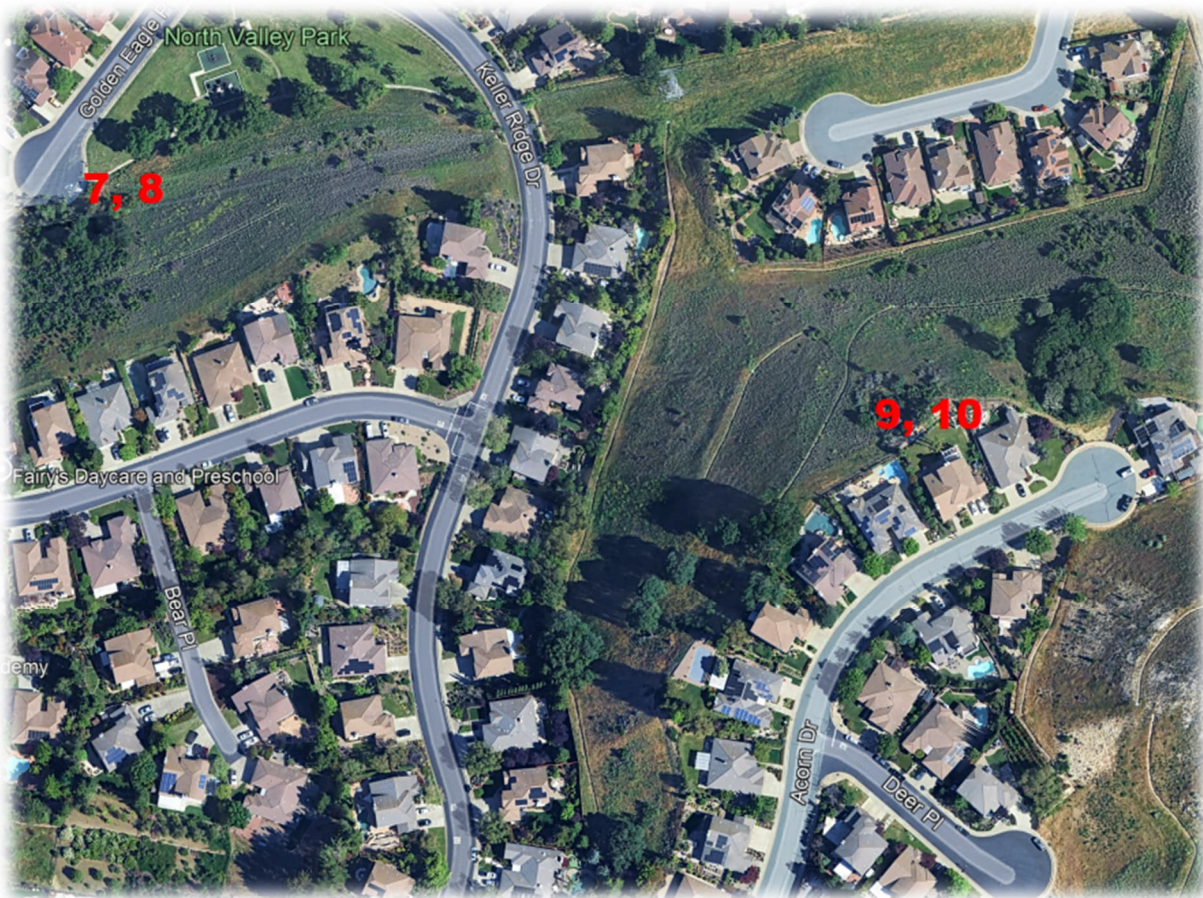
Exhibit 7 – Site Plan (Kelok Way Area). Photograph numbers shown in red.

In general, we observed surface creep above most V-ditches. Periodic maintenance should be sufficient to prevent soil from entering and disrupting flow in the ditches. Significant organic debris are present in the V-ditches, especially south of Keller Ridge Drive, and should be cleaned. The drain inlet shown in Photograph 9 from our March 1, 2024 letter still has not been cleaned. Overall, conditions remain similar to those observed during our 2023/2024 reconnaissance. The following photographs depict the conditions documented during our site review.
