March 9, 2023

BSK Project No. G00000499

**SUBJECT:      Geological and Geotechnical Site Review  
                 Oakhurst Geologic Hazards Abatement District (GHAD)  
                 Clayton, CA**

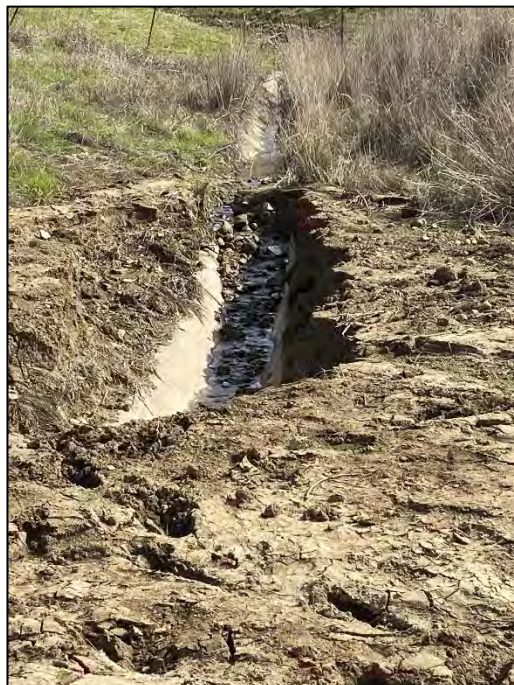
*Based on our communication with the City, we understand that during the early 2023 rain storms, a debris-flow occurred within a swale/V-ditch located upslope of Clayton Road and south of Peacock Creek Drive (circled in red), which clogged a drop inlet and caused water to overflow onto Clayton Road.*

- Storm damage debris retention basin above Windmill Canyon Drive is no longer able to stop and retain debris flow materials. The basin will require reconstruction of the earthen berm that was in-place to stop and retain flow.
- The Swale/V-ditch located upslope of Clayton Road and south of Peacock Creek Drive should be repaired and the drop inlet should be unclogged.

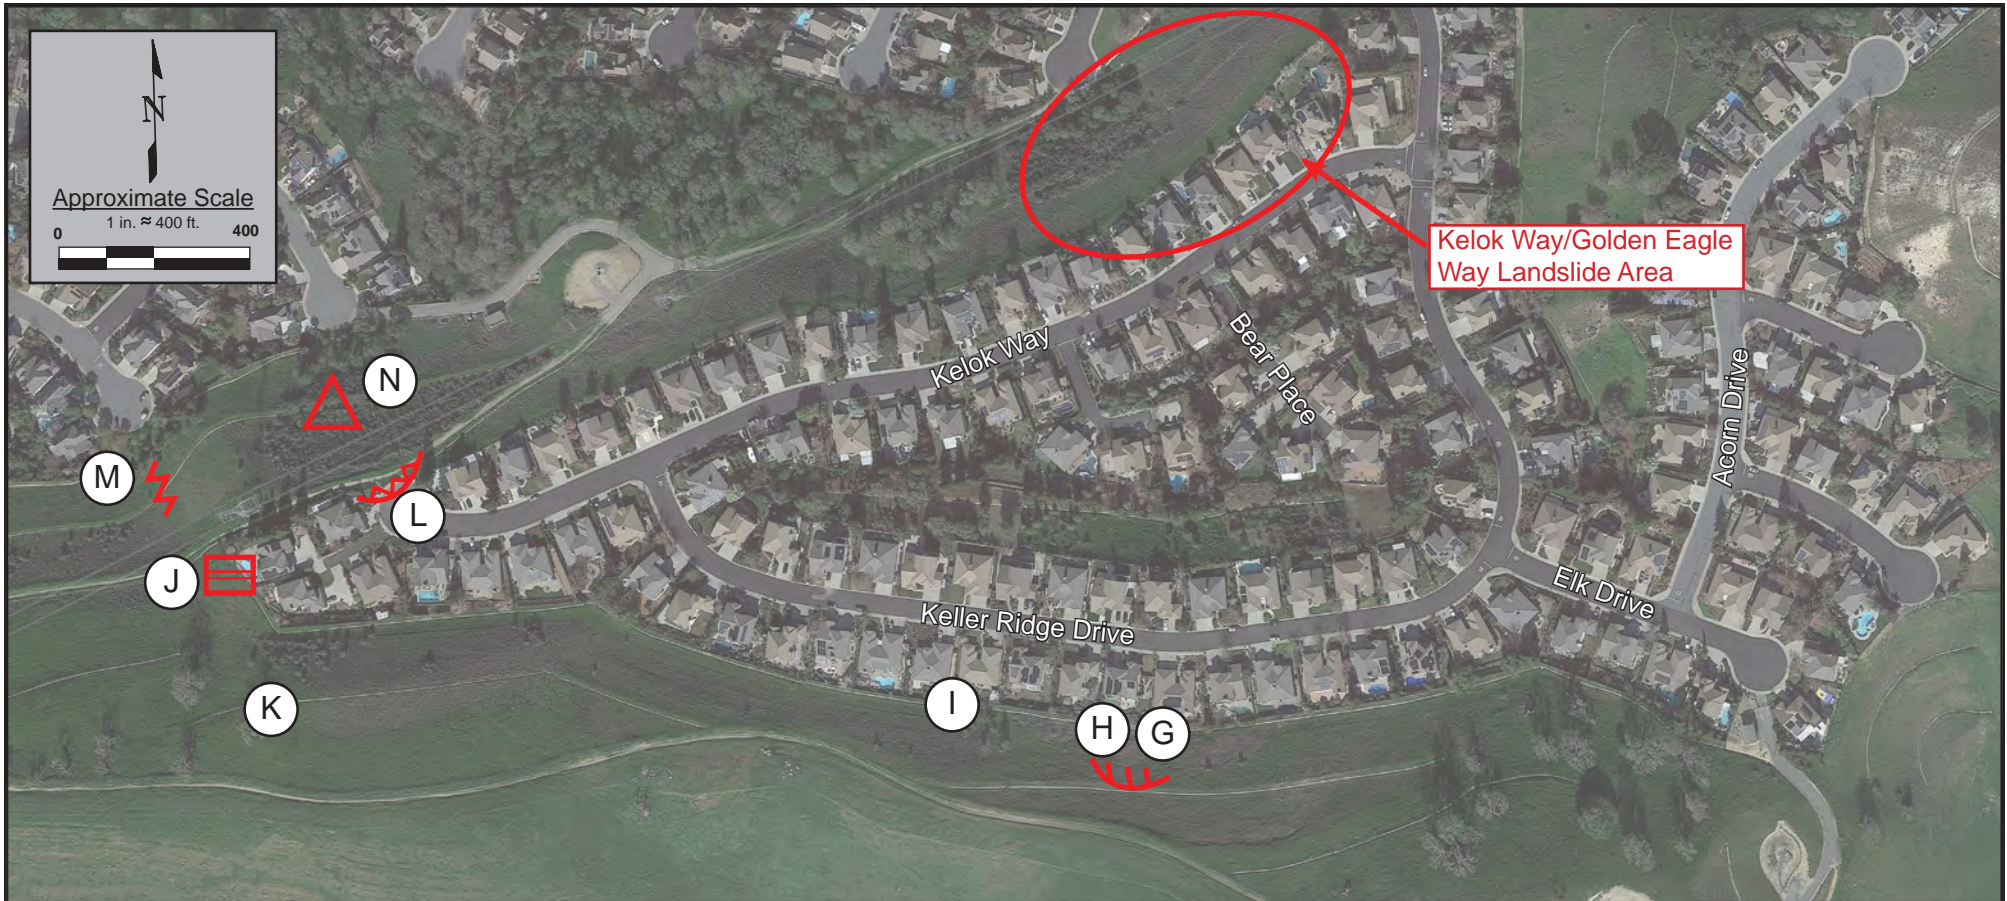
FIGURE  
**3B**

- Significant settling and downslope movement on the north side of the Cul-de-sac at Kelok Way is likely to result in failure of the pavement, failure of utilities traversing the area of instability, and continue to cause damage to the residence at 8053 Kelok Way. It is unclear how much the incipient landslide mass may have moved, and at what rate it is moving, since the inclinometer that was used to gauge movement has been compromised. We strongly recommend that a replacement inclinometer be installed and, together with available piezometers that have been installed during previous investigations, monitoring of both the inclinometer and piezometers should be resumed. If possible, additional inclinometers should be considered to better isolate stable ground versus landslide mass.

- Monitoring of inclinometers between Kelok Way and the park by Golden Eagle Way should also be resumed. We recommend that the seven inclinometers (BGC SI-1, CEG SI-1, CSA SI-1, CSA SI-2, CSA SI-3, W SI-1 and W SI-5) be monitored at least twice per year, preferably quarterly. Depth to groundwater in each inclinometer should also be measured and logged.
- All subdrain clean-outs and discharge pipes for the slope should be located and flow should be measured (or approximated). Depth to water and discharge should also be measured and recorded for the dewatering wells in the roadway at Kelok Way.

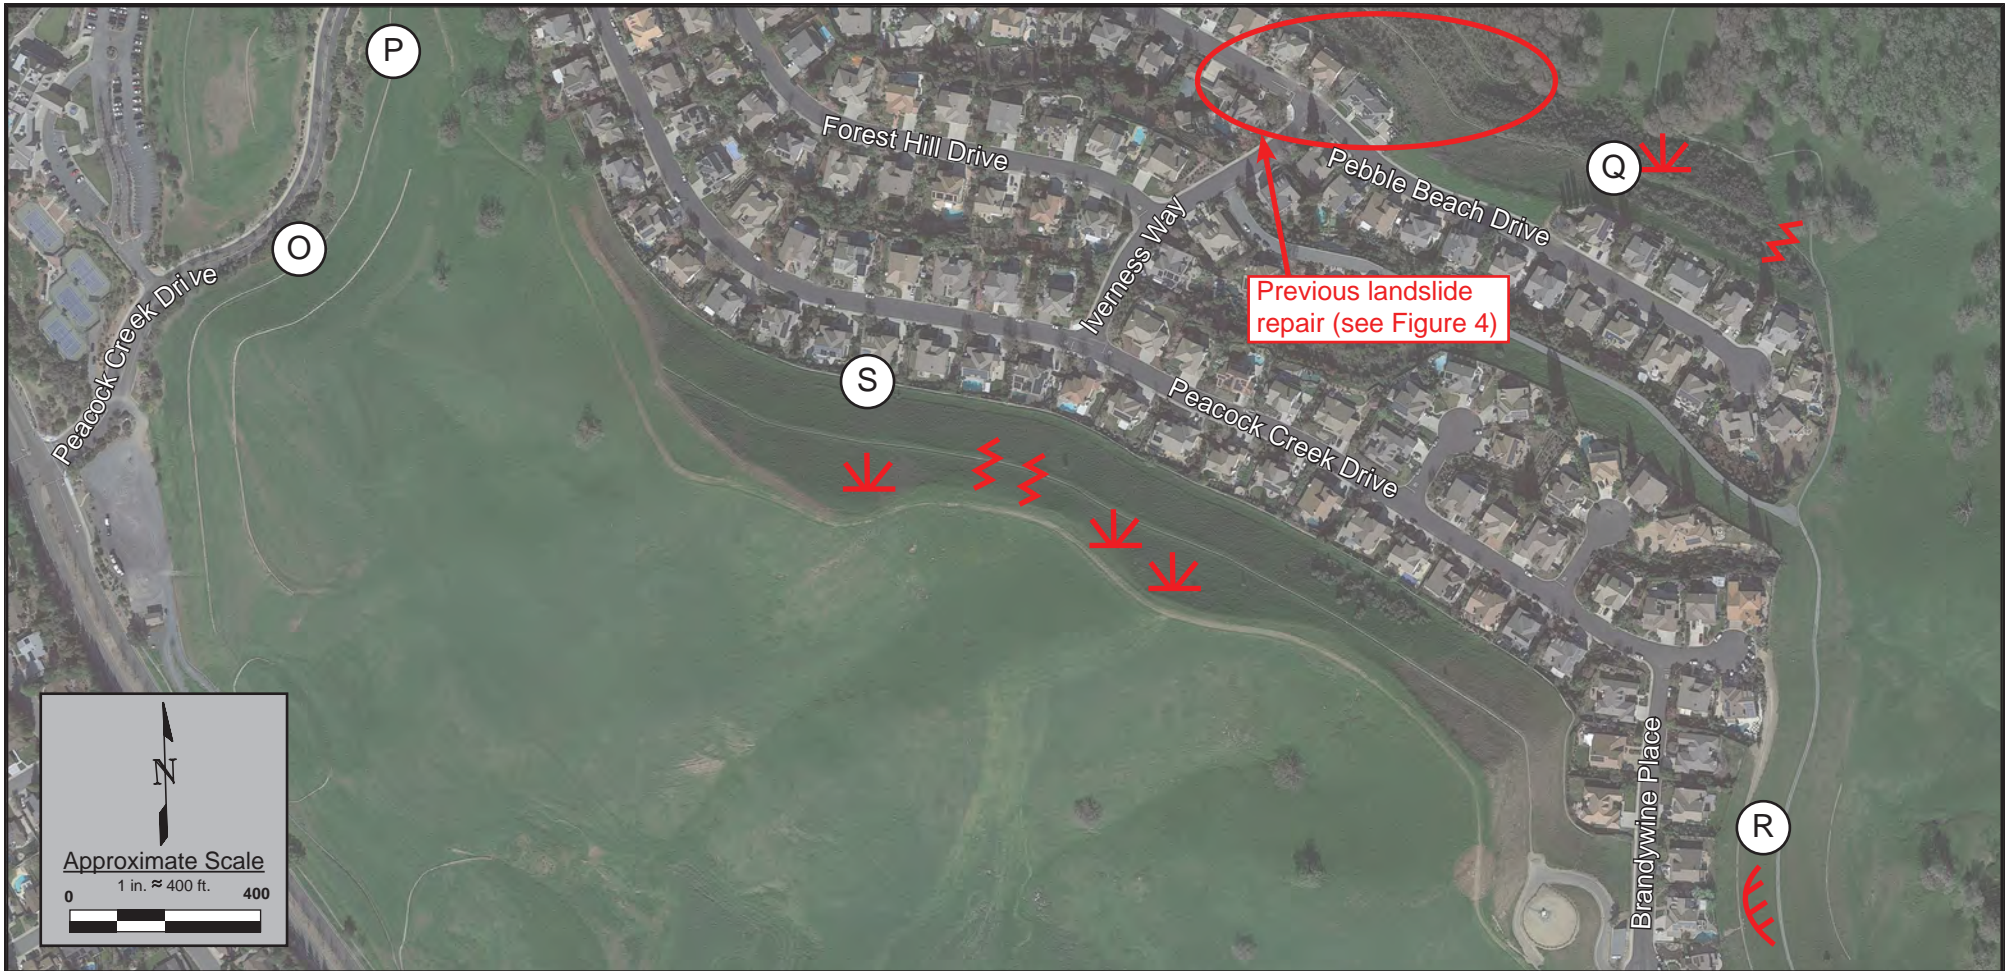
The following photos depict the conditions documented during our site review. The approximate photo locations are presented on Figure 3C.

- Moist and hummocky slopes above Peacock Creek Drive and east of Brandywine place indicate large areas of shallow slope instability that could result in shallow flows during heavy rain events.
- Cracked and/or offset V-ditch panels, while not numerous, can result in drainage obstructions, overflow, and erosion to slopes. Patches and/or replacement of V-ditch panels should be prioritized and undertaken on a regular basis.
- V-ditch and drop inlet maintenance should be continued and inspections of the drainage system, slopes and pavements should be continued. We recommend that drainage system maintenance occur prior to the onset of the rainy season each year. Inspections should take place prior to maintenance.
